Title: Cab Door Latch Stuck, Door will not open

Applies To: MV, HV, RH, LT, 2018 LoneStar

This document will guide the user through getting a jammed cab door open and properly adjusting the cab door latch assembly when the door is hard to unlock or will not open at all.

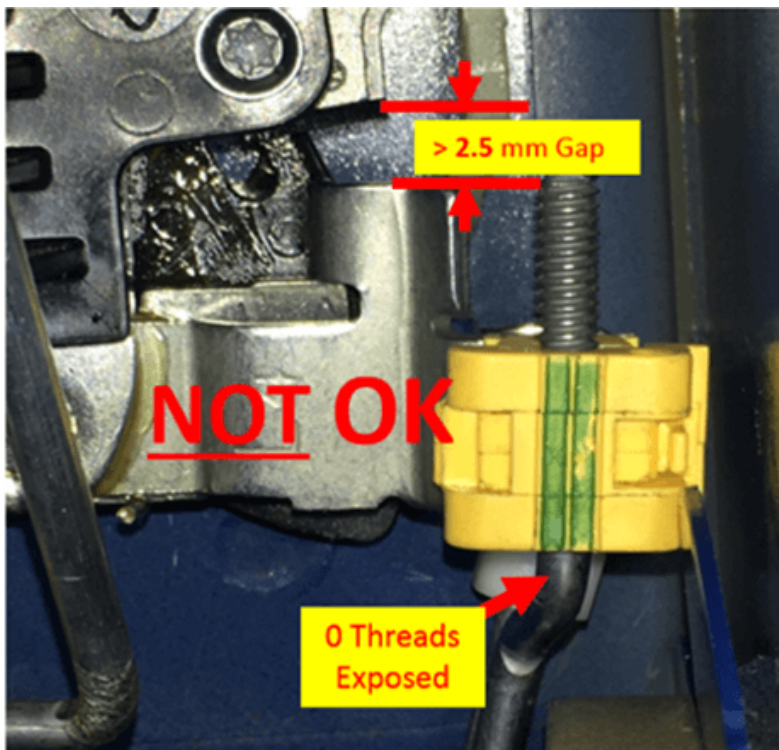
Exterior handle lever has preload due to improper assembly at the factory. This failure shows up right away after build very early in the truck's life. (Truck Movers finds them on the exit lot) If the yellow clip is fastened to the threaded rod causing the latch lever to rotate down, this can cause the latch to fall into a dead zone where the door cannot be opened from inside or outside.

Step 1: With the door assembly apart including pulling back part of the plastic vapor barrier, check for threads showing on the bottom of the rod under the yellow retaining clip shown below. Trucks built after September 10, 2018 will have a nut under the yellow clip in place of the open threads showing.

See photo below for an example of an **INCORRECT** adjustment. The yellow clip is too low.

Step 3: Undo clip and readjust as shown in step 2; Once correctly adjusted you will need to completely assemble the interior door assembly to properly test the latch.

NOTE: If the yellow clip is damaged or stripped the lock assembly will need to be replaced. The yellow clip is not a separate service part at this time.

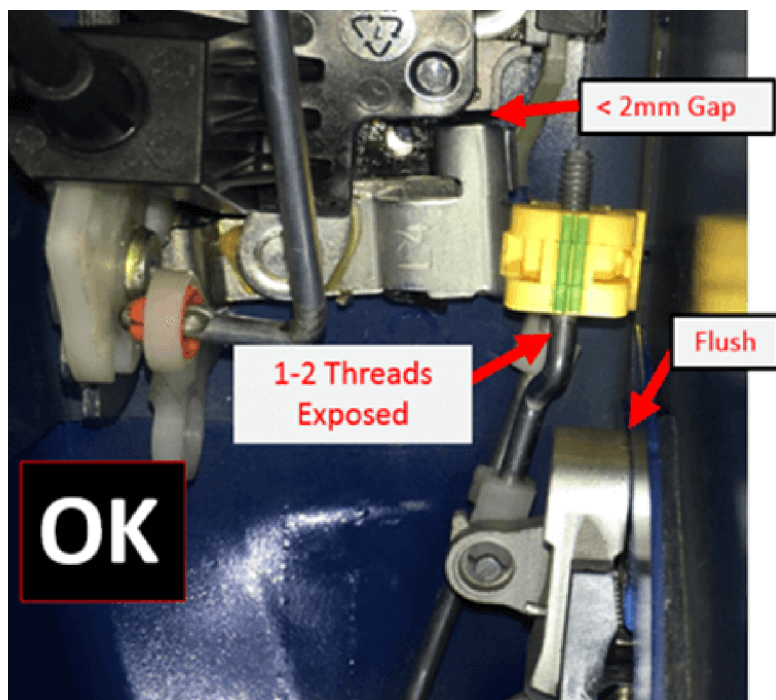
Step 2: See photo below of an example of a **CORRECTLY** adjusted door assembly. (Not pictured; there may be a nut threaded onto the rod under the yellow clip in place of the exposed threads.)

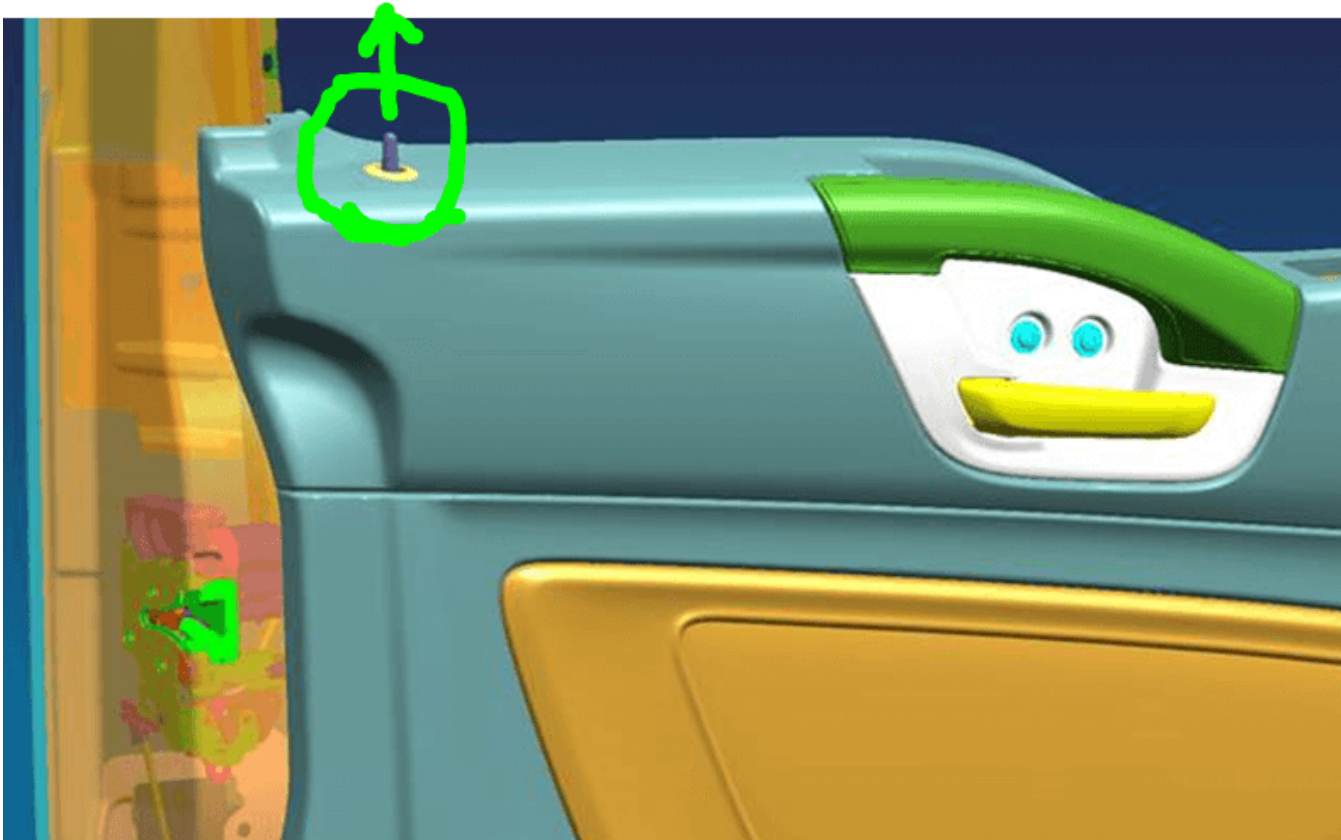
Two levers inside the door latch assembly bind together and jam. There have been reports in which an occupant has pushed down on the lock button at the back of the door where it may get jammed in the locked position; then when trying to open the door from the inside, it causes the internal lock lever to get stuck behind the handle lever (Inside the latch assembly) causing the door to be inoperable. (Not able to be opened from the inside or outside.)

NOTE: Also note that in some cases the trim ring around the door lock knob may have to be removed to be able to grab the knob to pull it up.

Step 1: If a door is not able to be opened using the inside handle or exterior handle, pull up and hold the interior door lock knob/rod in the upper unlocked position while pushing the power door unlock button on the door pod switch. This action should unjam the internal latch levers. If the truck does not have power locks pull the interior door handle while hold the lock knob/rod in the upper unlocked position.

Step 2: Then while still holding the interior lock knob/rod up, pull the interior door pull and the door should open.

Step 3: Once you get the door open follow the interior door panels removal procedures outlined in the service manual to gain access to the door latch assembly to remove and replace with new service part. Once the new latch is installed and correctly adjusted you will need to completely assemble the interior door assembly to properly test the function of the latch.
