GROUP BOD	MODEL 2020MY Telluride (ON)
	NUMBER 196	DATE October 2019
TECHNICAL SERVICE BULLETIN		
SUBJECT: SERVICE ACTION: 2ND ROW SEAT EASY ENTRY CABLE INSPECTION AND REPAIR (SA406)

This issue number is **SA406**.

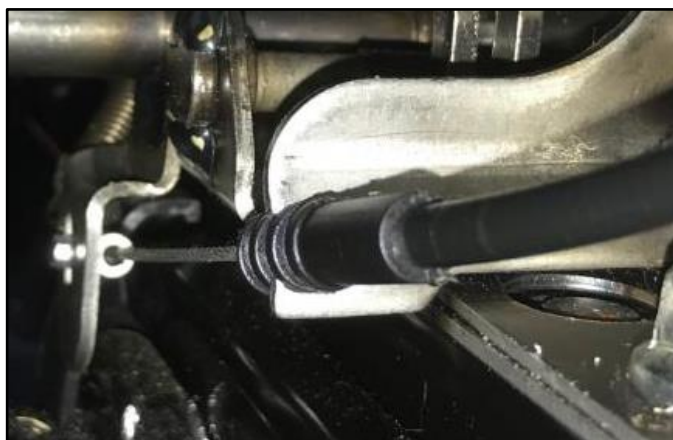
This bulletin provides information on how to inspect and repair the 2nd row easy entry cable on some 2020MY Telluride (ON) equipped with captain chairs, produced between June 03, 2019 through July 31, 2019, which may exhibit normal seat folding, but no forward sliding operation when pressing the easy entry button due to the seat release cable not properly secured to the retaining bracket. To repair this concern, follow the procedure outlined in this bulletin. Before conducting the procedure, verify that the vehicle is included in the list of affected VINs.

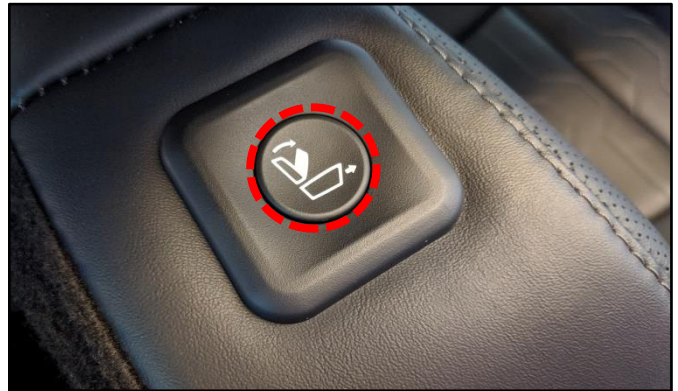
1. Press the Easy Entry button on the 2nd row seat. (LH side shown)

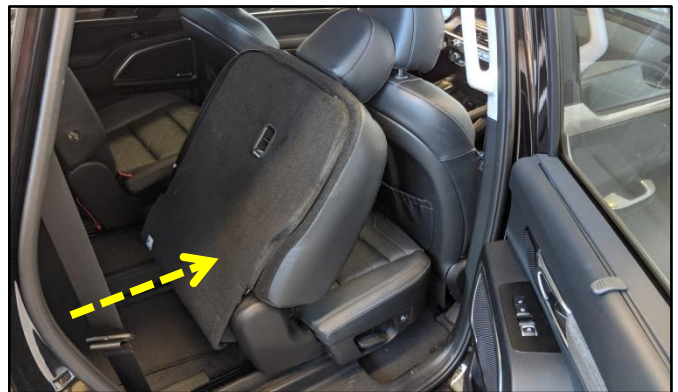
2. The 2nd row seat should slide forward automatically.

If the seat does slide forward automatically, proceed to step 3.

If the seat does not slide forward automatically, slide the seat manually by pushing forward.

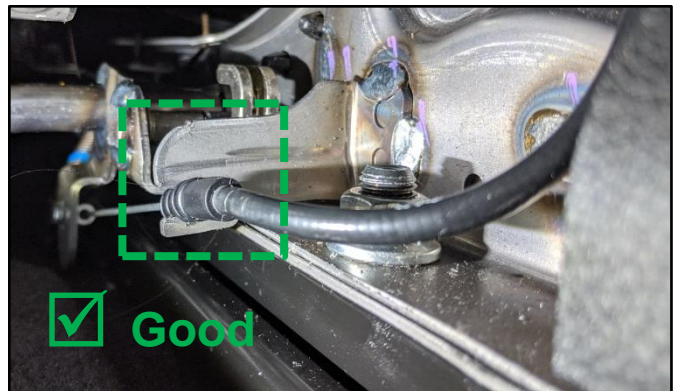
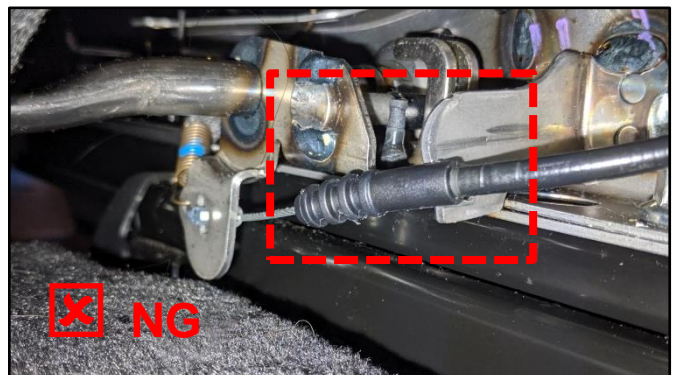
3. Locate the seat release cable under the back of the 2nd row seat assembly and check that it is correctly attached to the cable retaining bracket.

If the release cable is attached correctly (**Good**), this service is complete and further action is required.

If the release cable is **not** attached correctly (**NG**), pull the seat to the upright position and proceed to page 3 to attach the seat cable correctly.
