MODEL
2014MY
Soul (PS)

NUMBER
152 (Rev 1, 10/28/2019)

TECHNICAL SERVICE BULLETIN

SUBJECT: MULTI-FUNCTION SWITCH REPLACEMENT
FOR HEADLAMP FLICKERING

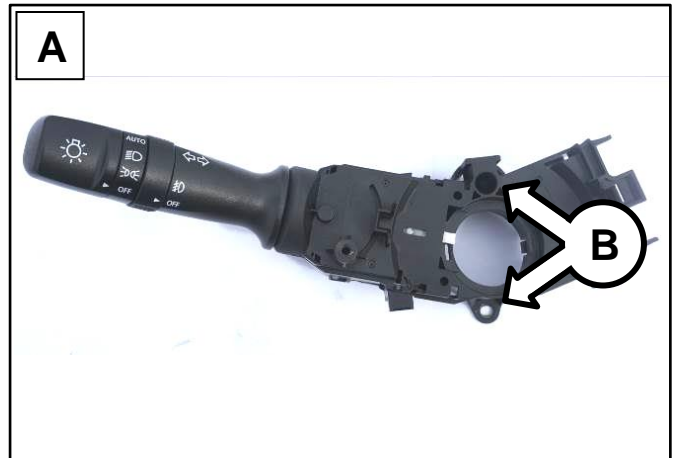
This bulletin provides the procedure to replace the multi-function switch on some 2014MY Soul (PS) vehicles, produced from July 21, 2013 through June 20, 2014, which may exhibit intermittent flickering of the low/high beams. To duplicate the concern, repeatedly operate the multi-function switch by activating the following:

1. Replace the multi-function switch (A) by referring to the “Body Electrical Switch → Multifunction Switch → Repair procedures” chapter in the applicable Shop Manual on KGIS.

Be sure to replace the two (2) multi-function switch retaining screws (part no.: 12290 05121) (B) when installing the new switch (A).
