GROUP ELE	MODEL 2018-2019MY Niro (DE EV/PHEV)
	NUMBER 186 (Rev 1, 10/14/2019)	DATE September 2019
<h2>TECHNICAL SERVICE BULLETIN</h2>		
<b>SUBJECT:</b> SERVICE ACTION: ELECTRIC WATER PUMP INSPECTION AND REPAIR (SA394)

This bulletin provides the procedure to inspect and repair the Electric Water Pump(s) (EWP) on some 2018-2019MY Niro (DE) HEV, PHEV, and EV vehicles produced between November 24, 2018 through January 30, 2019, which may exhibit a MIL ON (DTC U1116 and/or U1118) due to a coolant leak from the EWP Can Case. Follow the procedure in this bulletin to inspect and repair the EWP. Before conducting the procedure, verify that the vehicle is included in the list of affected VINs.

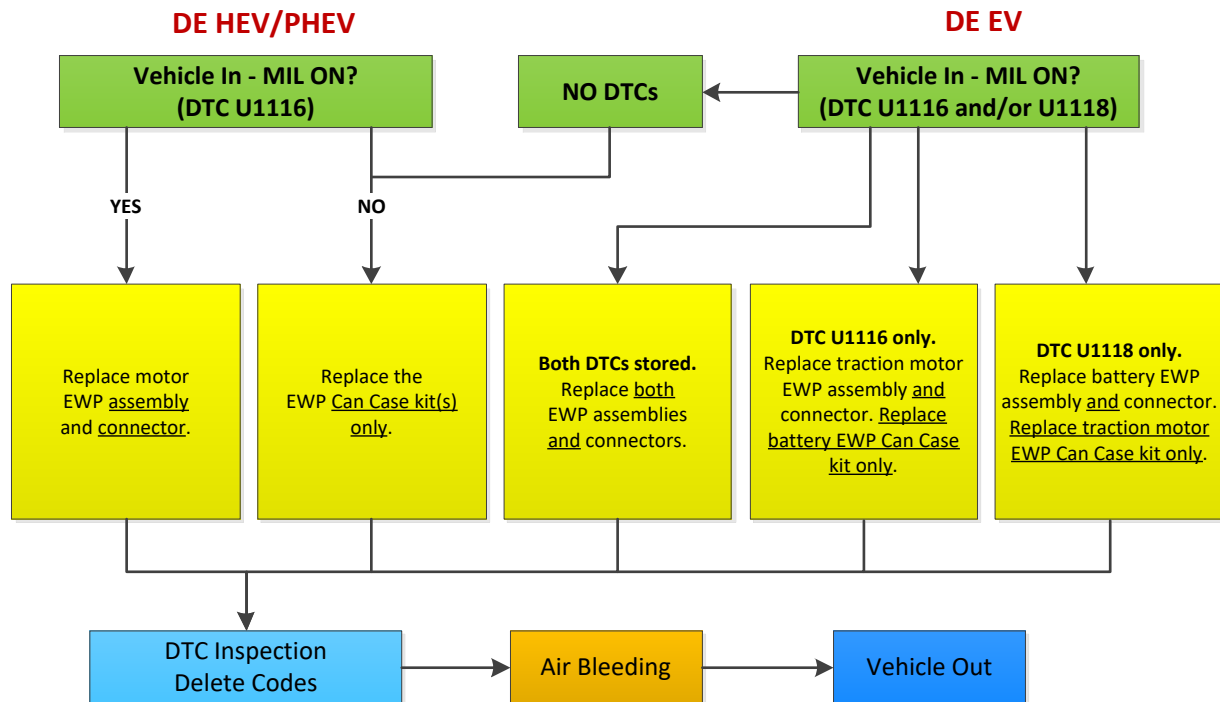
### EWP Repair Flowchart:

Model	MIL ON	Repair Procedure
(DE) (HEV/PHEV)	DTC U1116	Replace the <u>hybrid motor</u> EWP assembly and EWP connector.
	<u>NO</u> DTCs	Replace the hybrid motor EWP <u>Can Case kit only</u> .
(DE) (EV)	DTC U1116 <u>and</u> U1118	Replace the <u>both</u> the battery and traction motor EWP assemblies <u>and</u> EWP connectors.
	DTC U1116	Replace the traction motor EWP assembly <u>and</u> EWP connector. Replace the battery EWP Can Case kit.
	DTC U1118	Replace the battery EWP assembly <u>and</u> EWP connector. Replace the traction motor EWP Can Case kit.
	<u>NO</u> DTCs	Replace the traction motor <u>and</u> battery EWP <u>Can Case kits only</u> .
