GROUP ELE	MODEL 2020MY Telluride (ON)
	NUMBER 189	DATE October 2019
TECHNICAL SERVICE BULLETIN		
SUBJECT: SERVICE ACTION: RAIN SENSOR INSPECTION AND/OR REPLACEMENT (SA402)

This issue number is **SA402**.

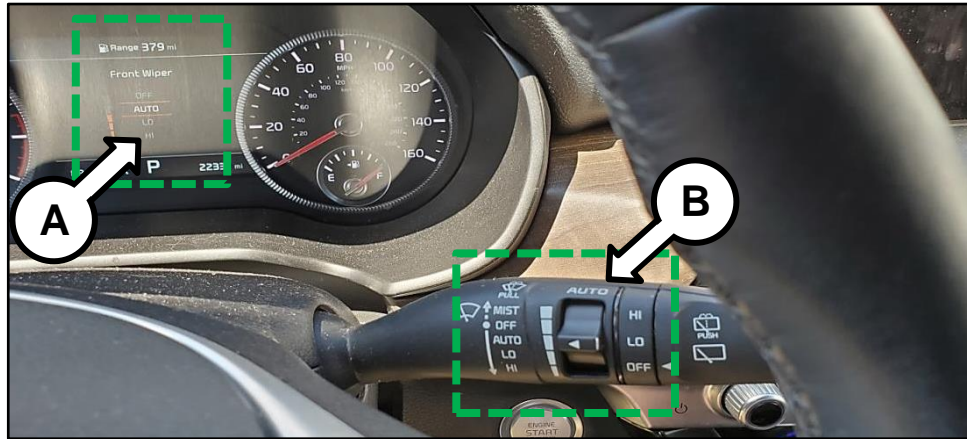
1. Turn the engine 'ON' and set the front wiper function to "AUTO" mode in the instrument cluster (A). Set the wiper switch (B) setting also in the "AUTO" position.

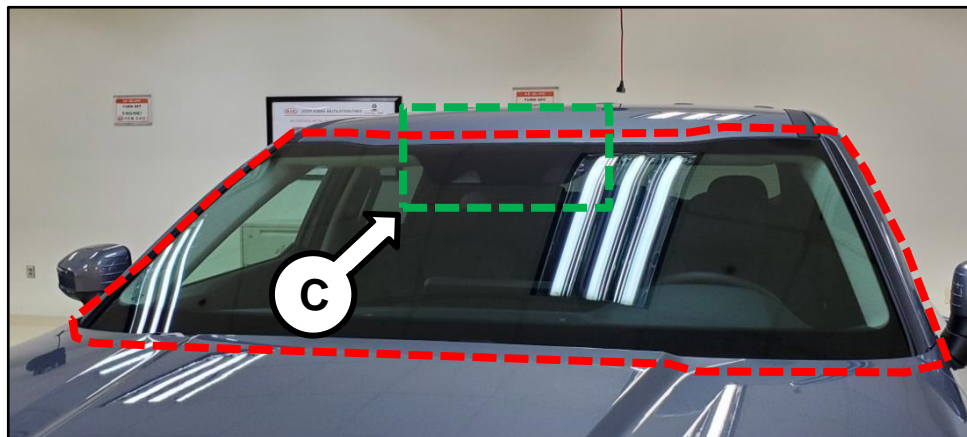
2. Ensure that the windshield (C) is clean and free from dirt or debris especially around the upper center area (outlined in green).

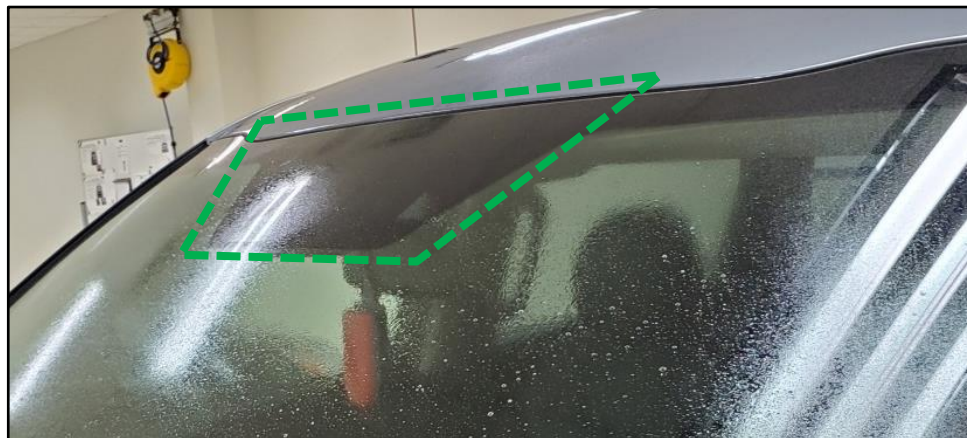
3. With the engine 'ON' and vehicle in 'PARK', use a water spray bottle begin to spray water in the top center windshield area, in front of the rear view mirror. If the front wipers operate automatically, this action is complete. No further action is required. If the front wipers **do not** operate automatically, then proceed to page 3.

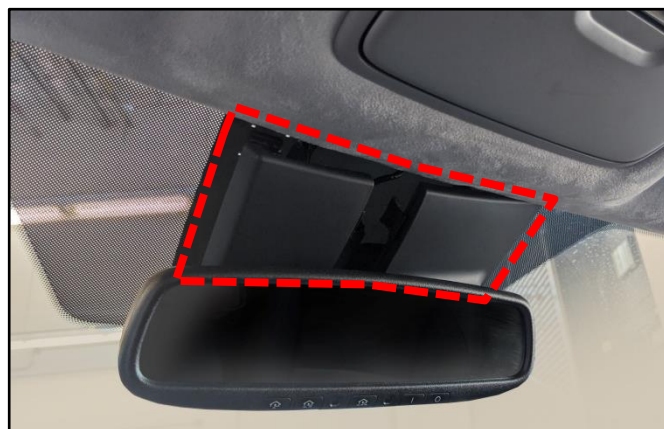
1. Remove the inside rearview mirror cover by referring to the "Body Electrical System → Wiper/Washer → Rain Sensor → Repair procedures" chapter in the applicable Shop Manual on KGIS.

Do not remove the rain module and sensor assembly at this time. Proceed to step 2.

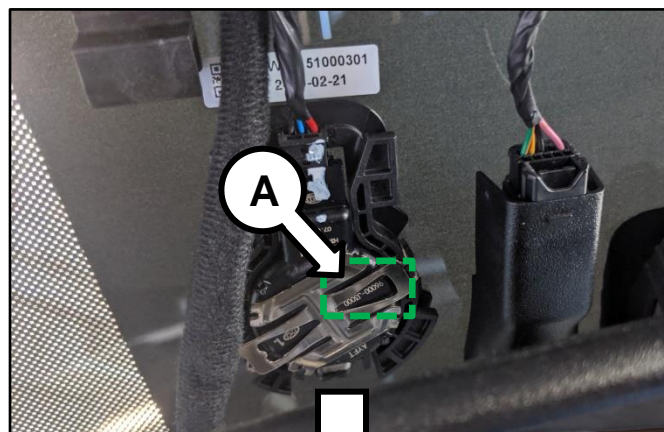
2. If the existing rain module and sensor assembly part number (A) does **not** match (P/N 96000 J3000), remove the existing rain module and sensor and replace it with the **96000 J3000FFF** part listed in page 5 as outlined on KGIS.

If the existing rain sensor is the correct part number (P/N 96000 J3000), proceed to diagnose and repair according to normal service guidelines and procedures.

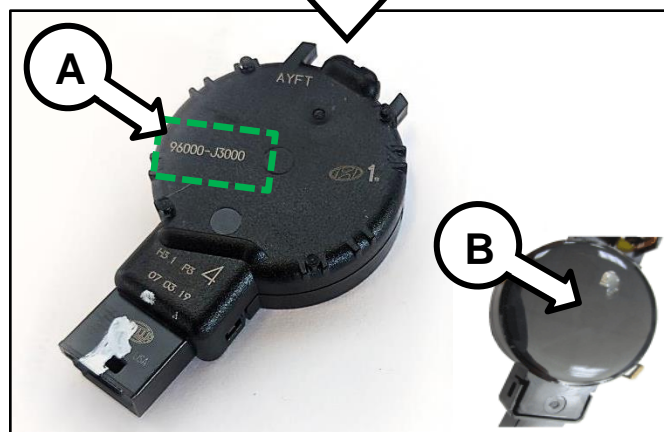
The windshield facing side (B) of the rain sensor has a film of silicone that is sensitive to foreign substances. Be careful not to touch.

3. Replace all of the other removed parts in the reverse order of removal.
