GROUP ENG	MODEL 2017-2018MY Forte (YDm)
NUMBER 208 (Rev 1, 10/16/2019)	DATE June 2019

TECHNICAL SERVICE BULLETIN

SUBJECT: ECU LOGIC IMPROVEMENT FOR P0300, P0301, P0302, P0303, P0304 AND/OR P219C00, P219D00, P219E00, P219F00

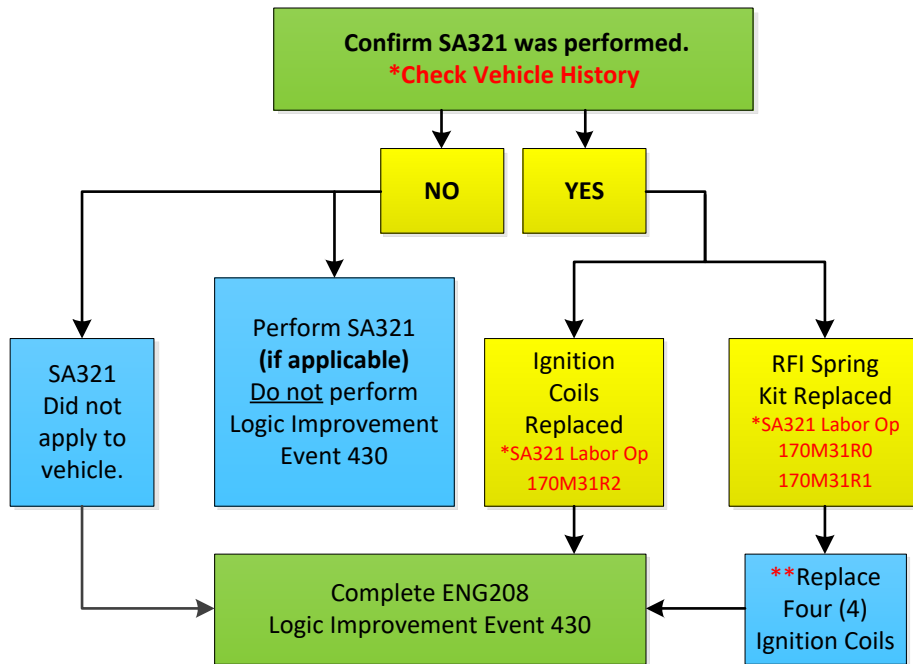
Flowchart:

Refer to Flowchart on page 2: Prior to upgrading the ECU Logic confirm SA321 has been completed.

*Check Vehicle History **Refer to LTS for Labor Op and Time to replace the ignition coils.
