JLRTB02006NAS1

TECHNICAL BULLETIN

412-01A

Reduced Air flow From Front Air Vents

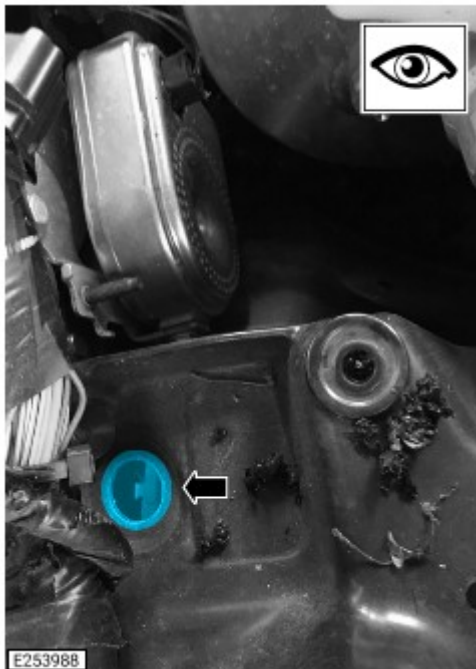
3.

Locate the hole on the right suspension top mount assembly, highlighted in the illustration.

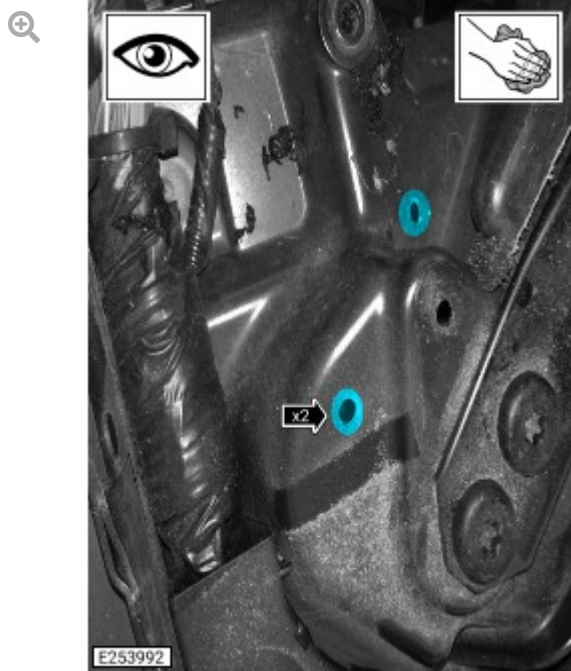
8.

Locate the 2 small holes on the right suspension top mount assembly.

- ■ Clean the area highlighted in the illustration.
