JTBO0677NAS2

TECHNICAL BULLETIN

307-01A

Oil Leak From Transmission

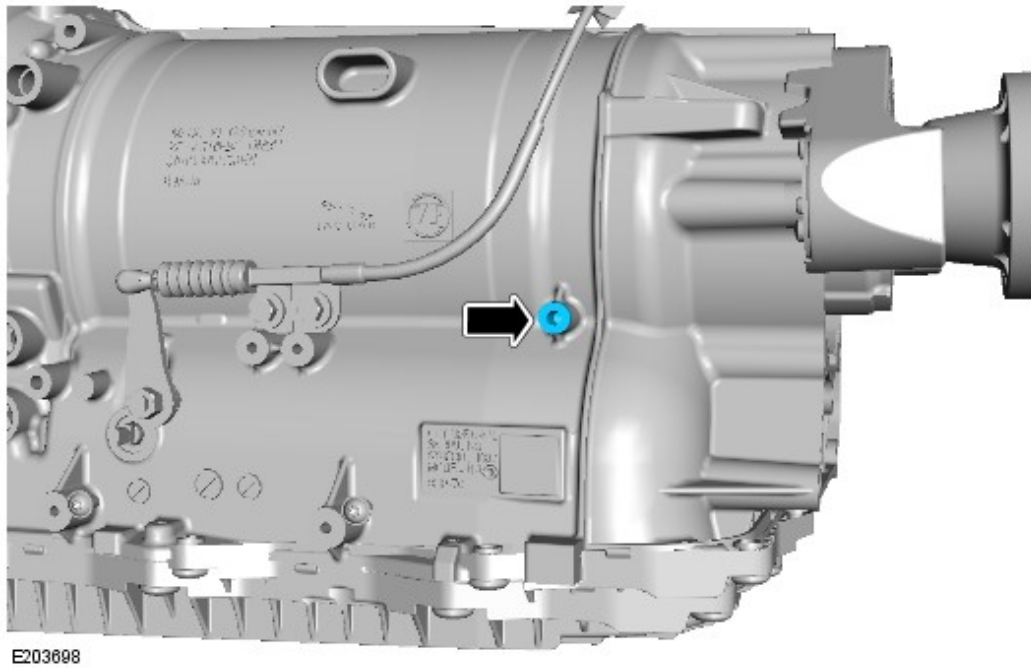
3.

Identify the root cause of the transmission oil leak.

- ■ If the transmission oil leak is from the area shown, **continue to step 4.**
 - ■ If the transmission oil leak is not from the area shown, **continue to step 5.**
-

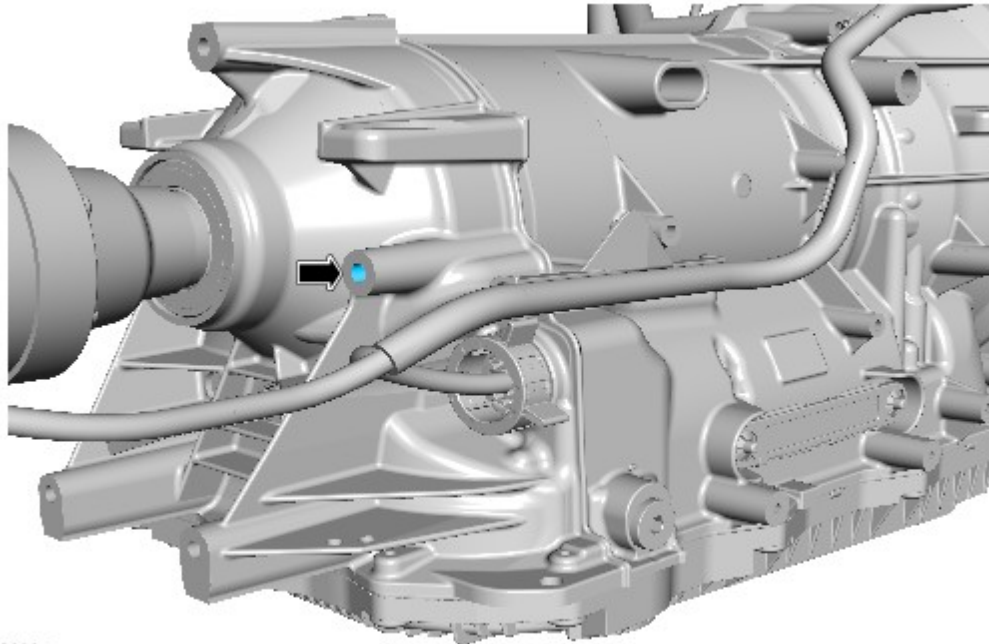
E239936

Identify the root cause of the transmission oil leak.

- ■ If the transmission oil leak is from the area shown, **continue to step 6.**
 - ■ If the transmission oil leak is not from the area shown, **continue to step 7.**
 - ■ If the transmission oil leak is not from the area shown and there was no transmission oil leak found in step 3, submit a Technical Assistance (TA) request with all supporting evidence attached.
-
