SERVICE BULLETIN

Classification: EL13-050c	Reference: NTB13-107c	Date: October 15, 2019
------------------------------	--------------------------	---------------------------

VEHICLE KEY NOT DETECTED / AUTHENTICATED ENGINE WILL NOT START

APPLIED VEHICLES: All Nissan vehicles equipped with Intelligent Key
OR Nissan Anti-Theft System (NATS) key

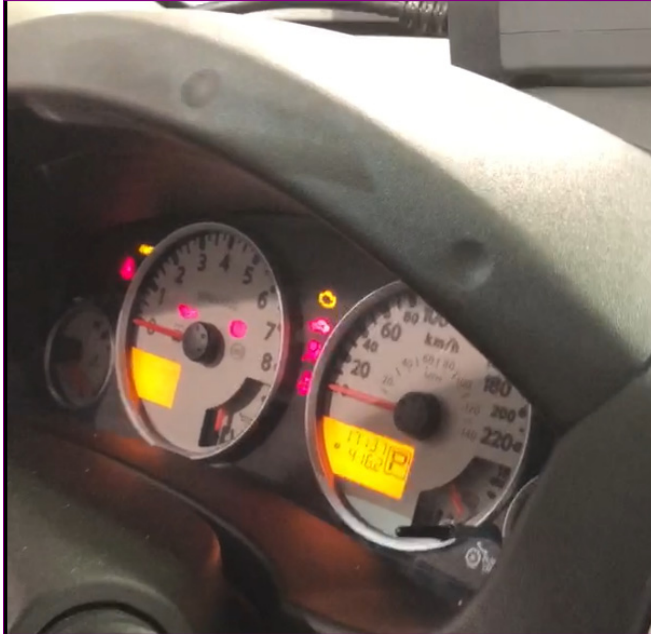
Figure 1

- If the key warning indicator on the dash remains illuminated during attempts to start the engine, this could indicate that the key was not authenticated properly.

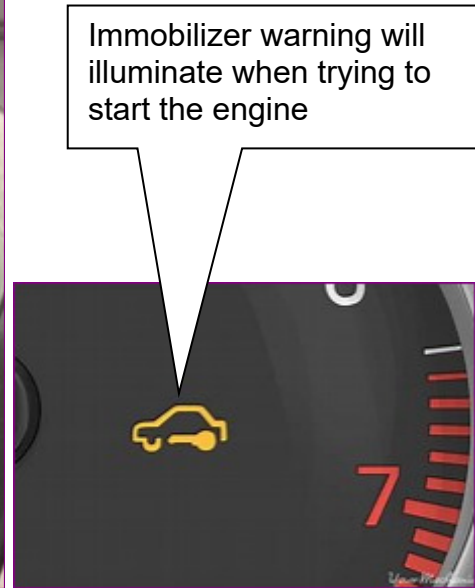
- The NATS key is not detected, causing:
 - The engine to **not** start (no response when the key is turned)
 - The Immobilizer warning lamp will illuminate (see Figure 2 on page 2)
 - DTCs B2191 (Difference of key) will be stored in the BCM, and P1615 (Difference of key) will be stored in the ECM

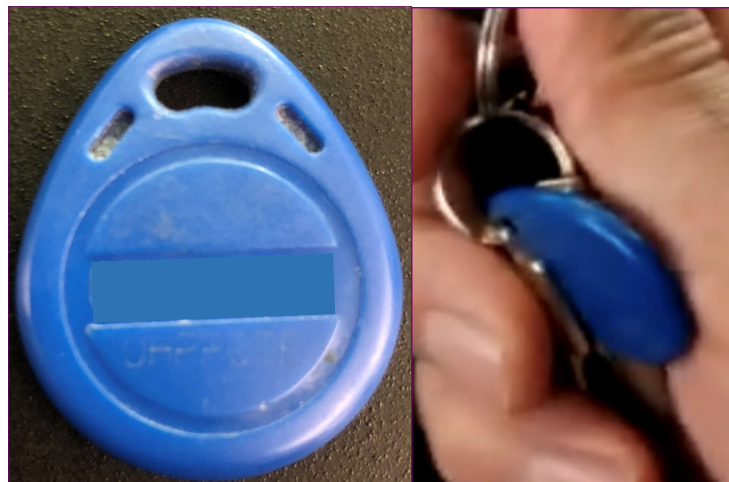
Figure 3

- If an RFID token (see Figure 3) is placed within close proximity to the vehicle key it can interfere with the RF signals, resulting in an inability to authenticate the key and cause a no start concern.
- Other contributors are:
 - Keys with a similar transponder frequency
 - Multiple keys on one keyring
- Remove all aftermarket devices from the vehicle, including all other keys, while diagnosing a no start concern.

- NATS keys also contain a transponder that can be affected by interference.
- For interference to cause a no start condition, the source of the interference will typically be in close proximity to the key; for example, an RFID chip on a key chain with the key. See Figure 3, below.

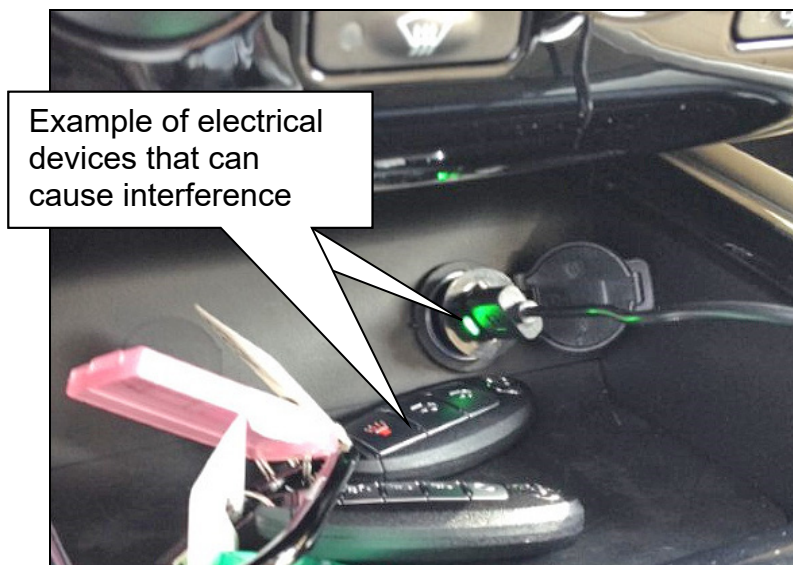
Figure 4

- If none of the previous are causing any symptoms, check for the presence of an aftermarket alarm system, radar detector, or **ANY** electronic devices, including other keys.
- RF signals coming from the vehicle surroundings can interfere with the key signals, such as radar detectors or aftermarket alarm systems **in other vehicles** or **surrounding buildings**.
- If you are unable to duplicate the concern, it is important to determine WHERE the vehicle was located when the customer experienced the no start concern.
