Service Bulletin No. 3123

MODEL: J series	TYPE: Service Information	SECTION/GROUP: 03-Body	DATE: 10/30/19
SUBJECT: Insulating the gap in the floor under the dash area			
CONDITIONS: Service Information Only

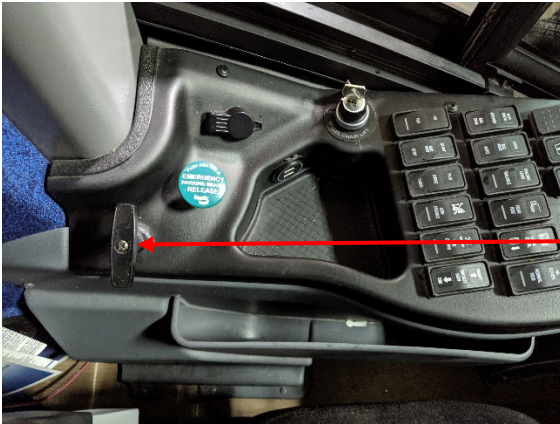
Pull the lever to
open Front Junction
Box door

Open the front junction box door by pulling the lever on the driver's left-hand console.

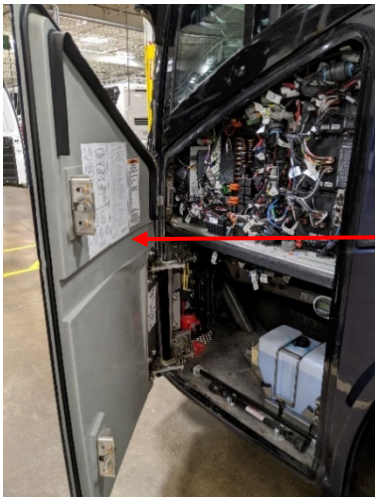
Opened Front
Junction Box door

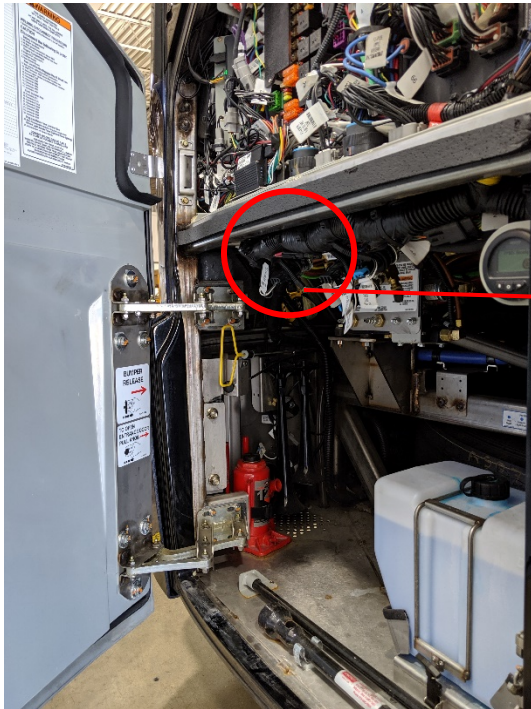
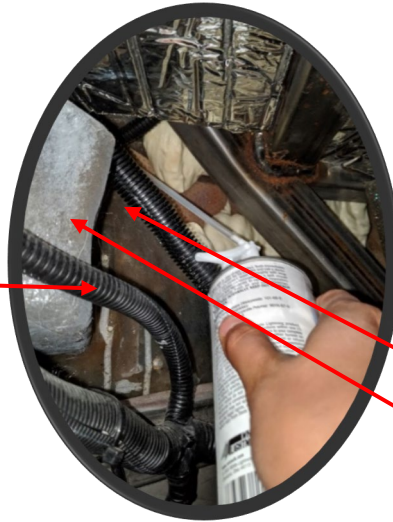
Un-insulated area

Head-light bucket

Spray the insulation foam under the driver's floor near the head-light.

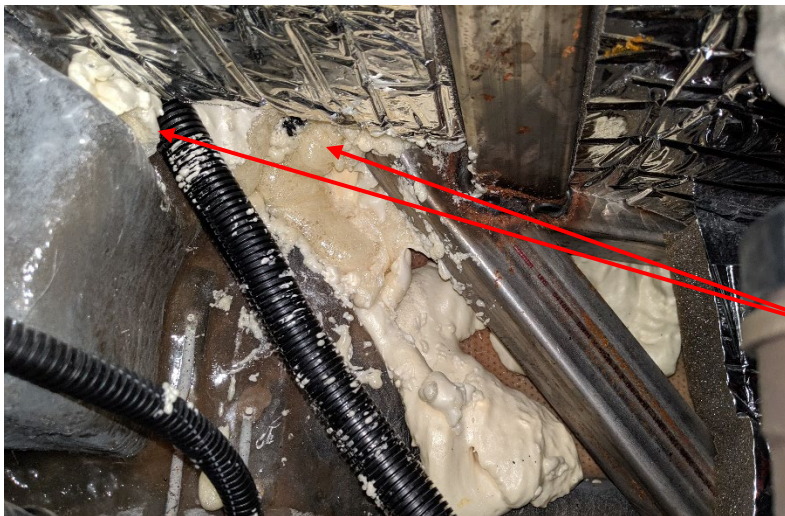
Newly sprayed insulation

Spray the insulation foam until the gap is sealed. Wipe off any excess.
