SERVICE BULLETIN

Classification:	Reference:	Date:
HA19-002	NTB19-080	October 24, 2019

2014-2020 ROGUE; NO AIR FLOW FROM VENTS DUE TO SNOW BUILD-UP

APPLIED VEHICLES: 2014-2020 Rogue (T32)
2017-2019 Rogue Hybrid (T32H)

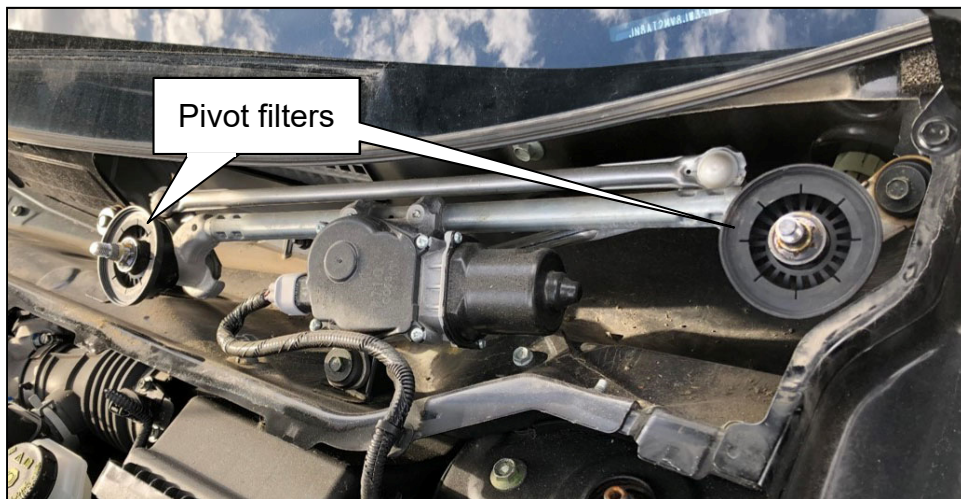
Figure 1

Make sure to install both wiper pivot filters. If the wiper pivot filters are not installed, snow may enter the blower motor inlet and cause damage to the blower motor.

1. Remove all snow, water, and any debris from the HVAC intake, cowl area, and where the blower motor mounts.
 - For removal of the cowl top cover and related parts, refer the Electronic Service Manual (ESM), section **BODY EXTERIOR, DOORS, ROOF & VEHICLE SECURITY – EXTERIOR – REMOVAL AND INSTALLATION – COWL TOP**.
2. Clean or replace the blower motor as needed.
3. If not already equipped: Install a wiper pivot filter on each wiper pivot (see Figure 1).
 - See **PARTS INFORMATION** on the last page of this bulletin.

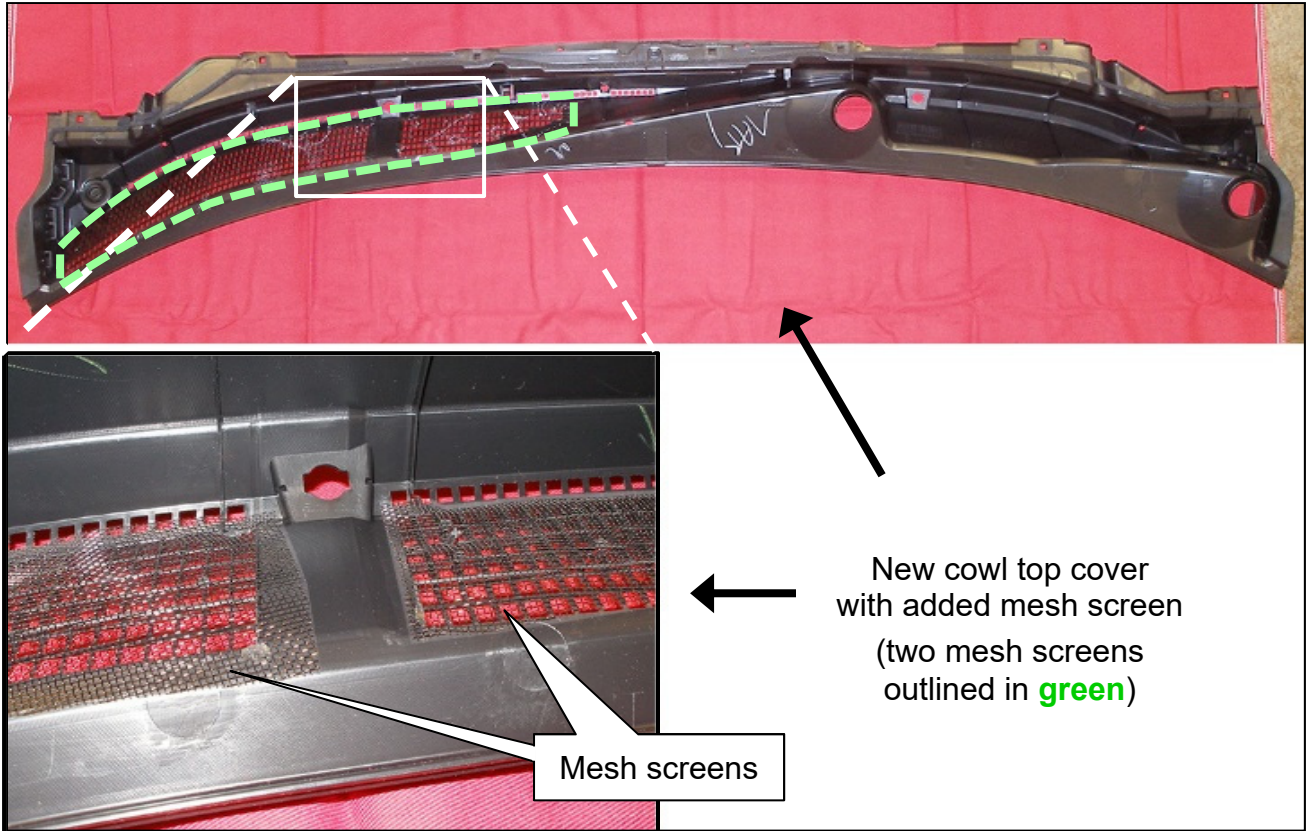
Figure 2

Make sure to install the new cowl top cover listed in **PARTS INFORMATION**. If the new cowl top cover is not installed, snow may continue to enter the blower motor inlet and cause damage to the blower motor.

4. Reassemble the vehicle using the new cowl top cover listed in **PARTS INFORMATION**.
