Bulletin No.: PIT5657B  
Published date: 10/15/2019

### PIT5657B Loose Shifter Lever / Poor Shift Actuation from Shift Lever / Shift to Park Message / Dead Battery

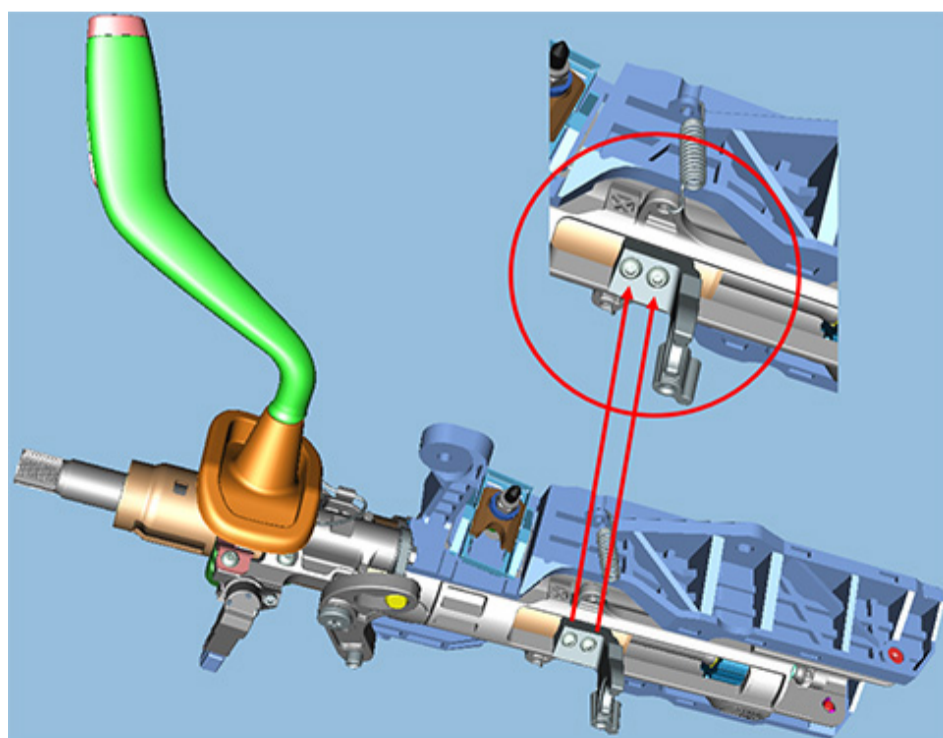
Involved Region or Country	North America
Condition	Some customers may comment of a loose shifter lever, poor shift actuation from the shift handle, and/or unable to shift to park. If the shifter will not go into park, the ignition will not turn off completely, which could cause a dead battery. Also, a "Shift to Park" message will be displayed on the DIC.
Cause	This concern could be caused by the shift cable bracket attaching bolts being loose, see picture below.

**Note:** Do NOT tighten these bolts, they are not serviceable.

Inspect the shift cable bracket attaching bolts for being loose. If the bolts are found to be loose, replace the steering column assembly. Do NOT tighten or replace these bolts, they are not serviceable.

If the bolts/bracket are not found to be loose, refer to High Shift Effort in SI to continue diagnosing root cause
