Preliminary Information

PIP5496B Fuel Tank Hard To Fill Possible MIL With DTC P0446

| Brand: | Model: | Model Years: | VIN: | | Engine: | Transmissions: |
|---|---|---|---|---|---|---|
| Chevrolet | Equinox | 2018 - 2020 | All | All | 1.5L LYX and 2.0L LTG | All |
| GMC | Terrain | 2018 - 2020 | All | All | 1.5L LYX and 2.0L LTG | All |

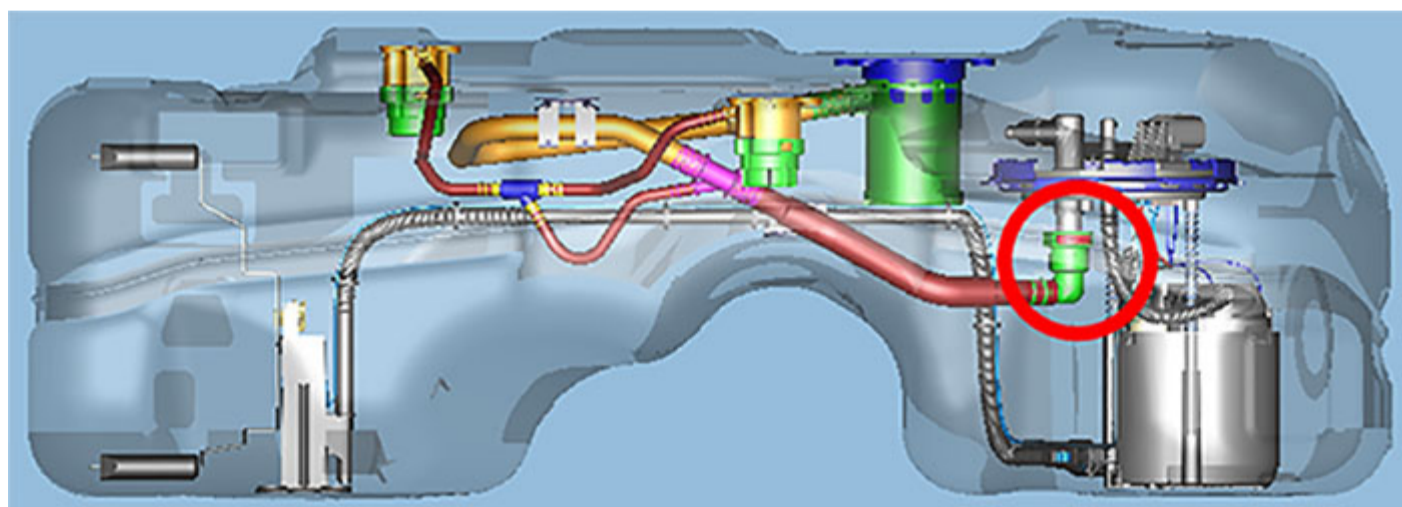
| Condition | Fuel tank hard to fill with fuel, evaporative emission canister saturated with fuel and possible DTC P0446. |
| Cause | Vent hose disconnected from fuel pump module assembly inside fuel tank. |

Reconnect fuel vent hose to fuel pump module inside fuel tank. Reference picture below showing properly connected fuel vent hose.

Also inspect evaporative emission canister for fuel saturation and replace canister as needed.
