Preliminary Information

PIP5684 GE-52250 Power Smoke Diagnostic Leak Detector Turbocharger Charge Air And Induction System Tester MIL Reduced Engine Power

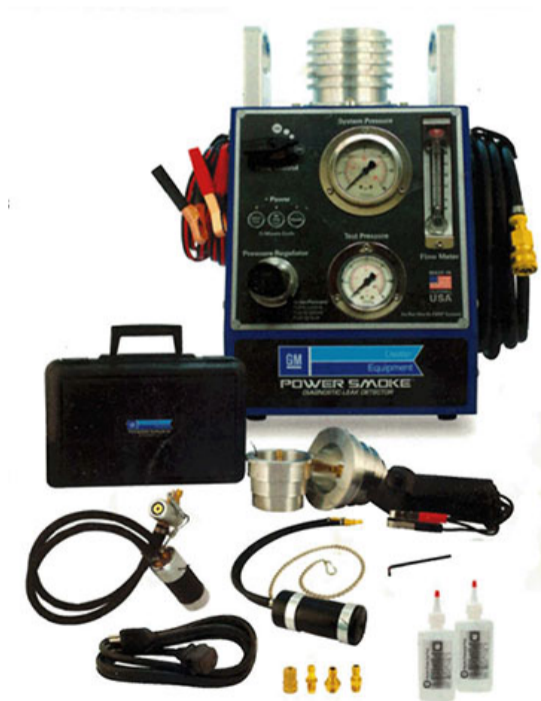
GE-52250 is shown below.

Note: The adapters may vary as the tool evolves.

The technician should follow SI diagnostics. If no cause for the concern is found or during diagnosis a leak check is required, power smoke diagnostic leak detector GE-52250 can be very helpful in locating leaks.
