Preliminary Information

PIT5535E Service Front Camera / Service Lane Departure Warning / Service Lane Keep Assist Message with DTC B1008 SYM4B / IntelliBeam Headlight / Windshield Wind Rush Noise

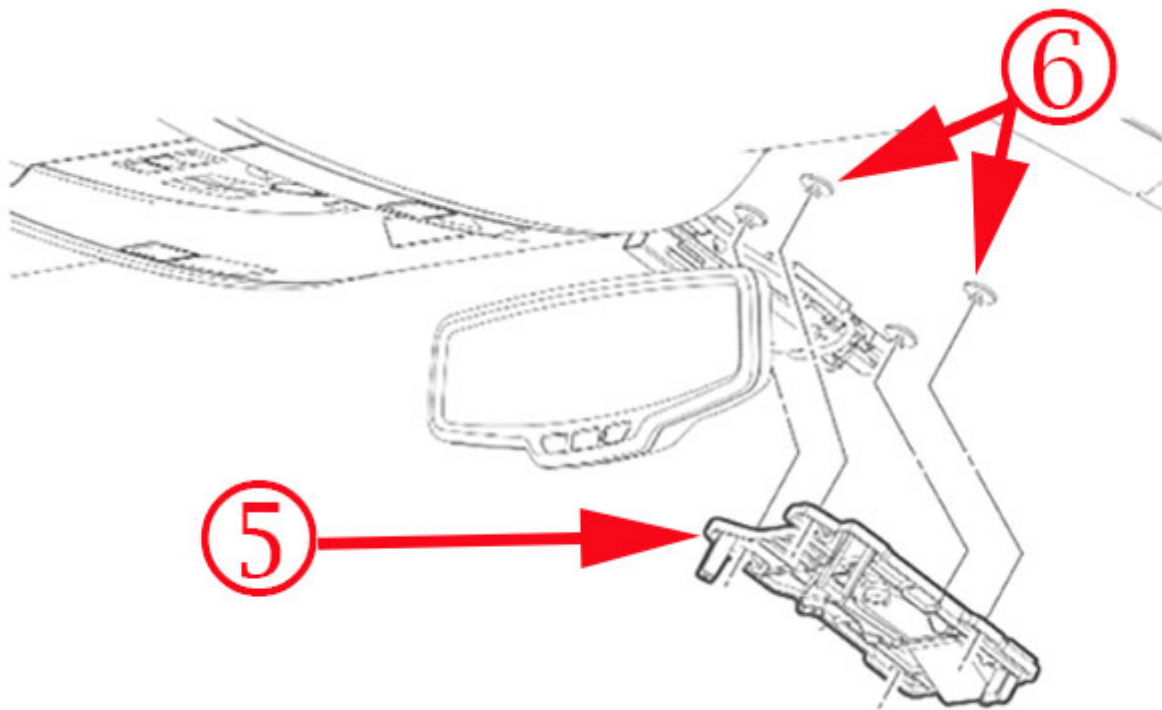
- Verify the front view camera module bracket (5) is fully seated down and secured on the windshield pins (6), shown below.

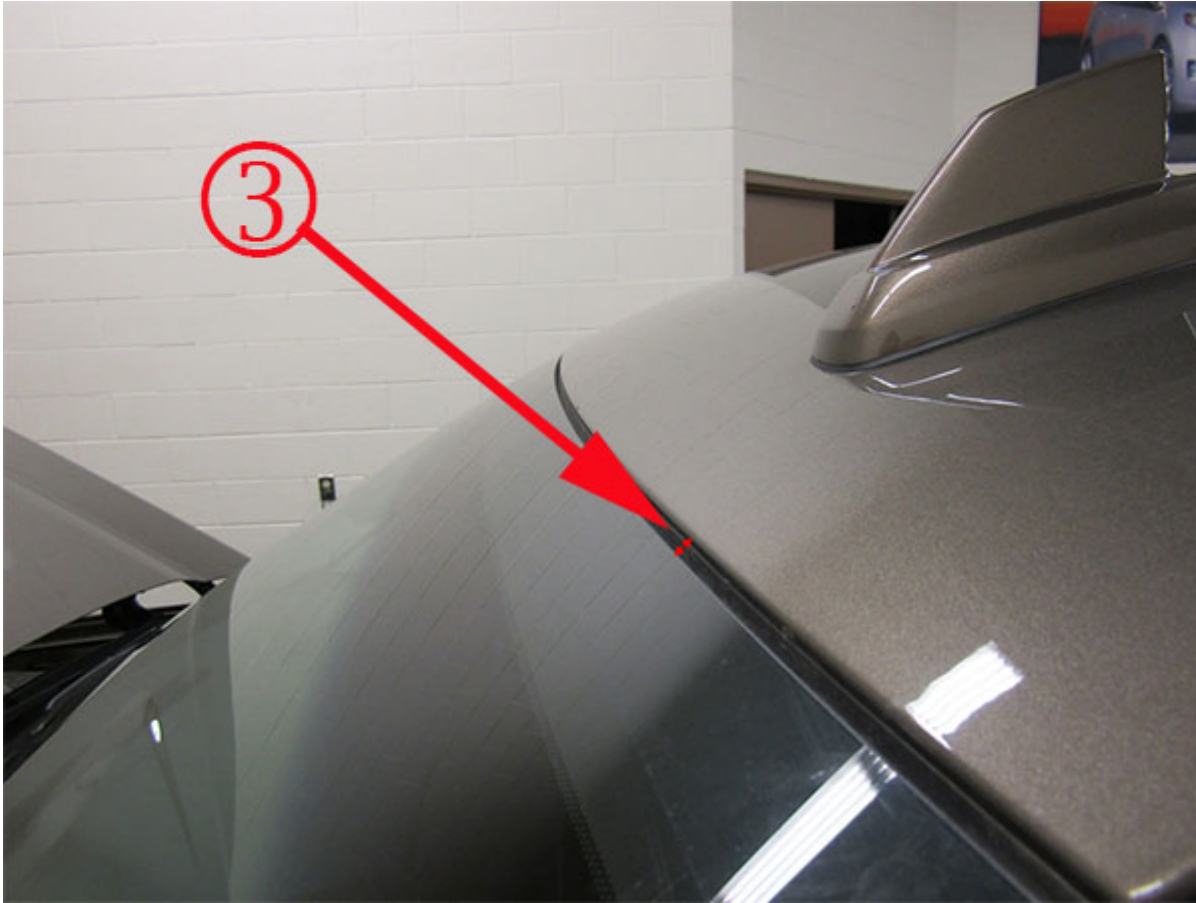
Inspect the gap between the top of the windshield and roof sheet metal (3), shown below. This gap should be 3.6 mm (+/- 1 mm).

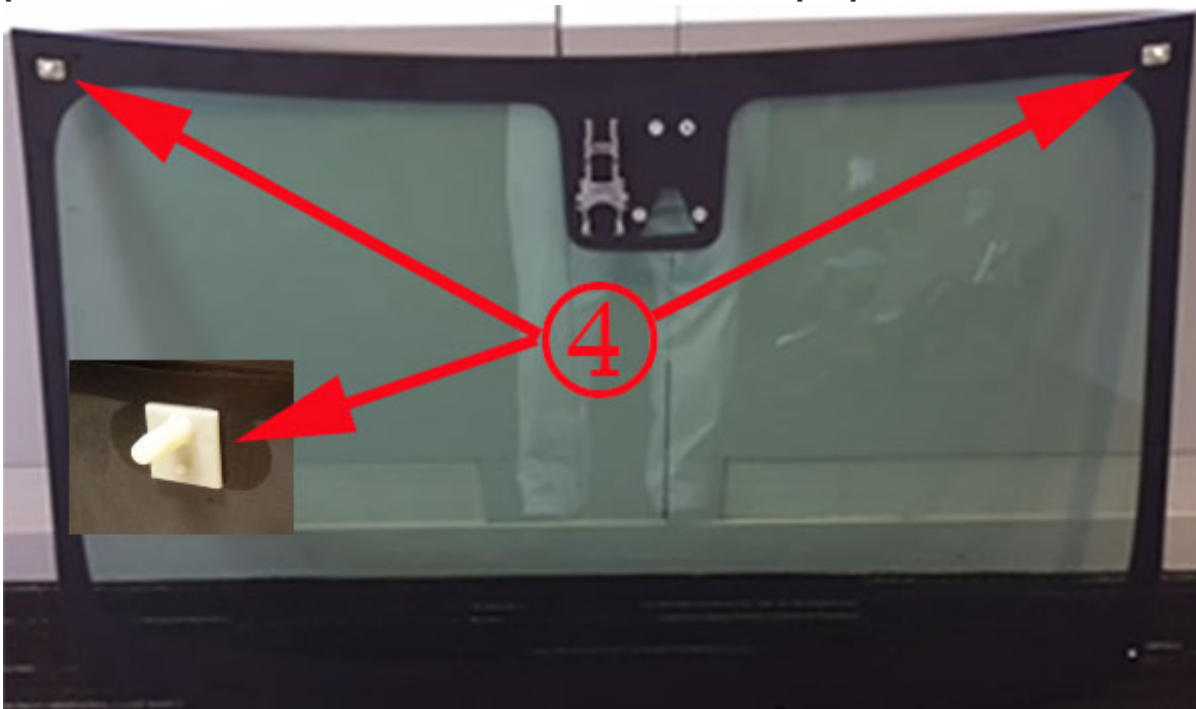
Factory GM windshields use alignment/locating pins (4) in the upper corners of the windshield, which makes it much easier to properly align the windshield to the body opening, shown below. Most aftermarket windshields do not use these alignment/locating pins, which can make it more difficult to ensure a proper installation.

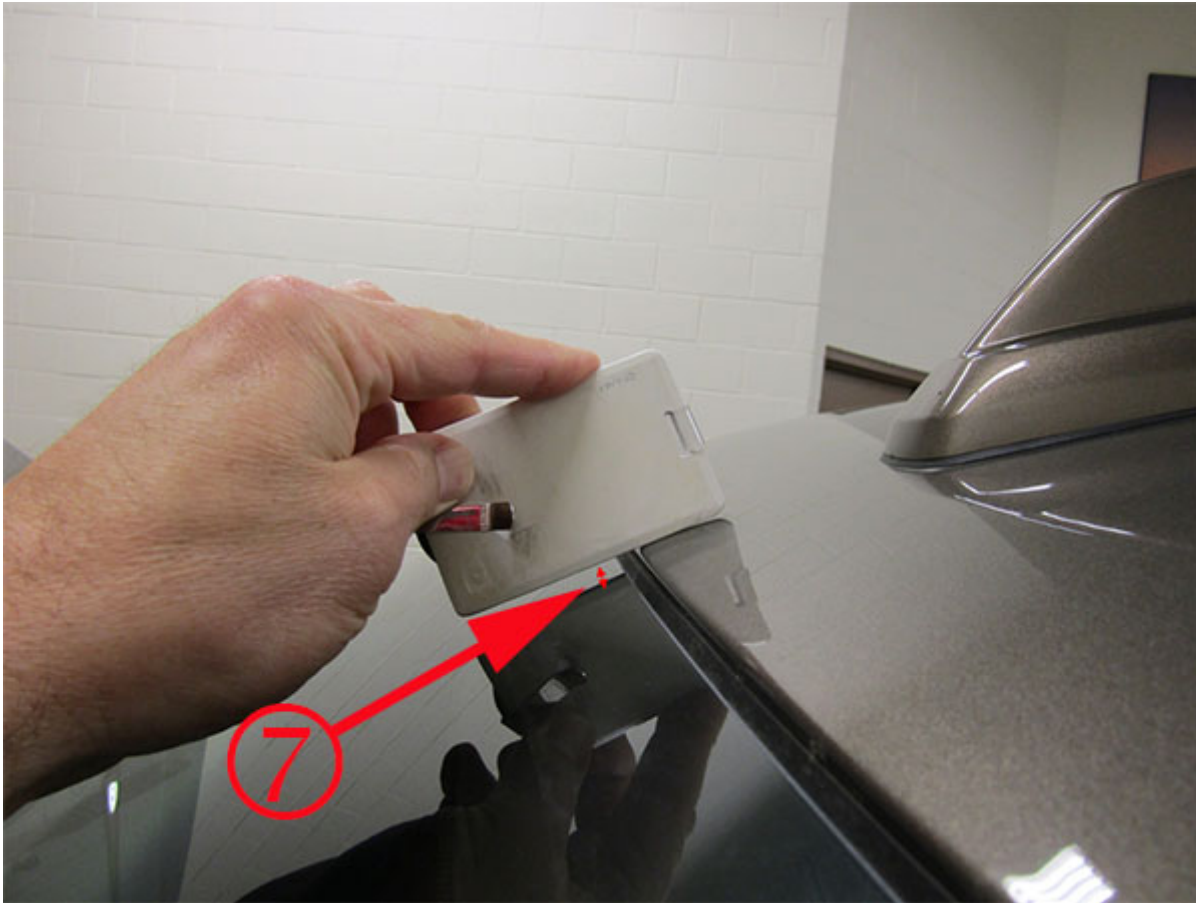
Also, inspect to make sure the windshield is sub-flush to the roof sheet metal (7), as shown below. If the windshield is proud of the roof sheet it could indicate:

- The old urethane adhesive bead was not cut low enough and left excessively thick.
- Windshield alignment/locating pin(s) are not fully in the alignment hole(s).
- During windshield installation it was not firmly pressed around the entire outside edge in order to wet-out the urethane adhesive bead.
- The urethane adhesive bead dried before the windshield was installed.

NOTE: A windshield proud of the roof sheet metal could cause excessive wind noise.

Either of these windshield mounting issues could cause the camera to be misaligned and

unable to complete the learn.

NOTE: If the windshield has to be removed/replaced for any of the above reasons, it is suggested that a factory GM windshield be installed.

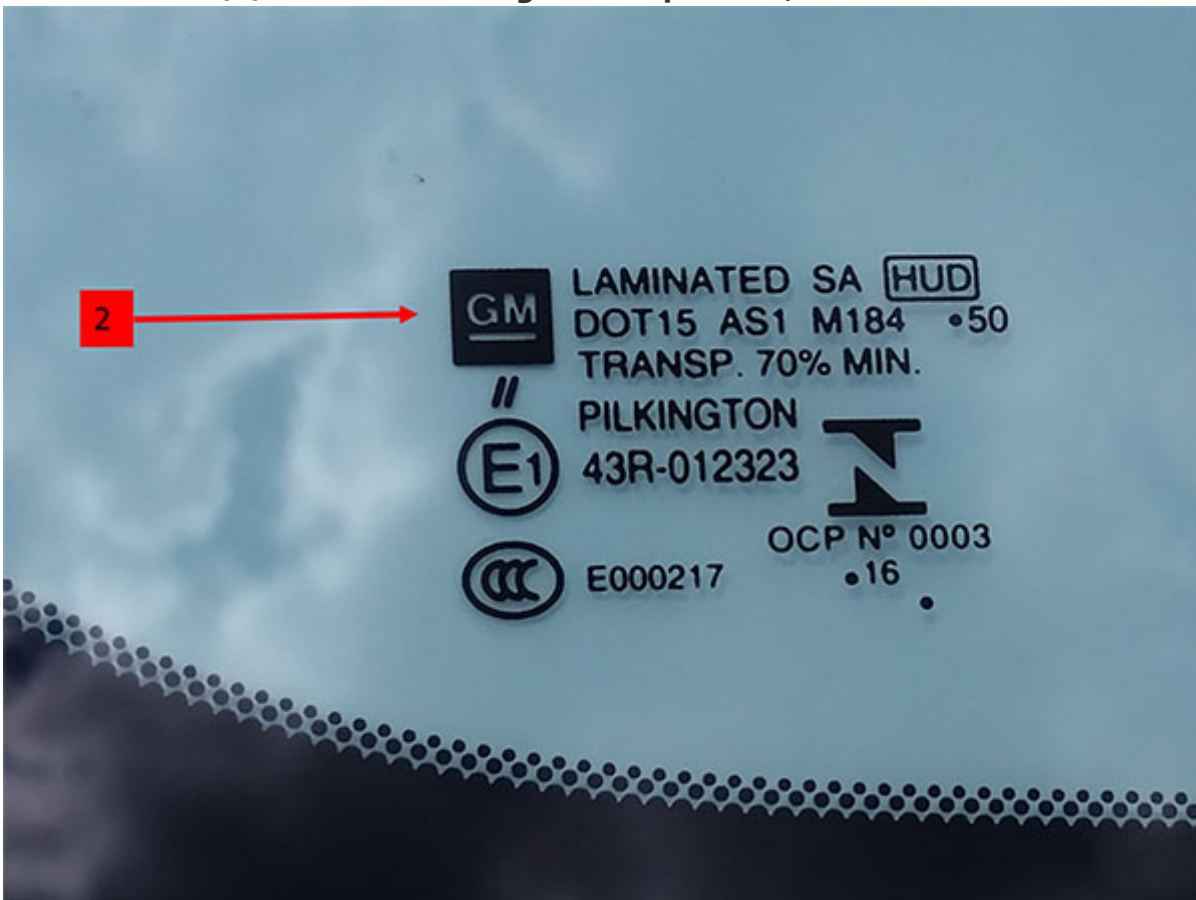
- If, after performing the checks listed above and the root cause of the camera not completing the calibration/learn is still not found, inspect for an aftermarket windshield being installed in the vehicle. To determine whether or not the windshield is an aftermarket or factory windshield, inspect for the "GM" Logo in the lower right corner of windshield, as shown below (2). If the "GM" Logo is not present, then the windshield is aftermarket.

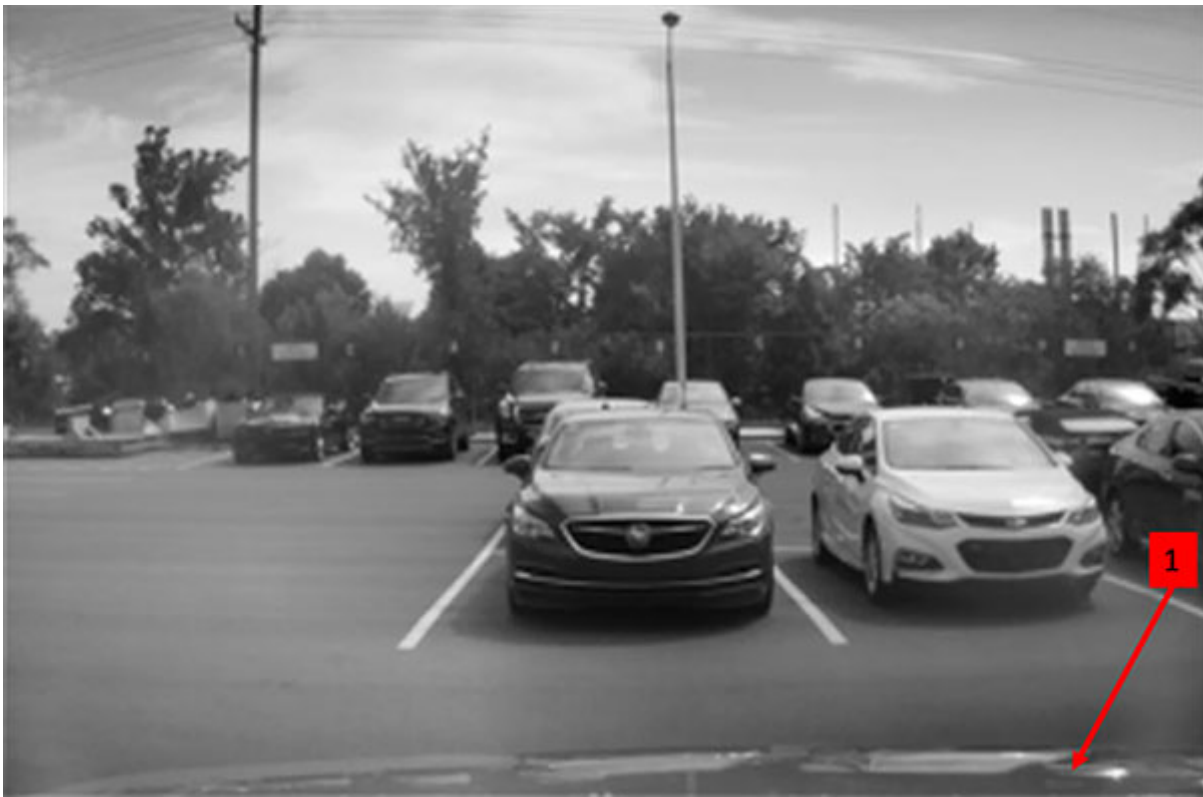
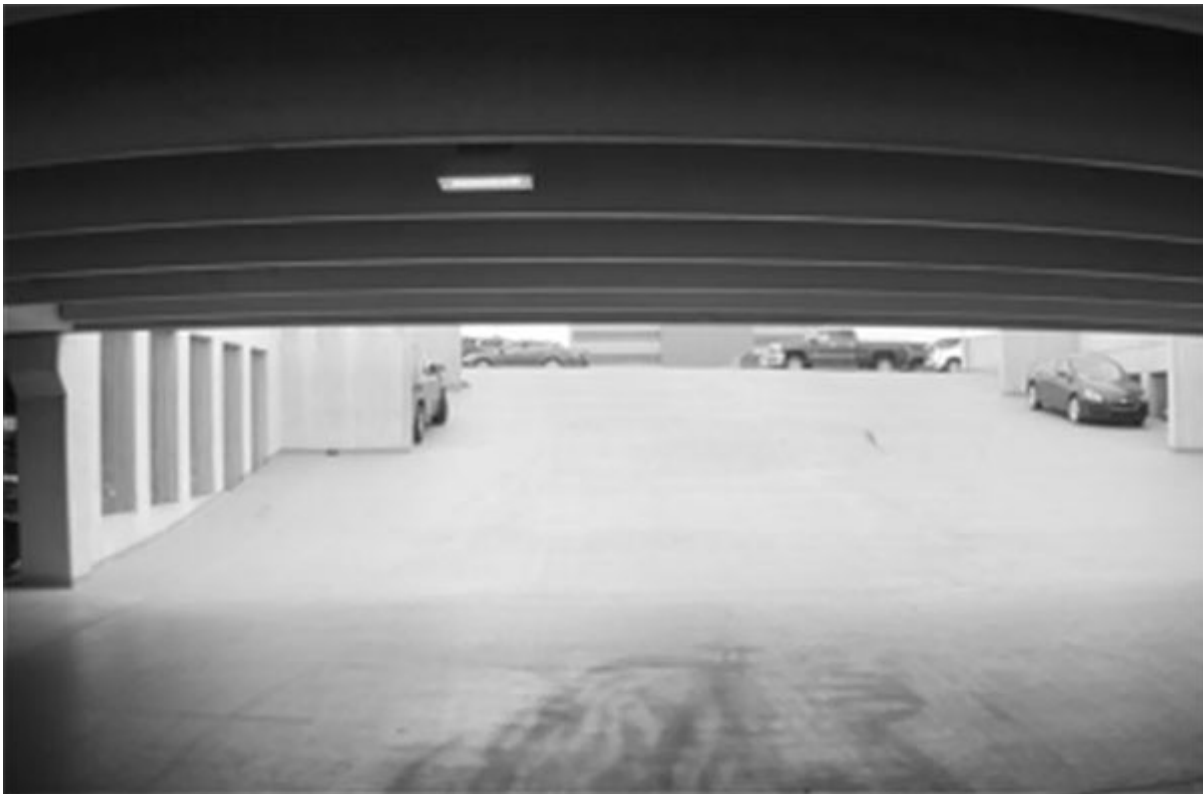
It has been found that some aftermarket windshields do not properly mount/position the front view camera. Shown below are some images, taken with engineering tools (see note below), of what the front view camera is actually seeing. The first image is taken from a truck with an aftermarket windshield. As shown below, the camera is seeing part of the hood (1). Because of this, the camera is not seeing movement in the area of the hood and can not complete the learn. The second image below is from a truck with a factory windshield and there is no hood seen by the front view camera.
