# Preliminary Information

## PIT5550C Left Side Third Row Seat will not Power Fold/Unfold or Moves One Inch at a Time

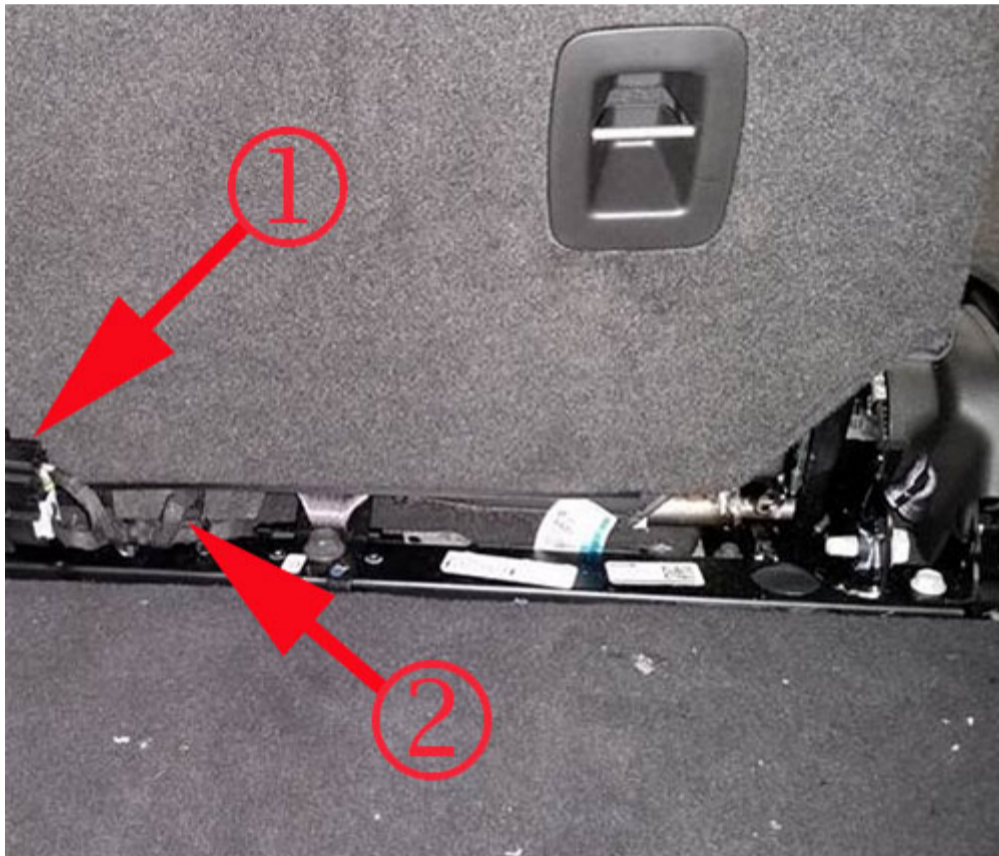
If normal SI diagnostics does not lead to a correction, check for open circuits between the third row folding seat control module and the hall effect sensor which is located within the folding seat drive motor. If open circuits are found, one common area to check for broken wires is about 6 inches away (2) from the third row K169 power folding seat control module (1).

The circuits may be broken internally in the insulation and may not be physically visible.

A pull test on the circuits to see if they stretch may help in diagnosing the location of the open in the circuit.

If a concern is found, repair the circuits as necessary and evaluate operation.

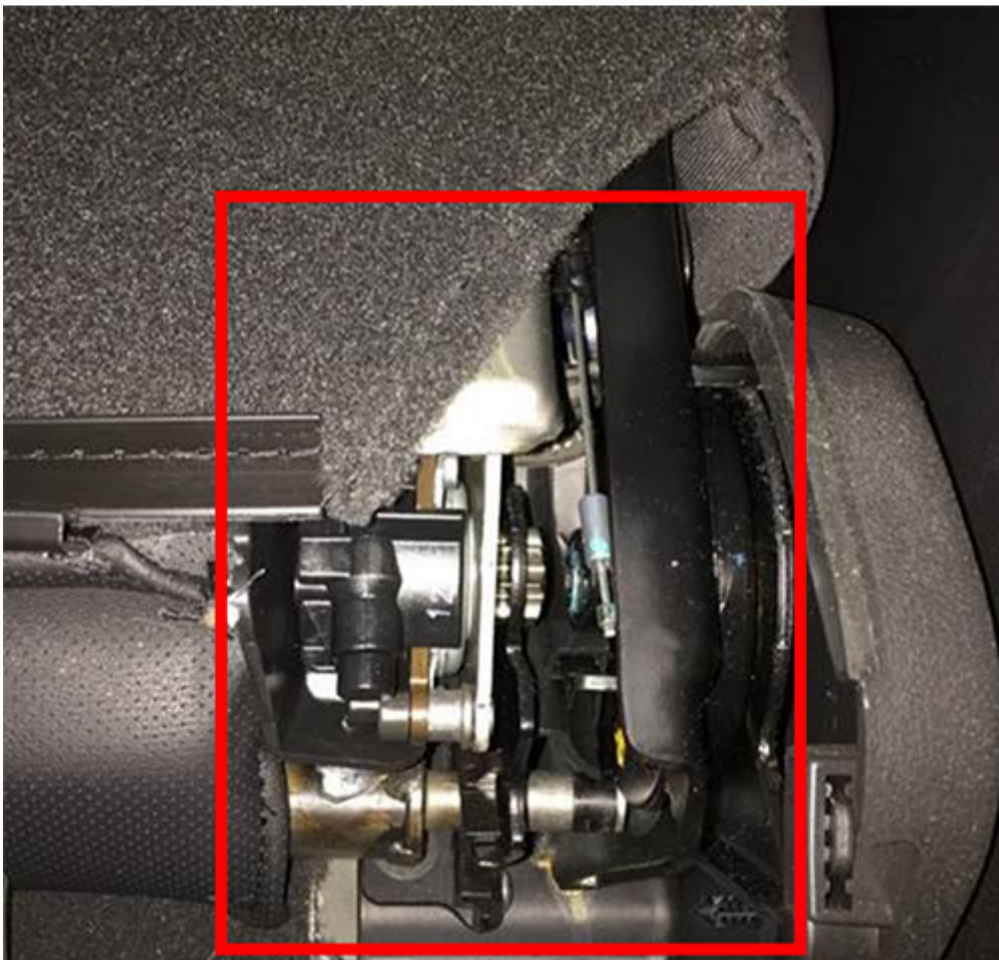
Example of in-tact frame shown above.

Inspect the 3rd row power seat frame and motor bracket to ensure no damage is present (See illustrations below).

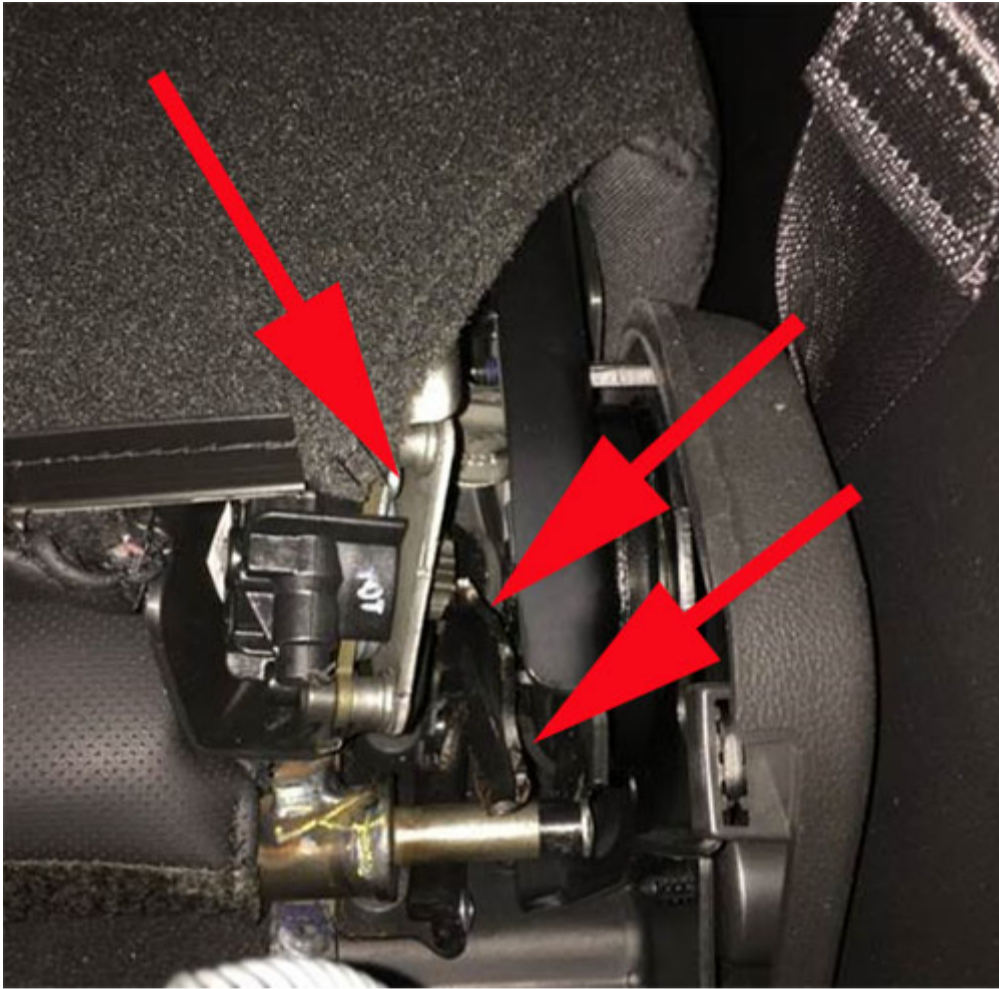
If a customer experiences this concern with the seat locked in the folded or unfolded position and they need to use the 3rd row power seat in the opposite position, damage may occur to the drive motor bracket and/or the seatback frame if the 3rd row power seat is manually forced to the opposite position, as there is no manual override function.

Example of damaged frame shown above.
