Bulletin No.: PIP5686

PIP5686 Engine Air Leak from The Foul PCV Tube, Whistle Noise, P0171 and/or P0174

Brand:	Model:	Model Years:	VIN:		Engine:	Transmissions:
			from	to		
Chevrolet	Silverado 1500 (New Model)	2019 - 2020	All	All	5.3L L84	All
GMC	Sierra 1500 (New Model)	2019 - 2020	All	All	5.3L L84	All

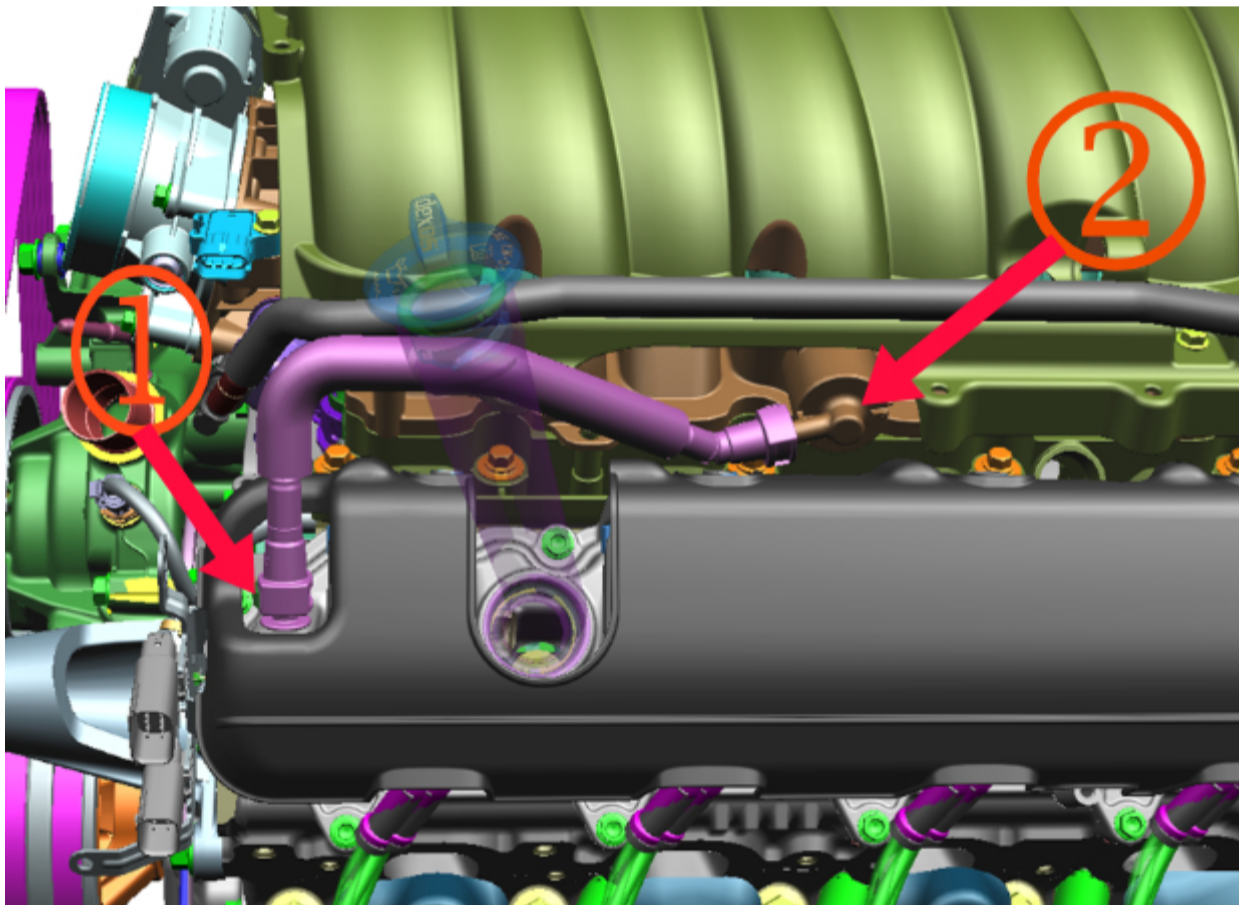
PCV Tube Locations: Location 1- Connector to Rocker Cover, Location 2- Connector to Intake Manifold

Involved Region or Country	North America
Condition	A vehicle may come into the dealer with a rough idle, lean running concern and/or air leak noise from the PCV system. Upon inspection the technician may find the SES lamp is illuminated and/or DTC 's P0171 and/or P0174 may be in active or stored history.
Cause	This condition may be caused by an incorrectly installed foul air PCV tube or tube may be damaged.

1. **Check to see if tube is installed and seated correctly . If tube is installed correctly it will be necessary to smoke test and confirm there are no leaks. Proceed to the steps below .**
 - a. **If no smoke is detected, then tug on PCV tube ends (Location 1 or 2) to ensure the tube is seated. If tube was not fully seated, then properly secure connection by pressing tube in until it clicks, and the tube does not come off by pulling on it. Proceed to step 4.**
 - b. **If smoke is detected, at either at the cover or manifold (Location 1 or 2) Remove and reinstall the same PCV tube to ensure both latches click. Proceed to Step 2.**
 - c. **If the tube is cracked or other damage in any other location besides (1 or 2) then it will be necessary to remove and replace with a new tube. Proceed to step 4.**

2. Repeat smoke test to verify condition is still present. If leak is still present at (Location 1 or 2) remove tube and inspect O-ring seals inside, look for damage or missing O-rings. Take images of findings. Replace with new tube if damage is found. Proceed to step 4.
