Published date: 10/28/2019

Preliminary Information

PIT5717 Sunroof, Rear Sliding Window, And/Or Wireless Charging Inoperative - Fuse F2DL And/Or F8DL Open

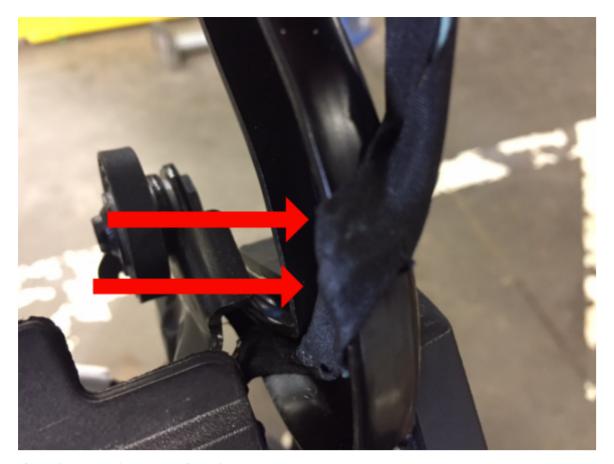
Involved Region or Country	North America
Condition	Some customers may comment the sunroof, rear sliding window, and/or the wireless charging mat may be inoperative. Technicians may find the F2DL or F8DL open.
Cause	Harness chaffing at the hinge area of the center console.

Inspect the center console harness at any part of the hinge area for chaffing. See example below.

If any harness damage is found, repair as necessary.
