# Service Update

## N192266190 Engine Control Software Issue

**Release Date:** October 2019

**Revision:** 02

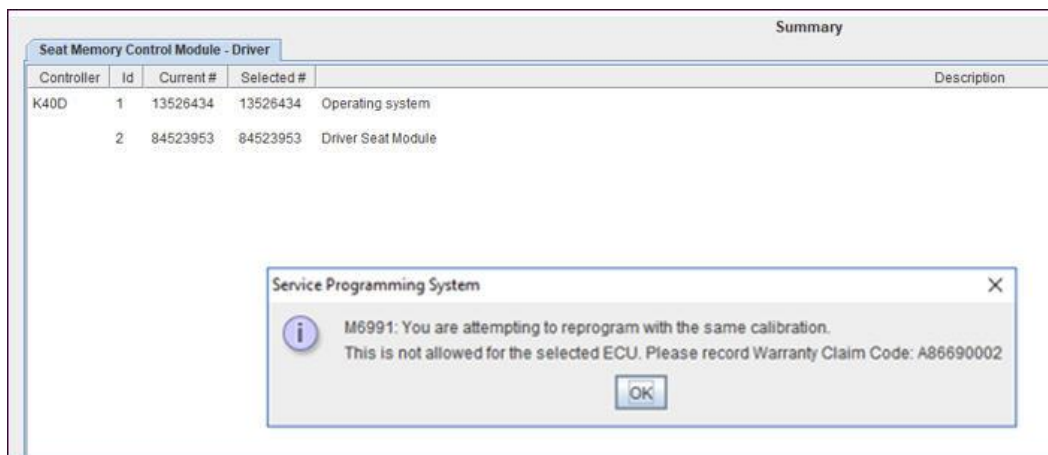
5164840

**Note:** If the Same Calibration/Software Warning is noted on the SPS Summary screen, record the warranty claim code (WCC) and select OK and follow screen instructions. After a successful programming event, the WCC is located in the Service Programming System dialogue box of the SPS Summary screen. No further action is required. Refer to the Warranty section of the bulletin.
