# Service Update

## N192210330 Cruise Control Indicator and Digital Speed Not Displaying (U.S. Only)

**Release Date:** October 2019

**Revision:** 01

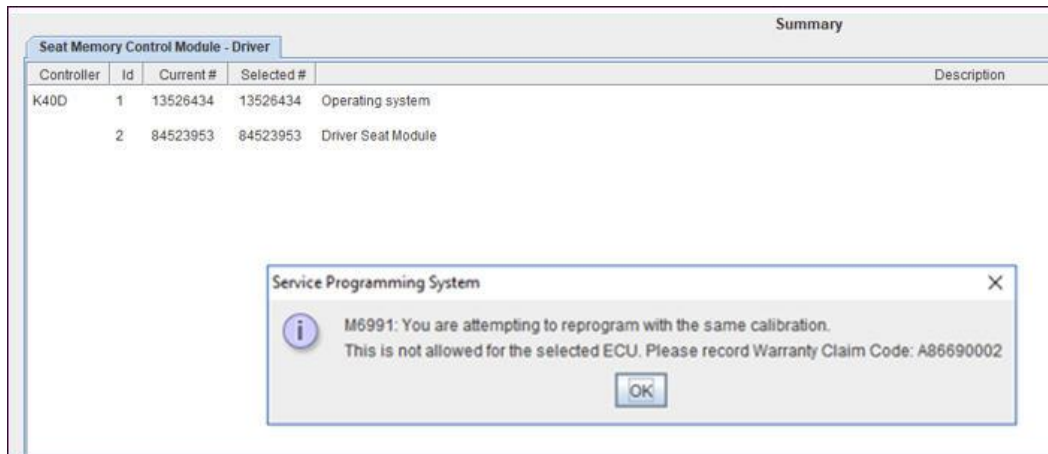
5164840

**Note:** If the Same Calibration/Software Warning is noted on the SPS Summary screen, record the warranty claim code (WCC) and select OK and follow screen instructions. The WCC is located in the Service Programming System dialogue box of the SPS Summary screen. No further action is required. Refer to the Warranty section of the bulletin.

1. Reprogram the Instrument Panel Cluster. Refer to *P16 Instrument Cluster – Programming, Setup and Configuration* in SI.

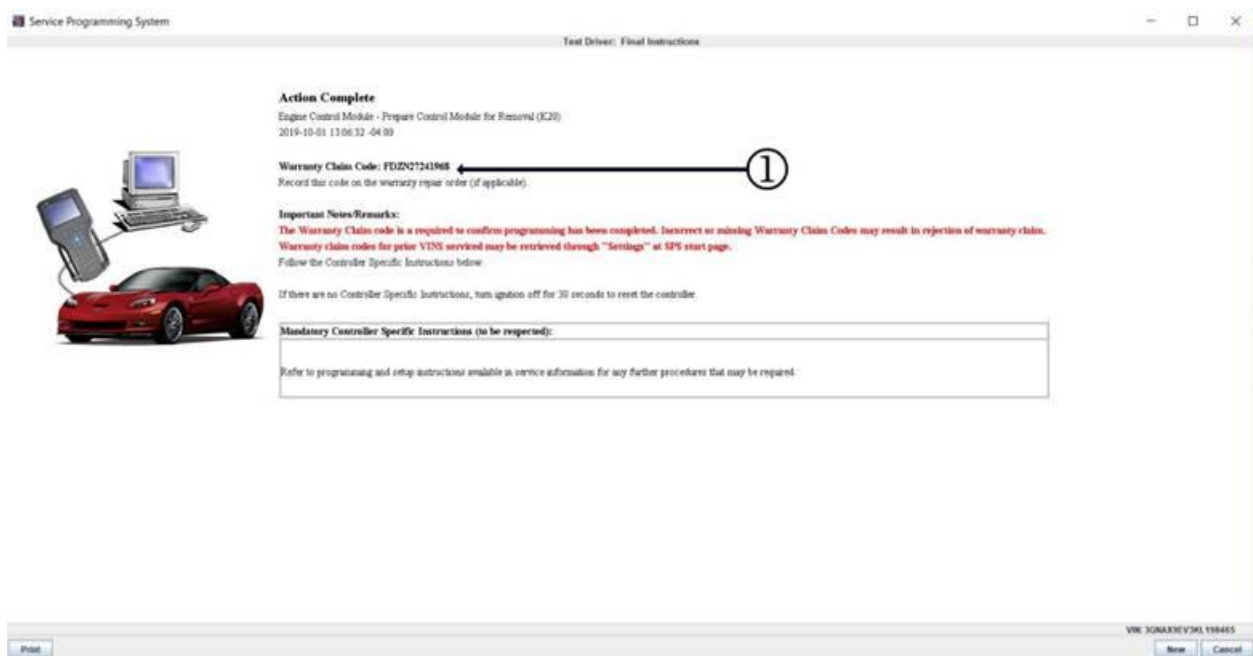
5418111

**Note:** To avoid warranty transaction rejections, you **MUST** record the warranty claim code provided on the SPS Warranty Claim Code (WCC) screen on the job card. Refer to callout 1 for the location of the WCC on the SPS screen.

2. Record SPS Warranty Claim Code on job card for warranty transaction submission.
