Service Update

N192266751 Incorrect Driver Display Message for Diesel Exhaust Fluid

Release Date: October 2019

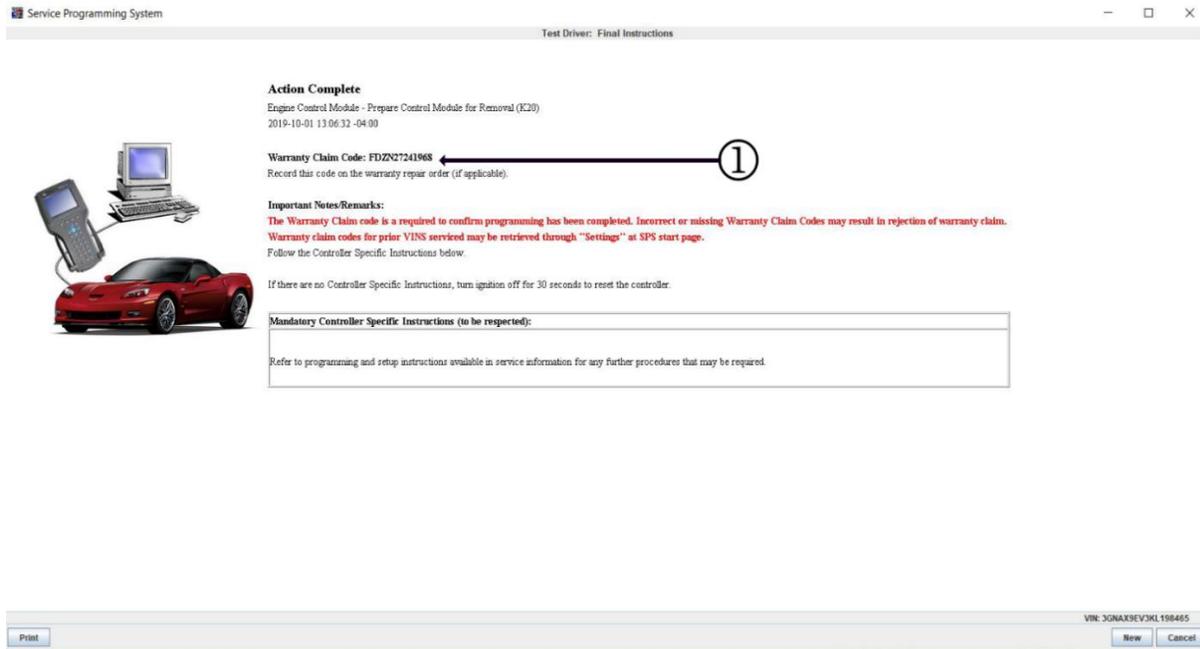
5418111

Note: To avoid warranty transaction rejections, you **MUST** record the warranty claim code provided on the SPS Warranty Claim Code (WCC) screen on the job card. Refer to callout 1 for the location of the WCC on the SPS screen.

6. Record SPS Warranty Claim Code on job card for warranty transaction submission.
7. Using GDS2, navigate to:
 - Module Diagnostics
 - (K20) Engine Control Module
 - Configuration/Reset Functions
 - Reset Functions
 - NOx Sensor 1 Reset- Select "Reset". No confirmation will happen after selecting reset.
 - Select back once.
 - Select NOx Catalyst Redundant Loading Reset-Select "Reset". No confirmation will happen after selecting reset.
 - Select back twice to Control Function
 - Select Particulate Filter Regeneration.
 - Select Particulate Filter Regeneration Enable and select "Enable". DO NOT perform a service regeneration
 - Clear all DTC's
8. Key off the vehicle and let all modules completely shut down (sleep).
9. Check vehicle for DTC's P0700 and/or U0100. Clear codes as required.
