Service Update

N192278200 Engine Control Module Software and Calibration Error

Release Date: October 2019

Make	Model	Model Year		RPO	Description
		From	To		
Cadillac	CT6	2019	2019

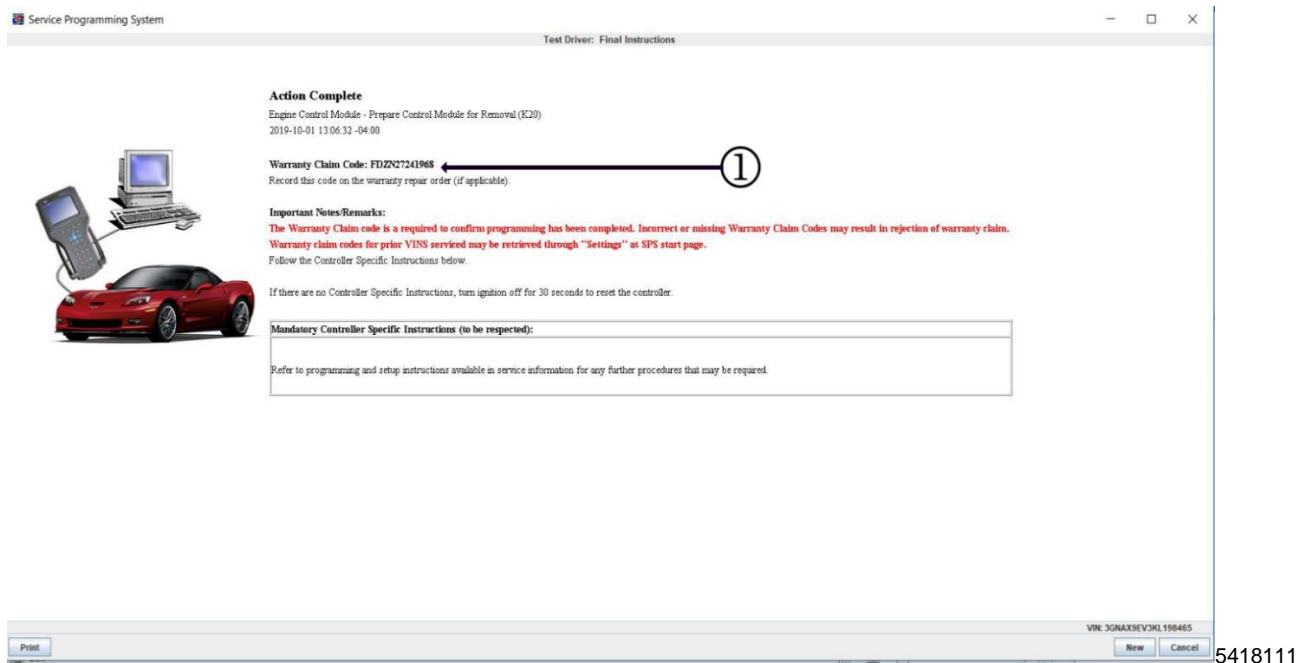
Note: To avoid warranty transaction rejections, you **MUST** record the warranty claim code provided on the SPS Warranty Claim Code (WCC) screen on the job card. Refer to callout 1 for the location of the WCC on the SPS screen.

2. Record SPS Warranty Claim Code on job card for warranty transaction submission.
