| Title | Diagnostic Trouble Codes ( DTC ) P2080-64, P2084-64, P242B-64 and P246F-64<br>Lighting The Malfunction Indicator Lamp ( MIL ) - <b>US17+OBD19 And</b><br><b>Newer Emissions, Model Years 2020 and Newer</b> |

| <b>Mack Model</b> | LR , TE - TerraPro , AN - Anthem , GR - Granite , PI - Pinnacle |

| <b>Volvo Model</b> | VN , VNL , VNR , VNX , VAH , VHD |

| Engine family | 11L Engine , 13L Engine , MP7 , MP8 |

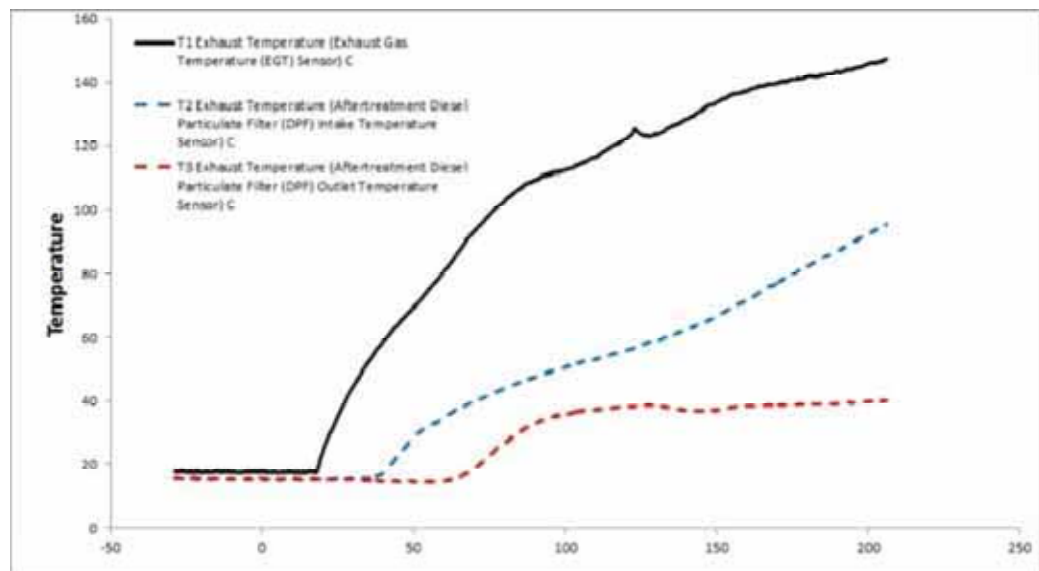
4. Start the engine.
5. Monitor exhaust temperatures on PTT:
  - The sensor temperatures should rise in the order of 1, 2, 3, 4 as shown below after starting the engine.

An example of proper temperature sensor function (this example uses a graph from a vehicle with three sensors) can be found below:

6. Evaluate results:
  - **If the sensor readings are equal at ambient temperature and rise in the correct order when the engine is running:** No further fault tracing should be performed. Clear the DTCs and return the vehicle to service.

- **If one or more sensors are displaying a different reading from the others or are spiking instead of smoothly increasing with the engine running:** The sensor(s) should be suspected to be faulty.

- **If the temperature sensor values rise out of order:** The sensors should be checked to ensure they are installed in the correct positions.
