Title Diagnostic Trouble Codes (DTC) P20EE And P103C, Diagnostic Procedure; **REPLACE S GUIDED DIAGNOSTICS IN PREMIUM TECH TOOL (PTT) - US17+OBD16 And US17+OBD2018 Emissions, Model Years 2018 And 2019**

Mack Model LR , MRU - TerraPro , TE - TerraPro , AN - Anthem , CHU - Pinnacle, Axle back , C XU - Pinnacle, Axle front , GR - Granite , GU - Granite , PI - Pinnacle

Volvo Model VNL , VNM , VNR , VAH , VHD

Cause Procedures and checks to follow for P20EE and P103C on US17+OBD2016 and US17+OBD2018 chassis.

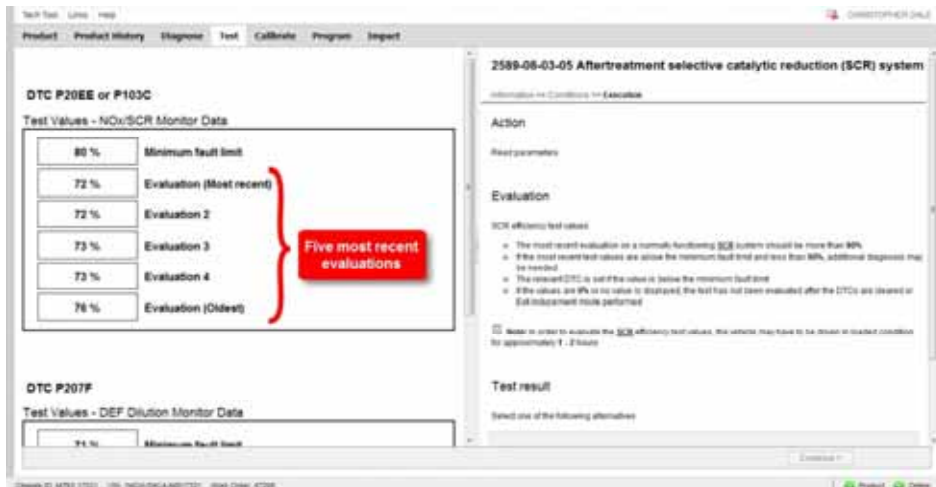
- The last five efficiency evaluations are displayed as shown in the screenshot above.

If all five tests are below the fault limit, SCR conversion has been poor for an extended amount of time.

If only one or two are below the fault limit, conversion is only intermittently poor.

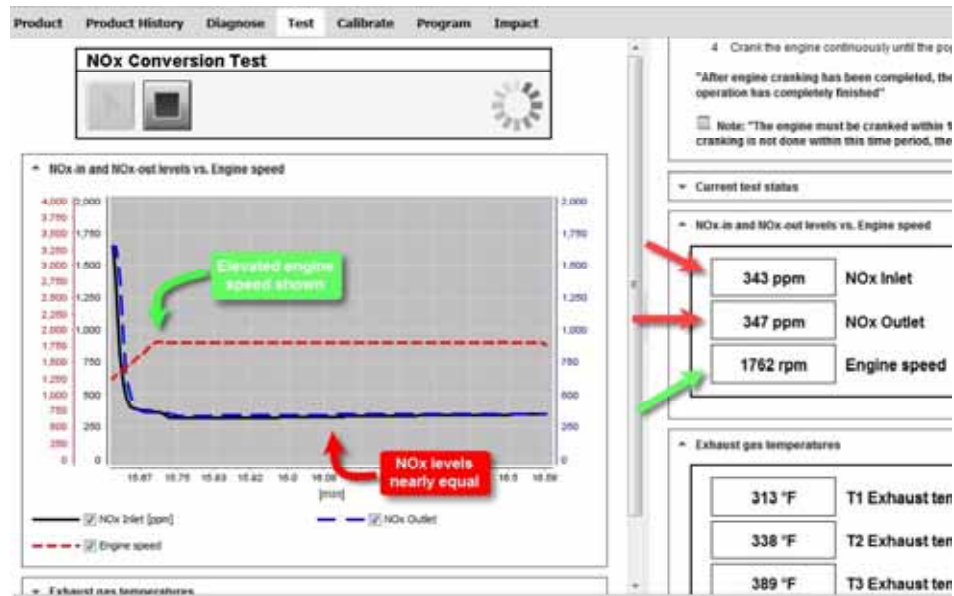
- While running NOx conversion test, if any new NOx sensor codes are logged (Egs: P220E-93, P220F-93), make sure to troubleshoot those codes.
- Inlet and Outlet NOx Sensor values should be close to each other at high engine speed (last portion of the test) as shown below.
- If during the test difference between NOx sensors are greater than 10%, it is recommended to replace the sensor reading the higher value and re-do the test.

The likelihood that both sensors require replacement at once is low. Replacement of both sensors at once should not be considered immediately unless affected by an upstream failure.

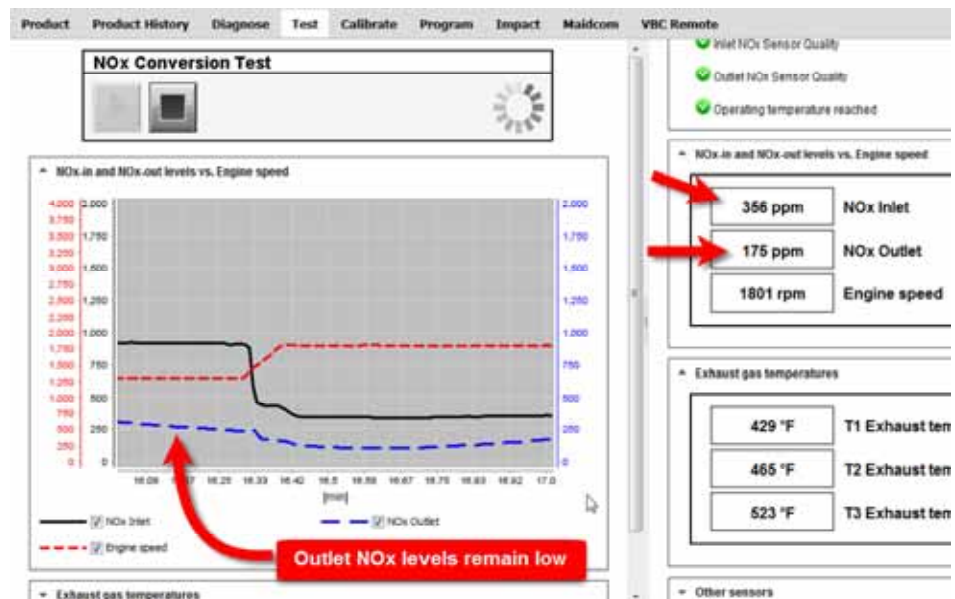
EMS Main Software Part Numbers 23470183 and 23470187, used for US17+OBD18 emissions, has a bug that allows DEF dosing to continue during the NOx conversion test. This causes continued low Outlet NOx sensor values as seen in the screen shot below and prevents the desired behavior shown above.

In this instance, review earlier sections of the test to ensure that both sensors are responding to changes in the same manner. Examples of different stages to review are shown below.

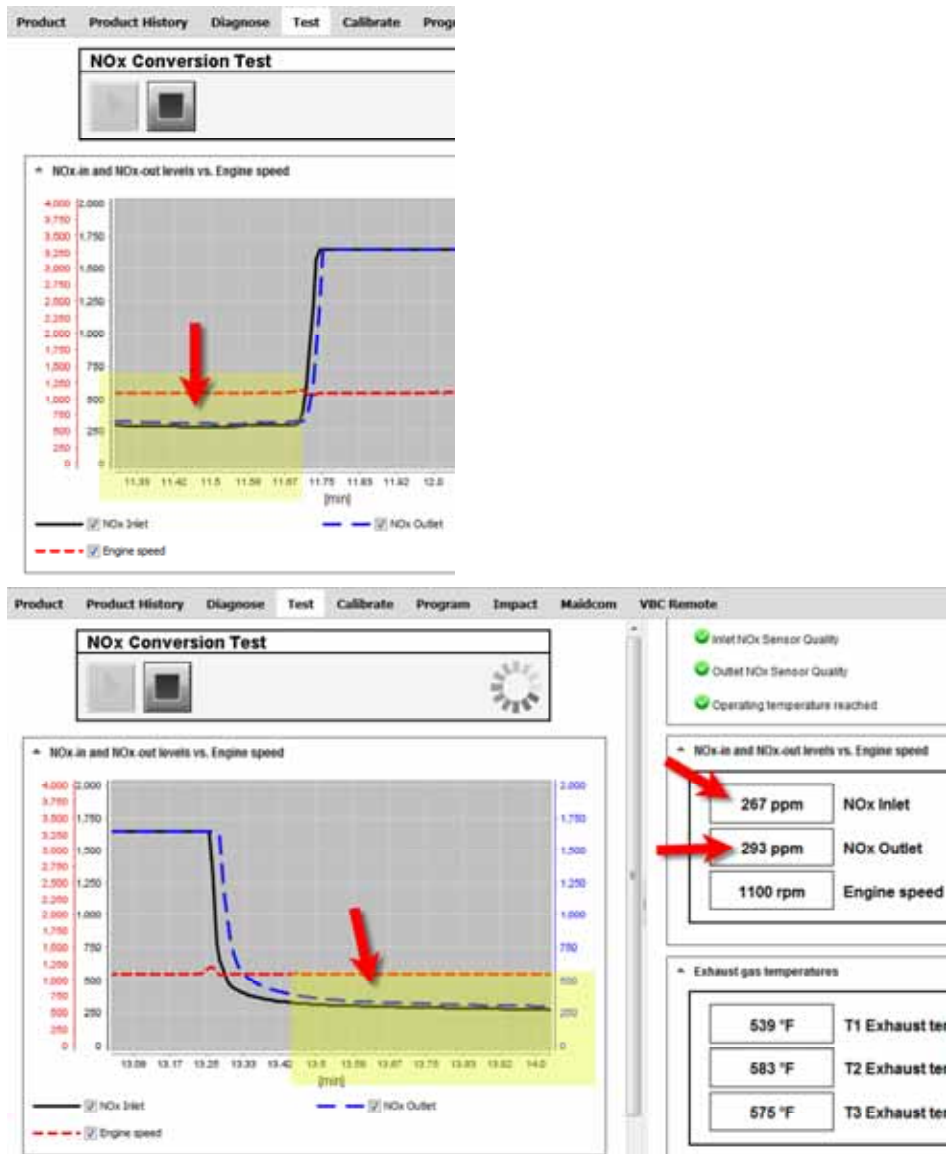
COMPARISON SHOULD BE DONE WHEN BOTH NOx SENSORS ARE READING BELOW 600 PPM.
