SIL 728

Service Information Letter

Units Affected: AT37-G and AT40-G units built on Ford 550 chassis (see attached list)

Rear Shear Plate Fastener Inspection

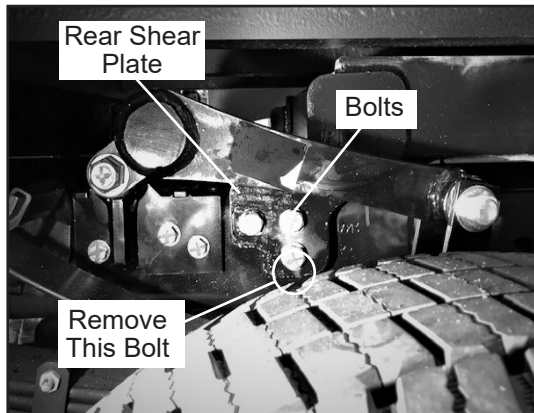
Figure 1 — Bolt Fasteners

Altec discovered that one of the fasteners used to attach the rear shear plate on the subbase of the unit to the chassis can contact the chassis u-bolt. The fastener can be a huck bolt or a bolt and nut. Movement of the u-bolt can possibly cause damage to the huck bolt or bolt and nut resulting in the fastener being broken off.

1. Position the unit on a level surface, apply the parking brake and chock the wheels.
2. Locate the rear shear plate on the subbase. It will be inside the rear wheel well.
3. Visually inspect the rear shear plates on both sides of the subbase to determine what type of fastener is used. The fastener can be bolts and nuts (refer to Figure 1) or huck bolts (refer to Figure 2) installed.

4. After the inspection is completed, determine which action is to be taken:
 - If the fasteners are bolts and nuts, go to Step 5.
 - If the fasteners are huck bolts, contact Altec.
Call 1-877-GO ALTEC (1-877-462-5832) to arrange for the repair.
5. If the fasteners are bolts and nuts, remove the bottom fastener (refer to Figure 1) and discard. Order and install a Hole Plug Kit, part number 990970059 (includes 2 plugs and instructions) for each unit to be repaired to plug the holes so that future inspectors will not think a fastener is missing. Call Altec to order the kit.
6. Return the unit to service.
