HYUNDAI Technical Service Bulletin	GROUP BODY ELECTRICAL	NUMBER 19-BE-016H
	DATE OCTOBER 2019	MODEL(S) ELANTRA (ADa)
SUBJECT: BLIND-SPOT RADAR REPLACEMENT, AND MOUNTING ANGLE VALIDATION

This bulletin provides the service procedure to replace the left and right Blind-Spot radar modules.

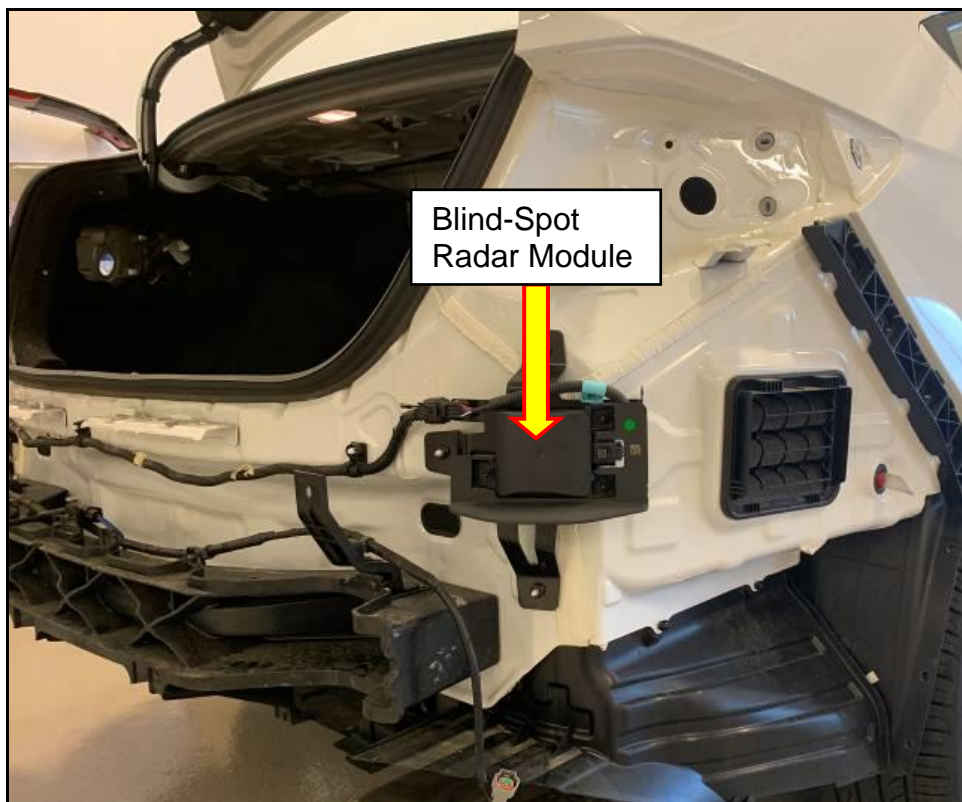
Description: Certain 2019 MY Elantra (ADa) vehicles may experience the Blind-Spot Collision Warning (BCW) light displayed on the instrument cluster. In some cases one and/or two of the following DTCs can be set:

- C2702 – Control Module Missing Calibration
- C2703 – Control Module Slave Missing Calibration
