GROUP	NUMBER		
Interior	19-BD-008H		
DATE	MODEL(S)		
October, 2019	Santa Fe (TMa)

## **Technical Service Bulletin**

## SUBJECT UPPER CONSOLE CUP HOLDER REPLACEMENT

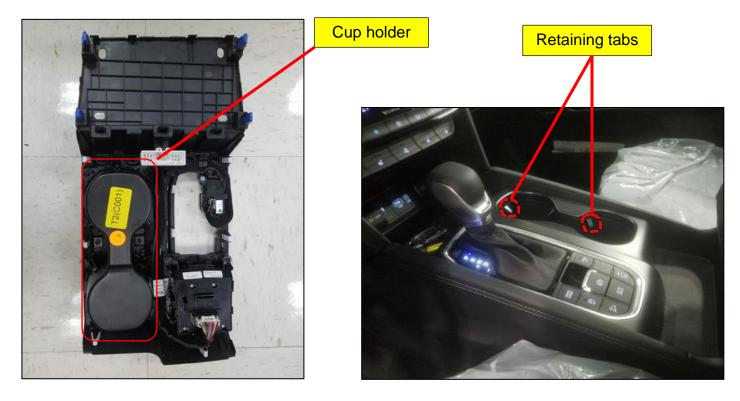
This bulletin provides instructions on the replacement of a cup holder with retaining tabs which cannot stabilize a cup due to inner O-ring displacement.

PART NAME	PART NUMBER	QTY
Cup Holder Assembly		
	84670-S2000-4X	1
