# Technical Service Bulletin

GROUP <b>CAMPAIGN</b>	NUMBER <b>19-01-034H</b>
DATE <b>October, 2019</b>	MODEL(S) <b>Veloster (JS)</b>

**SUBJECT:** BATTERY SENSOR DATA AND MISFIRE ECM UPDATE -  
(SERVICE CAMPAIGN T4F)

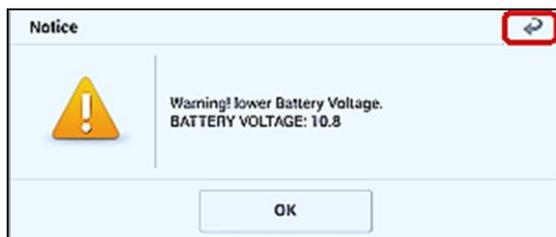
If voltage is below 12 volts as per the below GDS warning, then select **Back** and operate the vehicle in Ready mode for at least 20 minutes to ensure an adequate battery state of charge for reliable update results. Turn ignition back on, and then retry the ECU update again.
