Technical Service Bulletin

SUBJECT:		No: TSB-19-34-004	
ABNORMAL NOISE FROM REAR SHOCK ABSORBER		DATE: October 2019	
		MODEL: 2014-16 Outlander	
CIRCULATE TO:	<input type="checkbox"/> GENERAL MANAGER	<input checked="" type="checkbox"/> PARTS MANAGER	<input checked="" type="checkbox"/> TECHNICIAN
<input checked="" type="checkbox"/> SERVICE ADVISOR	<input checked="" type="checkbox"/> SERVICE MANAGER	<input checked="" type="checkbox"/> WARRANTY PROCESSOR	<input type="checkbox"/> SALES MANAGER

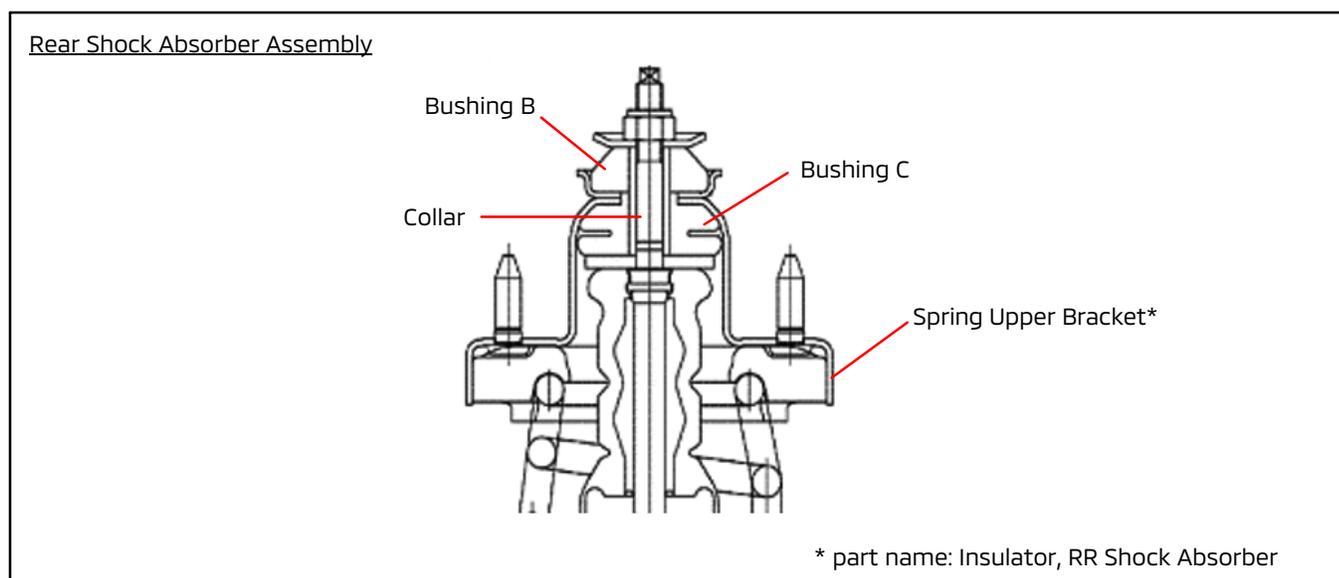
A customer may report an abnormal noise from the rear shock absorber. This may be due to abrasion of the upper bushing, causing the shape of the bushing to be deformed, resulting in interference between the collar and spring upper bracket while driving. The shape of the spring upper bracket has been improved to prevent the upper bushing from becoming deformed.

This TSB instructs dealers to replace the spring upper bracket, 2 bushings, collar, and nut with new parts to address the abnormal noise.
