SIB 01 21 18

2019-10-22

## N63: OIL CONSUMPTION CLASS ACTION SETTLEMENT DIAGNOSIS/REPAIRS (VERSION 12.0)

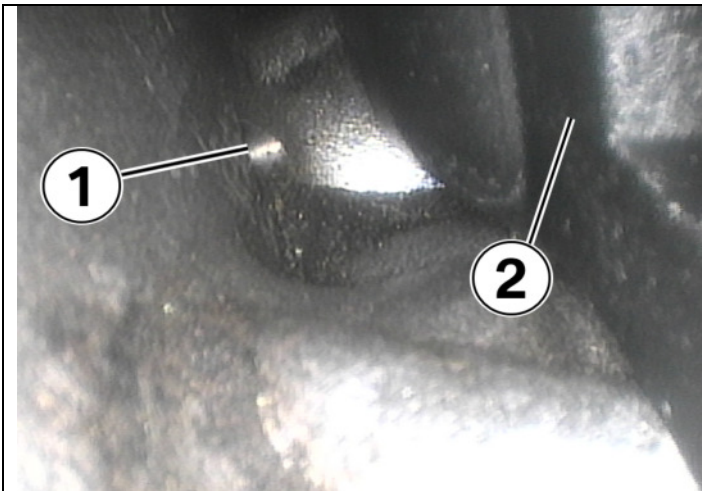
Once the bore scope has gone under the plastic reservoir tab then the engine valley drain hole (1) and surrounding area can be clearly inspected.

The dark material at the bottom of the photo is dust and dirt. This material appears to be reflective but it is dry.

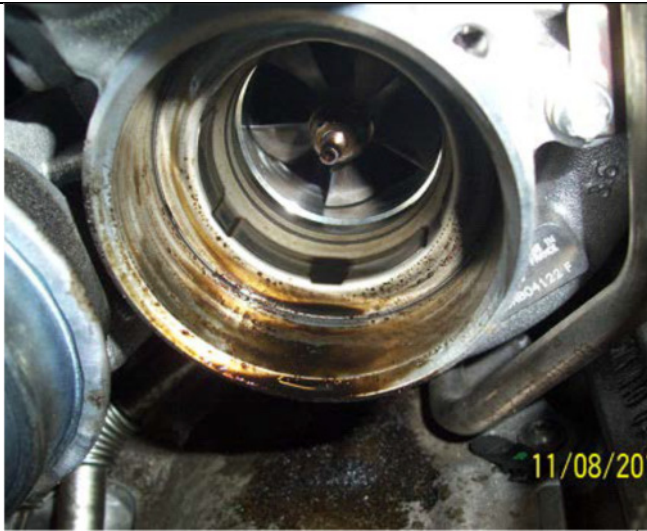
The turbocharger is OK.  
No engine oil can be seen around the turbocharger impeller.

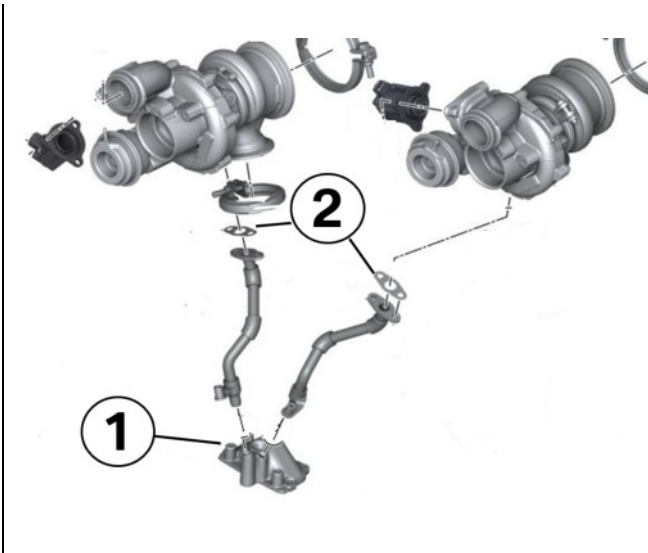
If engine oil is found under the turbos using a borescope then the oil return line cover (1) or the oil return line gaskets (2) are leaking engine oil.

(1) The oil return cover comes with all 3 O-rings. Use P/N 11 42 7 935 572.
