SIB 51 33 19

2019-10-30

SERVICE ACTION: INSPECT REAR WINDOW

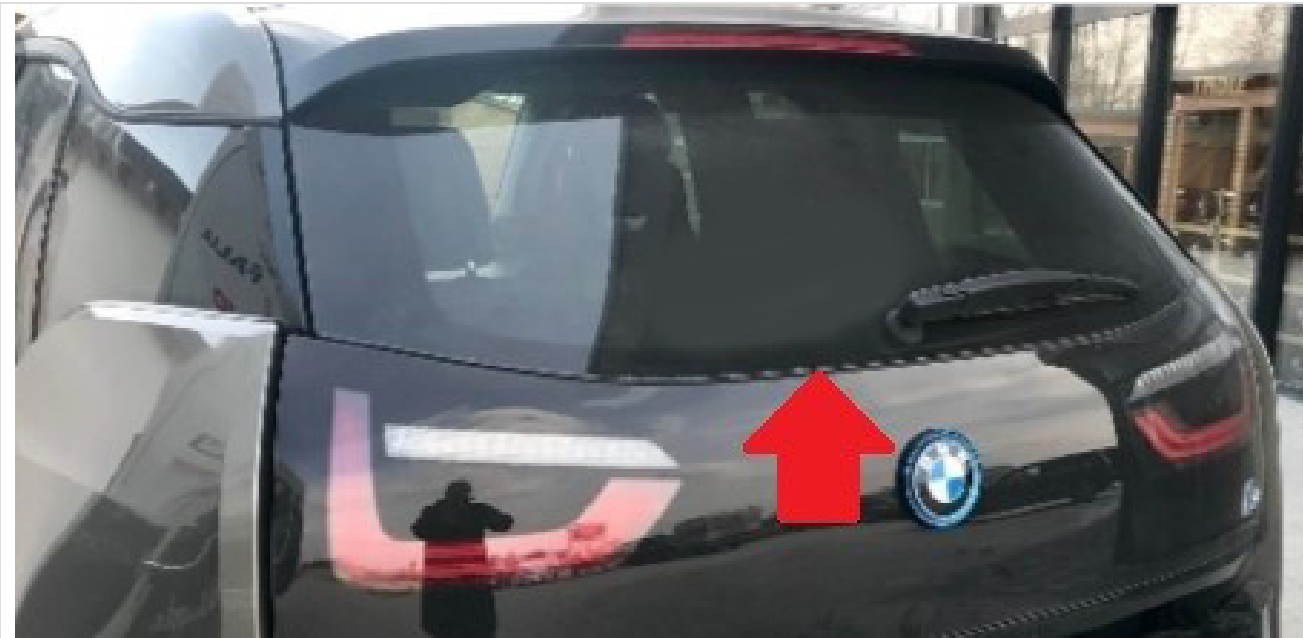
The rear window may be improperly bonded in the area shown above (red arrow), which could allow water to enter the luggage compartment.

During production, a small section of the adhesive for the rear window may have been fully bonded.

Inspect the bonding of the rear window glass. Reseal if necessary.
