SIB 52 15 19

FRONT SEAT HAS SIDE TO SIDE PLAY AND CAN MAKE NOISES WHEN CORNERING

F06 (6 Series Gran Coupe)	F12 (6 Series Convertible)	F13 (6 Series Coupe)
Vehicle Produced to March 17, 2013

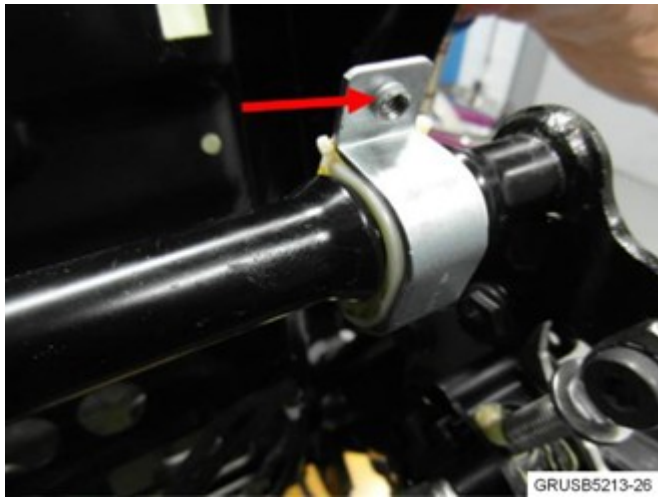
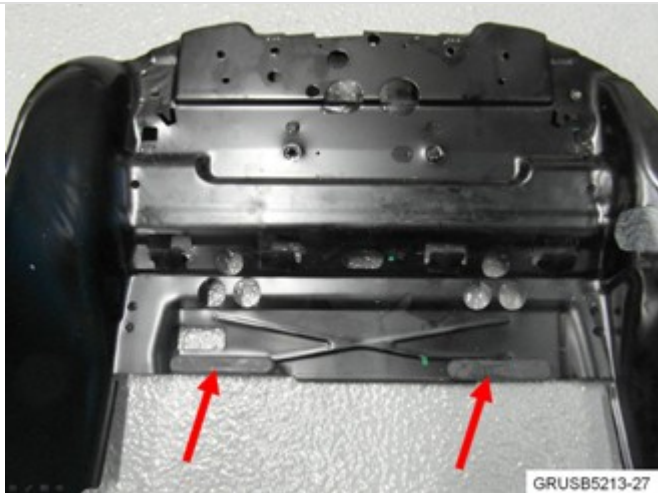
The front seat base cushion shell is deformed at the cross tube of the tilt adjustment.

16. Remove the two (self-retaining) screws securing (left and right) from the seat pivot point.

17. Remove the two self-tapping screws securing the cross tube mount (white bushing) and remove the seat cushion shell.
