SIB 54 08 19

2019-10-09

**SUNROOF REVERSES WHEN CLOSING****What's New** (Specific text highlighted):

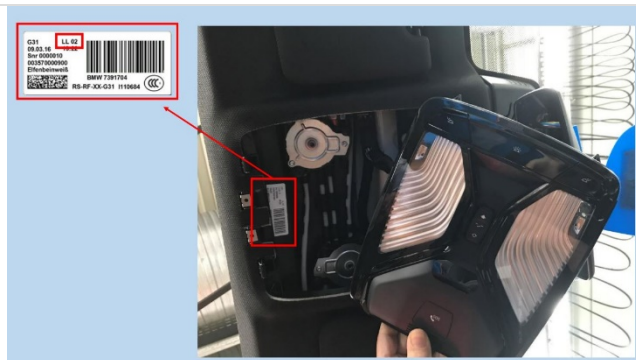
4. With the FZD removed, inspect the “LL” number on the ID tag on the bottom of the sunroof frame. Photo shows the location of the ID tag.

**LL42 or Lower:** Replace the glass/slide sunroof frame and wind deflector following ISTA repair instructions **REP 54 13 556 “Replacing panorama glass roof frame”**.

**LL43 or LL44:** Replace only the sunroof wind deflector following repair instructions **REP 54 13 090 “Removing and installing/replacing wind deflector”**.
