November 2019
FL821A

Emissions Recall: Western Star 4900 Exhaust Pipes

**Models Affected: Specific Western Star 4900 model vehicles
manufactured March 8, 2016, through July 25, 2019.**

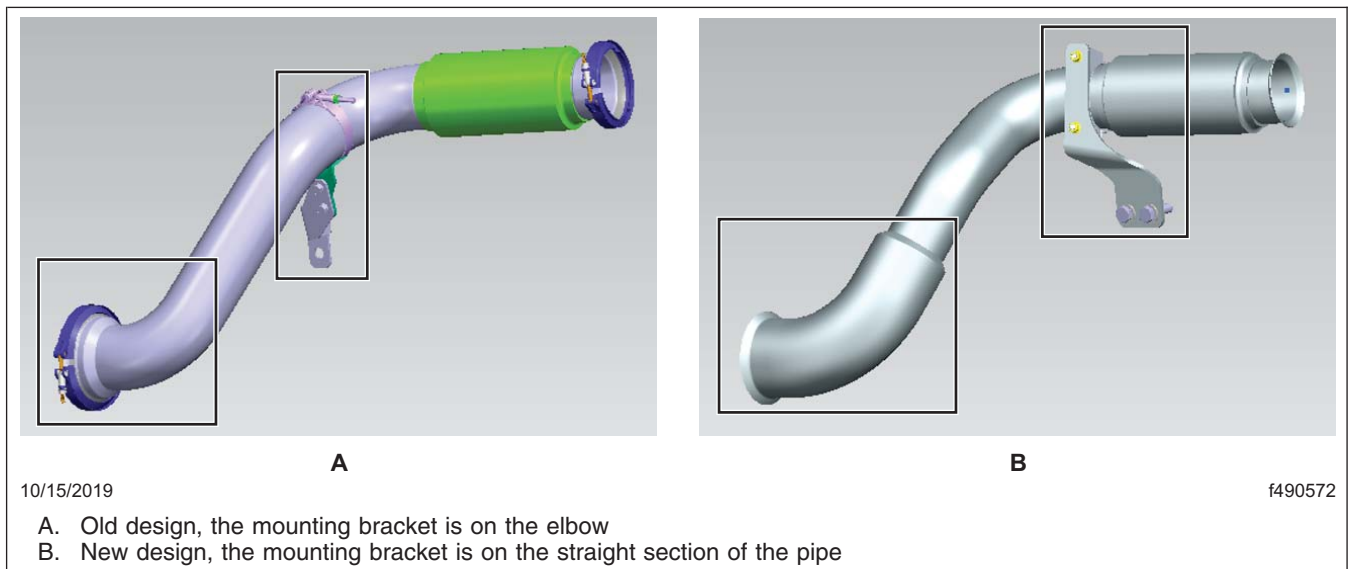
Fig. 1, Difference in the Shape of the Tube and Bracket Mounting Location

1. Check the base label (Form WAR259) for a completion sticker for FL821 (Form WAR260) indicating this work has been done. The base label is usually located on the passenger-side door about 12 inches (30 cm) below the door latch. If a completion sticker is present, no work is needed. If a completion sticker is not present, continue with the next step.
2. Park the vehicle on a level surface, shut down the engine, and set the parking brake. Chock the tires.
3. Compare the pipe shape and mounting bracket location, see [Fig. 1](#).
 - If the new pipe and mounting bracket have been installed, no work is needed. Go to step 4.
 - If the new pipe and mounting bracket have NOT been installed, go to Exhaust Pipe Assembly Procedure.
