Freightliner  
Service Bulletin

# AirLiner™ Suspension Air-Spring Bag Misalignment Troubleshooting

# 32-040

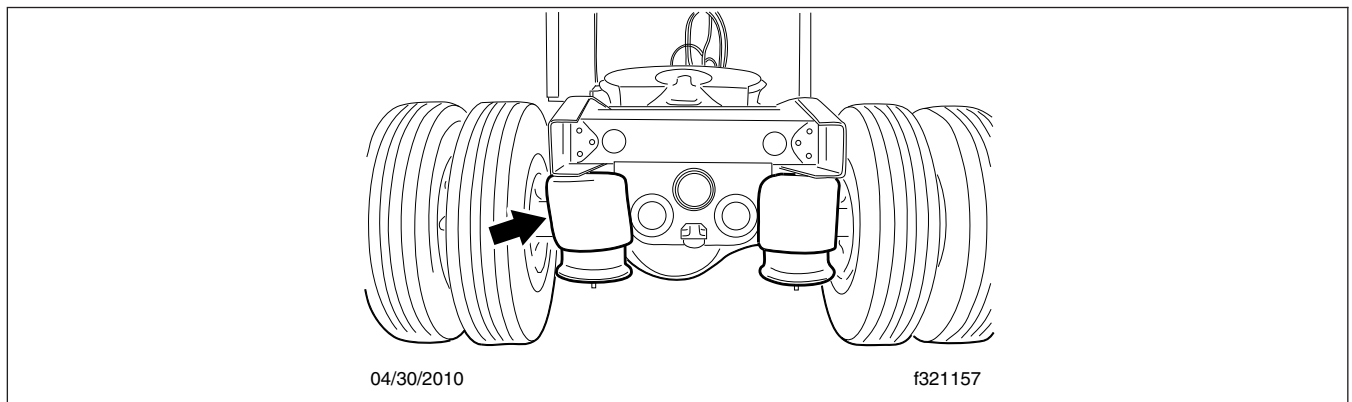
**IMPORTANT:** A leaning or tilted air-spring bag **does not** affect the operation of the Freightliner AirLiner rear suspension. This is an aesthetic issue only.

The most common air-spring bag alignment complaints are a leaning or tilted air-spring bag or different air-spring bag heights between left and right sides. See [Fig. 1](#).

**Fig. 1, Rear of Vehicle with Misaligned Air Bags**

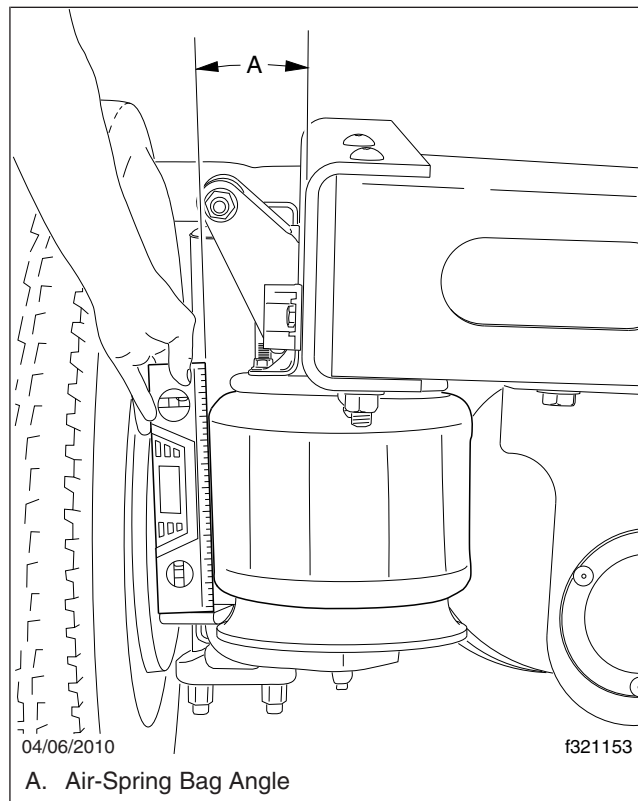
2. Using a digital level tool, check the angle of the air-spring bag, relative to the frame rail.
  - 2.1 Fully inflate the rear suspension, then place a digital level tool vertically against the outside of the frame rail web and set it to zero.
  - 2.2 Place the level tool vertically against the outside of the air-spring bag as shown in **Fig. 2**. If the angle is less than 6.0 degrees the air-spring bag angle is within specifications and no further action is required. If the angle is more than 6.0 degrees from vertical, proceed to the next step.

**Fig. 2, Checking the Air-Spring Bag Angle**

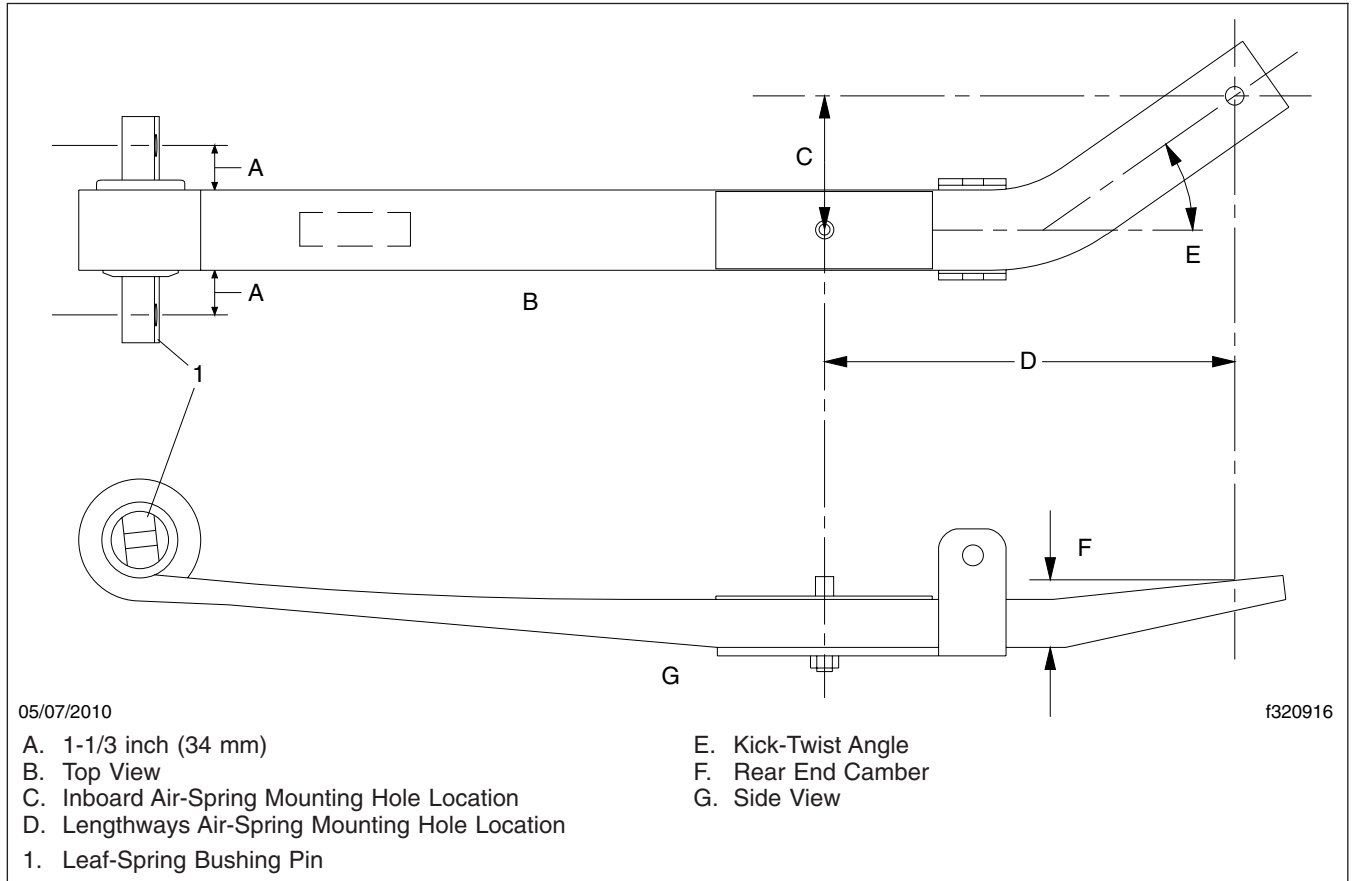
The critical leaf spring dimensions that directly affect these complaints are:

**Fig. 3, AirLiner Leaf Spring Critical Dimensions**

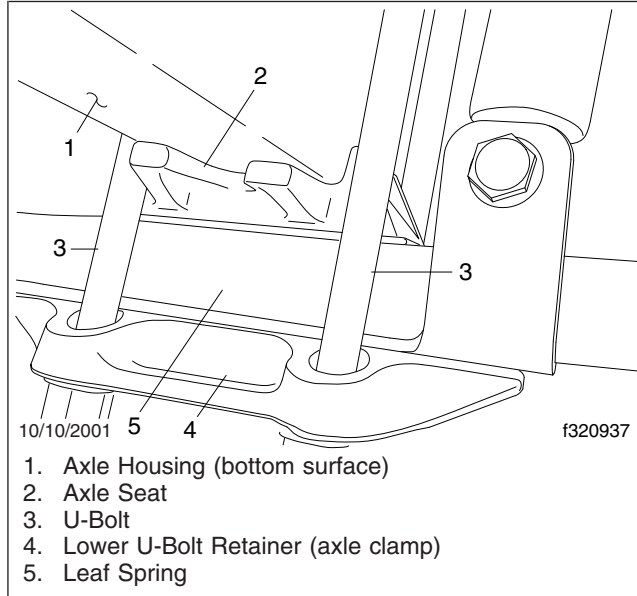
5. Check that the axle seats are installed correctly. See [Fig. 4](#). An axle seat installed backwards can cause a pronounced right-to-left air-spring bag height difference. Use PartsPro® module 431, EZWiring to see the engineering installation drawing of the axle seat.

**Fig. 4, Axle Seat Installation**

If an axle seat is found to be installed backwards, remove it then install it correctly, following the instructions in the section titled Freightliner Airliner Rear Suspension, in **Group 32**, of the applicable workshop/service manual.

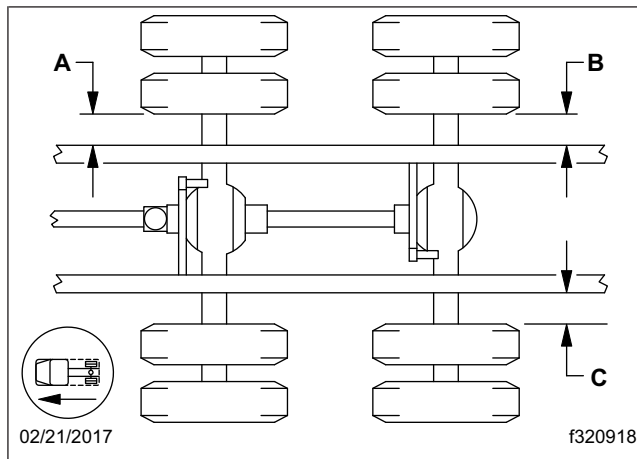
6. Check the rear axle(s) tracking. See **Fig. 5**.

**Fig. 5, Axle Tracking Measurements**

- 6.1 Measure from the inner side of the rear tire, to the outer side of the frame rail, at the right side of the forward-rear drive axle.
- 6.2 Measure the same distance at both sides of the rearmost drive axle.  
 Dimensions "B" and "C" must not vary from dimension "A" by more than 1/4 inch (6 mm).
- 6.3 If dimensions "B" and "C" vary from dimension "A" by more than 1/4 inch (6 mm), loosen the lateral torque rods at the frame rail and add or subtract shims as necessary, following the instructions in the section titled Freightliner Airliner Rear Suspension, in **Group 32**, of the applicable workshop/service manual.

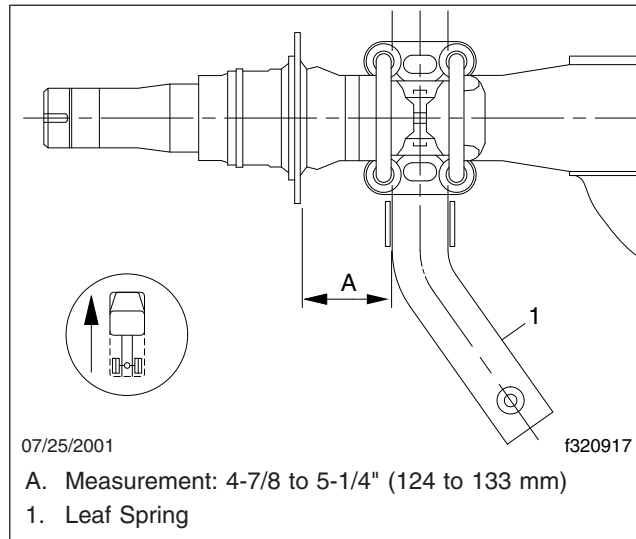
- Check that the axle clamps are correctly aligned on the axle housing and not shifted inboard or outboard. See **Fig. 6**. The distance from the brake spider flange to the outside surface of the leaf spring should be 4-7/8 to 5-1/4 inches (124 to 133 mm). The upper axle clamps should align with the dowels on the top surface of the axle housing.

**Fig. 6, Axle Clamp/Axle Alignment Measurement**

If the axle clamps are not correctly aligned, raise the vehicle and support the frame rails with safety stands. With the axle supported, loosen the U-bolts then install the axle clamps correctly.

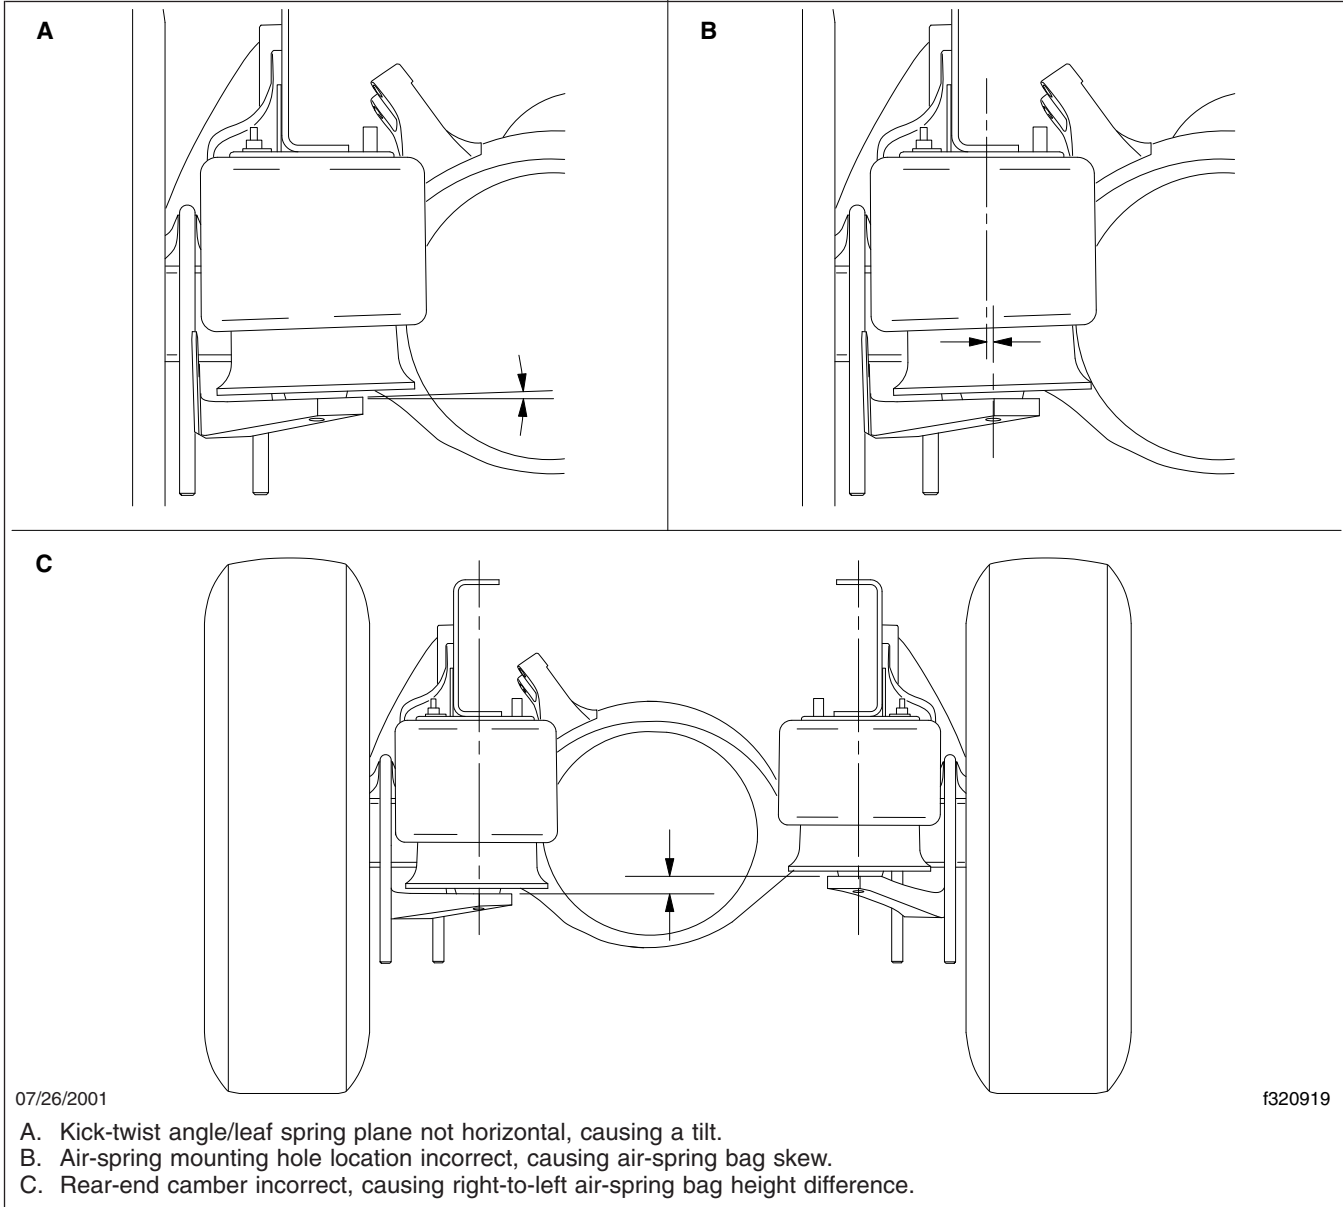
- A. Kick-twist angle/leaf spring plane not horizontal, causing a tilt.
- B. Air-spring mounting hole location incorrect, causing air-spring bag skew.
- C. Rear-end camber incorrect, causing right-to-left air-spring bag height difference.

**Fig. 7, Most Common Airbag Misalignment Complaints**

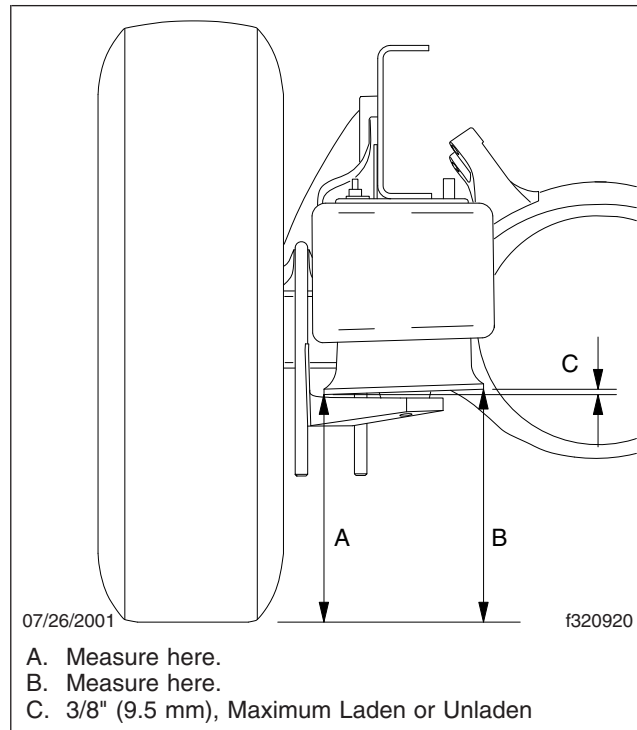
The plane of the leaf spring kick should be 0.0 degrees to + 4.0 degrees from the horizontal with the spring unladen, or  $\pm 2.0$  degrees from the horizontal when fully laden. Do the following procedure to determine if the kick-twist angle is within specification.

1. From the rear of the vehicle, measure the distance from each end of the air-spring piston to the ground. See **Fig. 8**. Repeat each measurement three times to ensure accuracy.

**Fig. 8, AirLiner Leaf Spring Kick-Twist Angle Measurement**

2. If the difference between the two measurements in the previous step is less than 3/8 inch (9.5 mm), no further modification is necessary.

If the difference between these two measurements is more than 3/8 inch (9.5 mm), the leaf spring is out of tolerance. Replace it following the instructions in the section titled Freightliner Airliner Rear Suspension, in **Group 32**, of the applicable workshop/service manual.

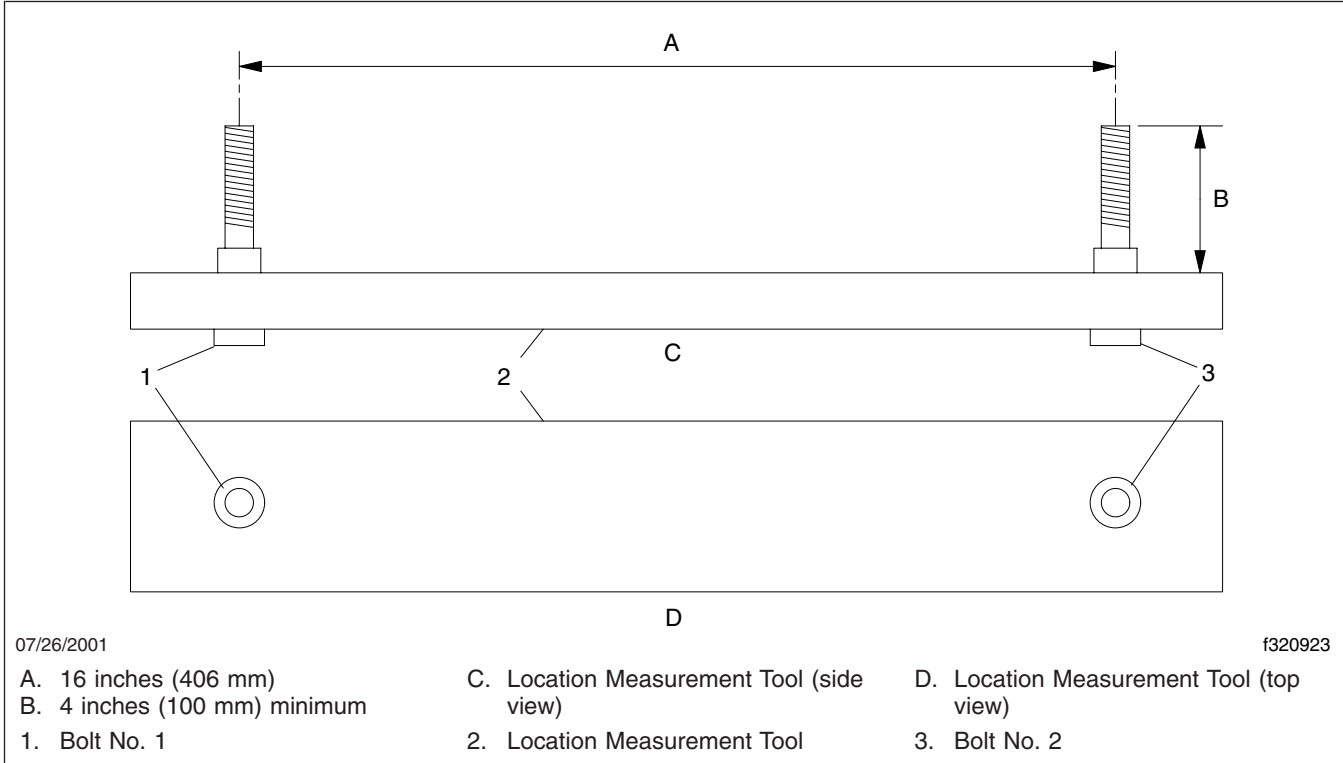
1. Drill two holes exactly 16 inches (406 mm) apart on a piece of wood or metal at least 18 inches (450 mm) long.
2. Install a bolt into each hole and secure with a nut and washers if needed. Select a bolt size that will protrude from the edge of the wood or metal by at least 4 inches (100 mm).
3. Measure the distance between the center of the bolts to ensure that they are exactly 16 inches (406 mm). Correct as necessary until this distance is accurate. See **Fig. 9**.

**Fig. 9, Air-Spring Mounting Hole Location Measurement Tool**

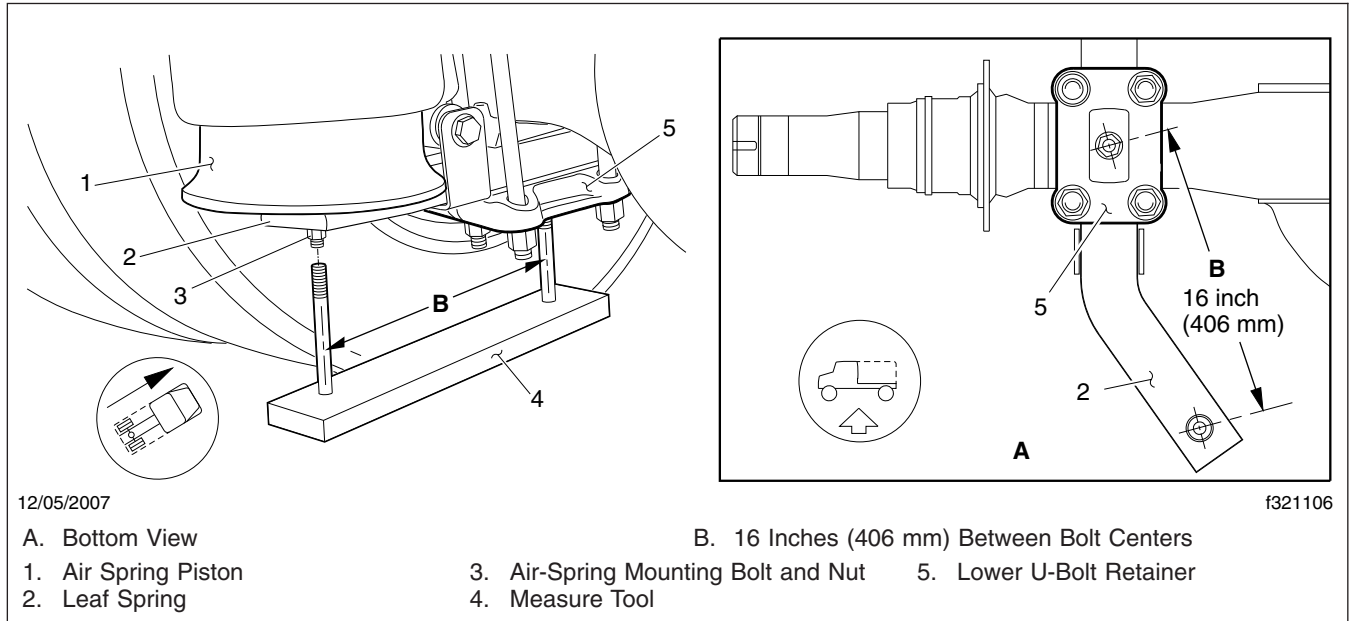
4. From under the vehicle, align the center of one of the bolts on the measurement tool with the center-bolt in the lower U-bolt retainer. See [Fig. 10](#).

**Fig. 10, Measuring the Air-Spring Mounting Hole Location**

5. Pivot the measurement tool around to align the second bolt on the measurement tool with the air-spring mounting bolt and nut. Make sure the first bolt is still aligned with the center-bolt in the lower U-bolt retainer. See **Fig. 10**.
6. If the second bolt aligns with the air-spring mounting bolt and nut, the leaf spring is within this tolerance. No further modification is necessary.

If the second bolt does not align with the air-spring mounting bolt and nut, the leaf spring is out of tolerance. Replace it, following the instructions in the section titled Freightliner Airliner Rear Suspension, in **Group 32**, of the applicable workshop/service manual.

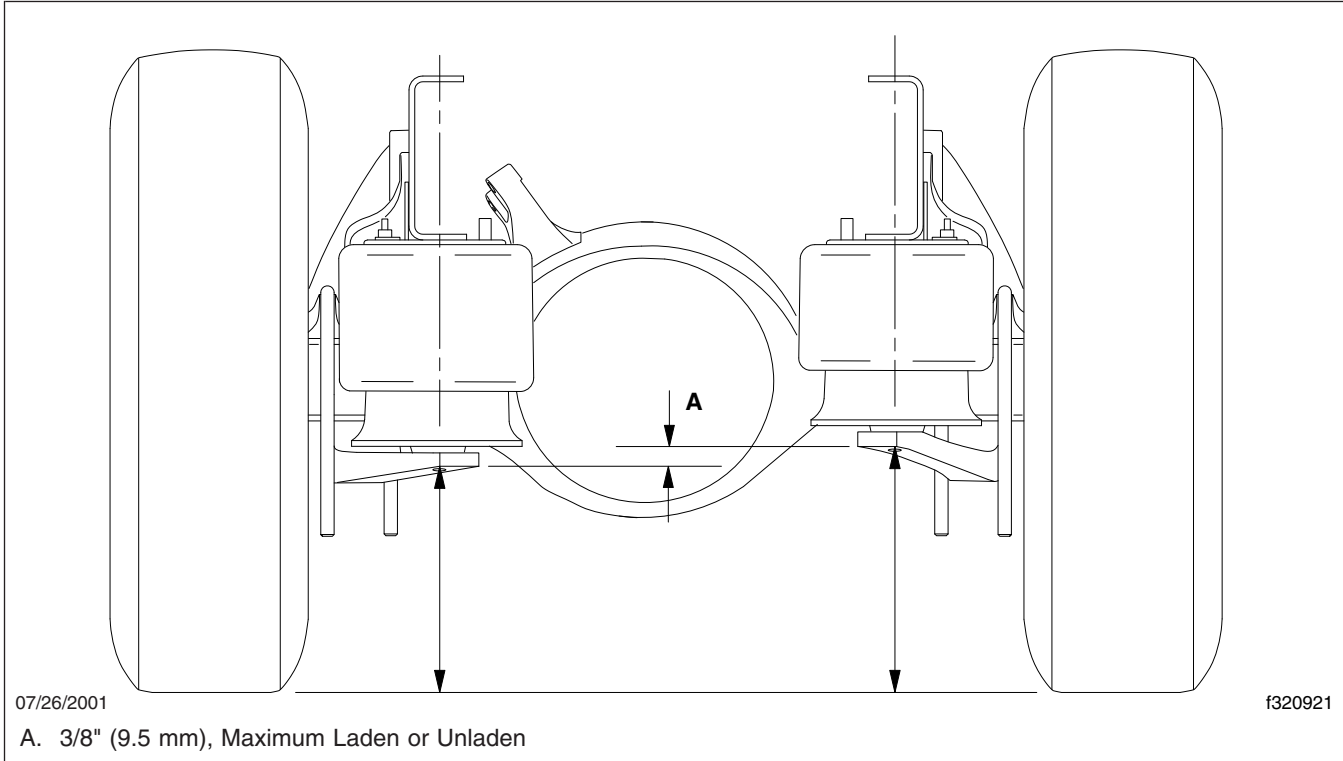
1. Measure the distance from the bottom of each leaf spring to the ground. Measure at the air-spring mounting hole. See **Fig. 11**. Repeat each measurement three times to ensure accuracy.

**Fig. 11, AirLiner Leaf Spring Rear-End Camber Measurement**

2. If the difference between the two leaf-spring measurements is less than 3/8 inch (9.5 mm), no further modification is necessary.  
 If the difference between the two measurements is more than 3/8 inch (9.5 mm), one or both of the leaf springs is out of tolerance. Go to the next step.
3. With the leaf springs installed on the vehicle, using a straight edge, measure the rear-end camber at the air-spring mounting hole on the leaf spring. See [Fig. 12](#). Repeat each measurement three times to ensure accuracy.
4. Compare the measured values to the camber specification shown in [Table 2](#).

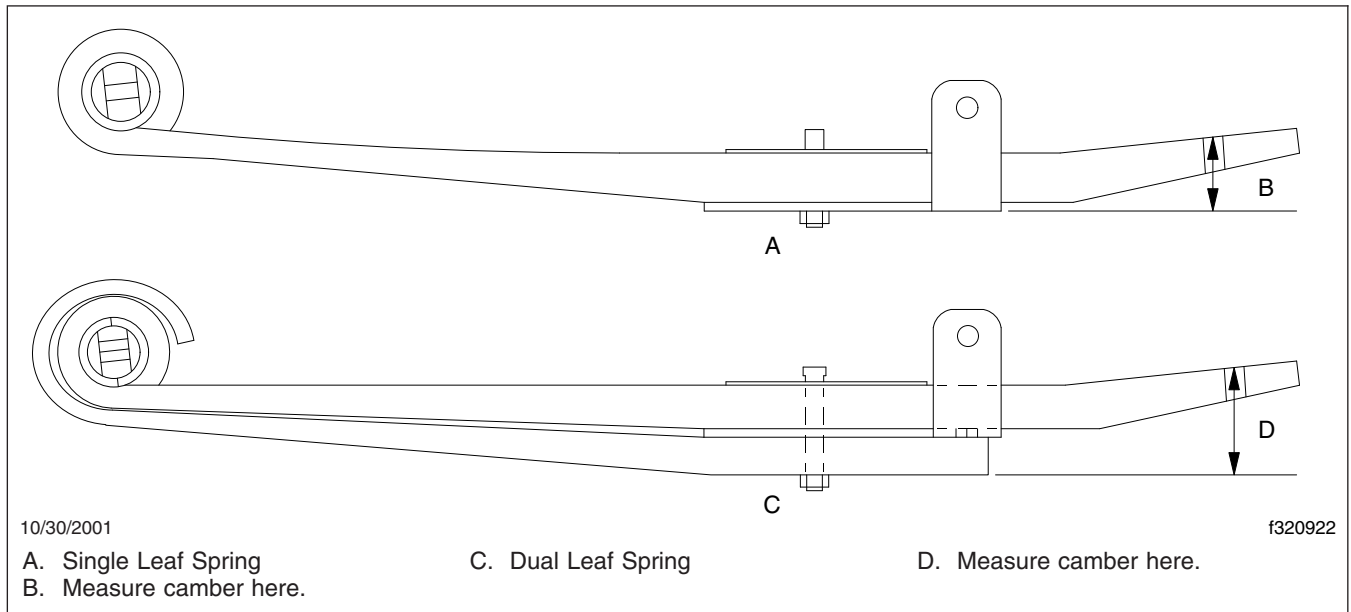
Fig. 12, AirLiner Leaf Spring Rear End Camber Measurements

- If a leaf spring is out of tolerance, remove it from the vehicle and repeat the rear-end camber measurement with the leaf spring lying on a flat surface.
- If the leaf spring is still out of tolerance replace it, following the instructions in the section titled Freightliner Airliner Rear Suspension, in **Group 32**, of the applicable workshop/service manual.
