Business Class M2  
Cascadia  
108SD/114SD  
> New Cascadia

Freightliner  
Service Bulletin

On New Cascadia vehicles built between January 17, 2019 and May 23, 2019, cab wiring can be damaged with an incorrect ground location. This can result in inoperable LIN bus-related steering wheel switches, cruise control dropout, poor AM/FM radio reception, and an inoperable steering wheel clockspring.

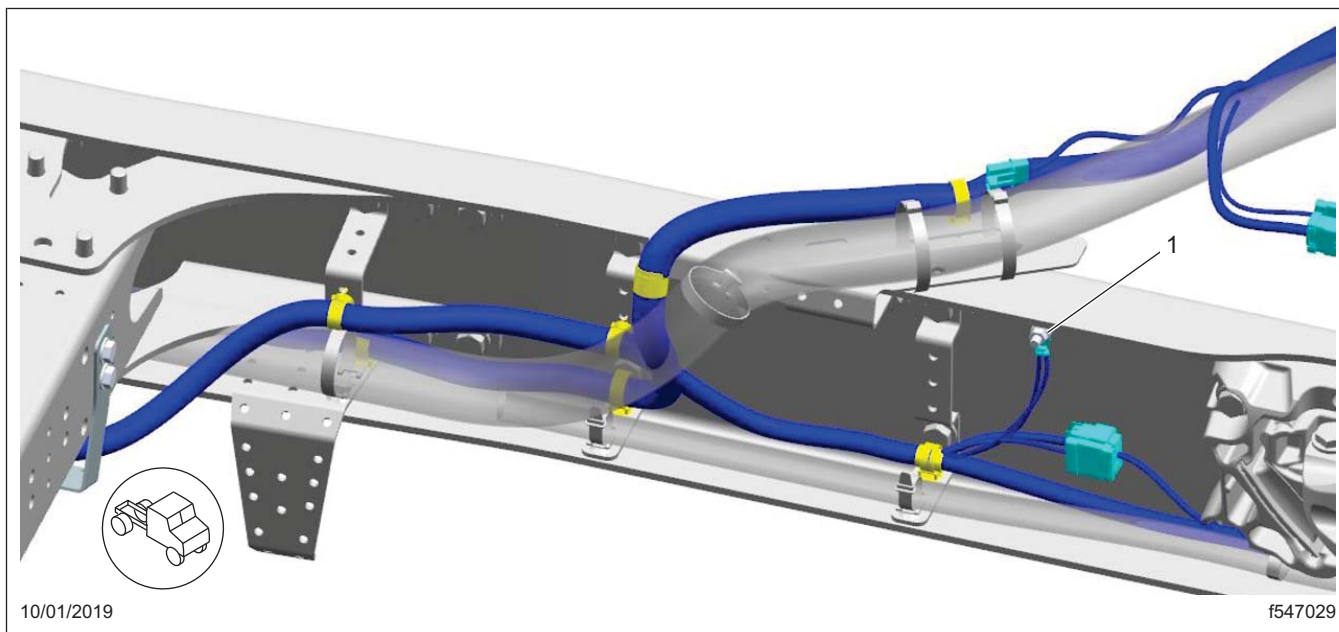
**Fig. 3, Frame-Mounted Stud for GNDP**

**NOTE:** Both sleeper cabs and day cabs with an under-cab battery box mounting have the same frame-mounted power ground (GNDP) stud. See [Fig. 3](#).
