SS 1034538 WST 5700 Intermittent Headlight Issues

Applicable Vehicles

All WST 5700 Built before 11/1/19

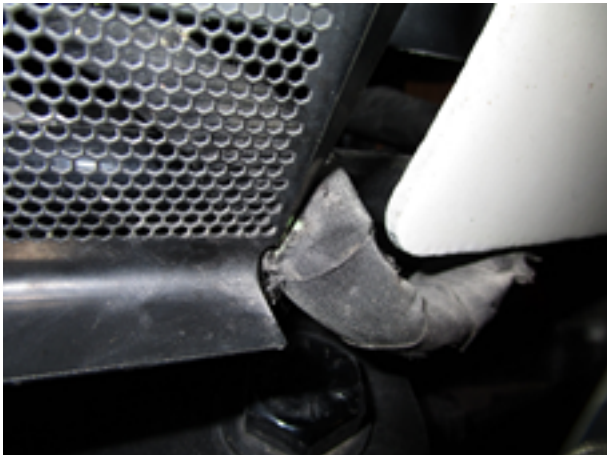
Hood harness runs from the hood to the chassis and has potential to get folded between the bumper and screen when the hood is closed. Chafing occurs causing intermittent headlight issues (lights on and off, high beam comes on when in low beam setting).

Rub point can be seen in picture below

Addition of 48-26131 twist-tube per spec 49-00316-000. Add length to breakout and add clipping point to front cross-member to keep harness off fill-gap screen when hood is closed.

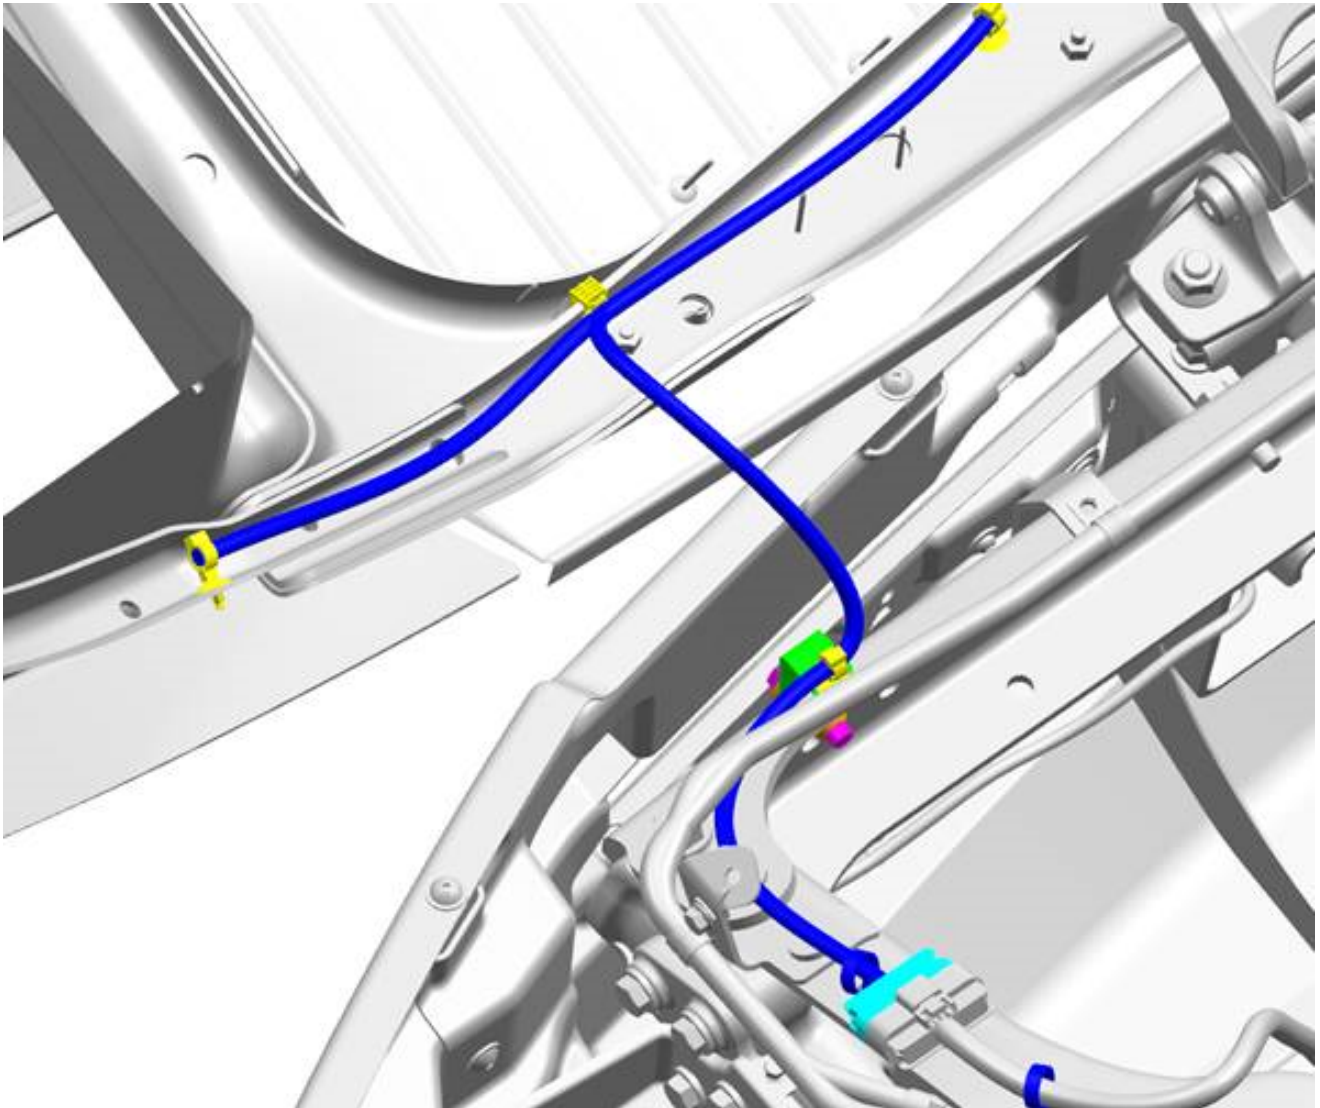
Illustration of fix can be seen in picture below
