**Subject:** ISX15/X15 CM2350 Rocker Lever Replacement - EDS Guided ATC for Multiple Customers

**Number:** Atc2248

**Date:** 18-Oct-2019

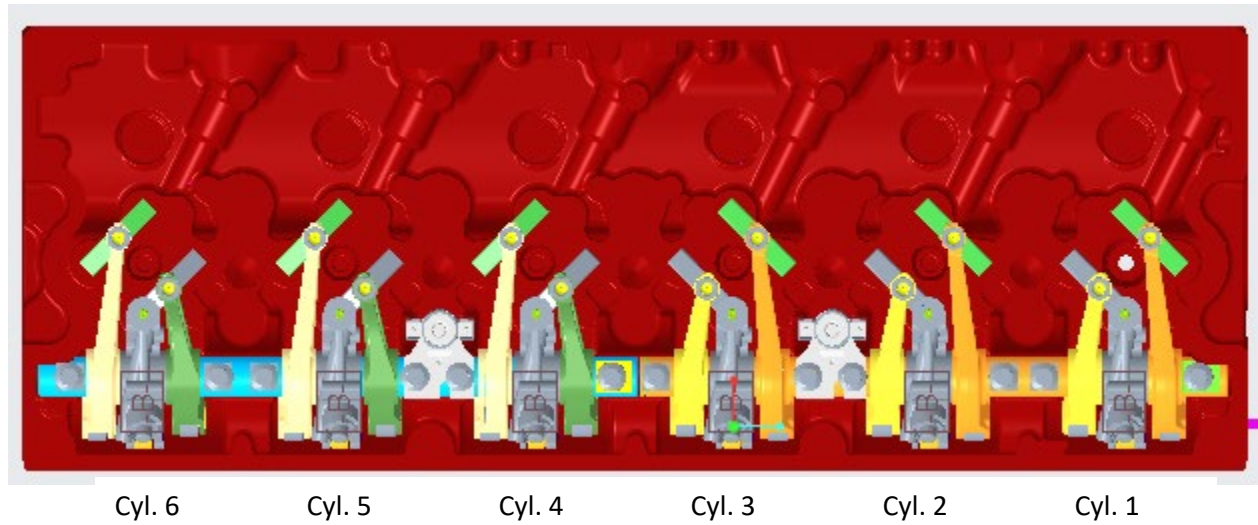
Front of Engine →

1. Intake Lever positions are identified by the longer lever pictured above
  2. Exhaust Lever positions are identified by the shorter\* lever pictured above
- \*The short lever located between the intake and exhaust levers is the brake lever

- B.2) Document the Cylinder Location and lever position of the failed Rocker levers. Record the values under EDS solution S00006294 in the comments field. Please refer to Attachment B for a graphic illustration of the Cylinder and Lever location details.
- B.3) Please refer to Service Bulletin 3666052 Camshaft Reuse Guidelines for Cummins Engines with Roller Followers or Roller Tappets for cam reuse and repair direction.
