Technical Service Bulletin

Technical Service Bulletin: TSB150187	Released Date: 16-Oct-2019
Fault Codes 322, 323, 324, 325, 331, and 332 Generated By Metallic Debris on Injector

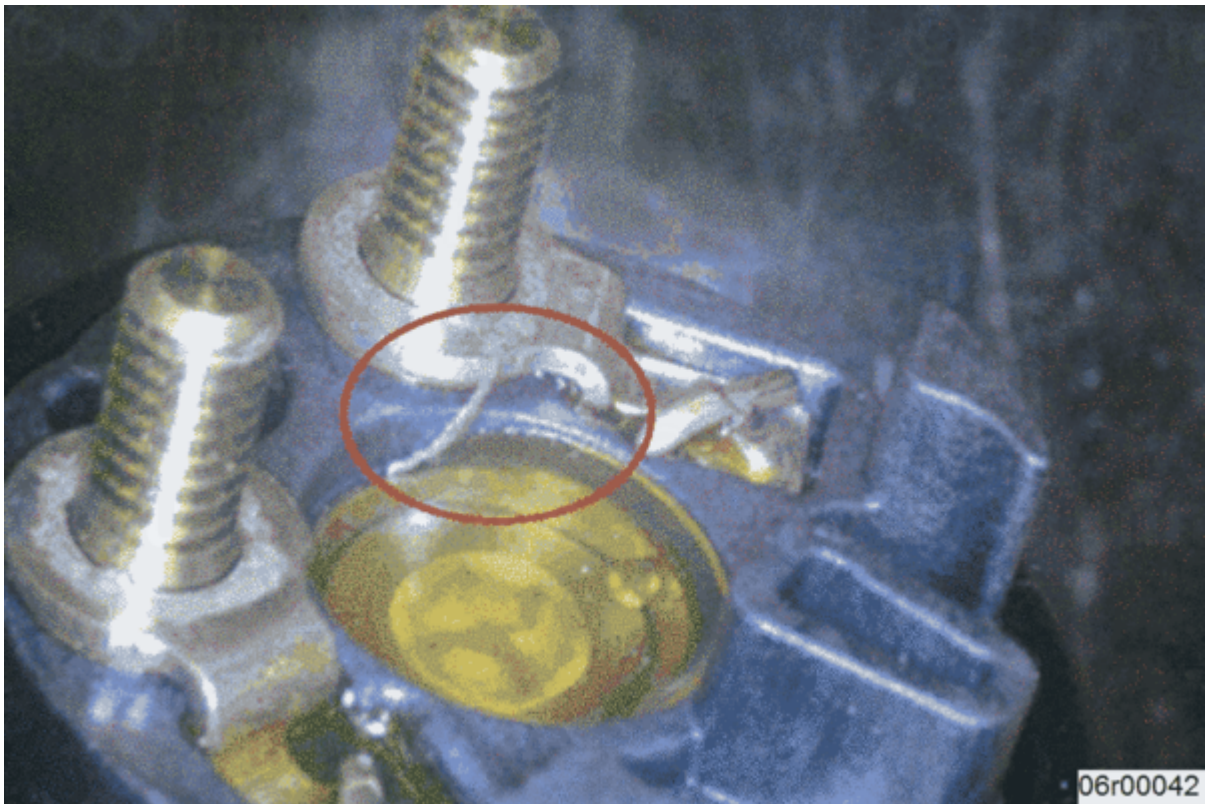
- Metallic debris was introduced onto the injector(s) as a result of a machining processes during engine assembly.
- Metallic sliver can be created when torqueing the injector solenoid wires to the injector solenoid signal post.
- The metallic debris can cause a short circuit path within the injector(s) stator terminals leading to fault code(s).

Figure 1, Injector Stator Contaminated With Metal Debris.

If metal debris is identified as shown in Figure 1 and 2 above, perform the following:

- With injectors in place, disconnect injector solenoid wires for affected injector. Clean the affected area of the metallic debris with safety solvent and a soft, clean cloth.
- Connect and torque injector solenoid wires. See corresponding service manual. Reference Procedure 019-063 in Section 19.
- Inspect the top of the injector to verify that no metal slivers were created or are present on the top of the injector.

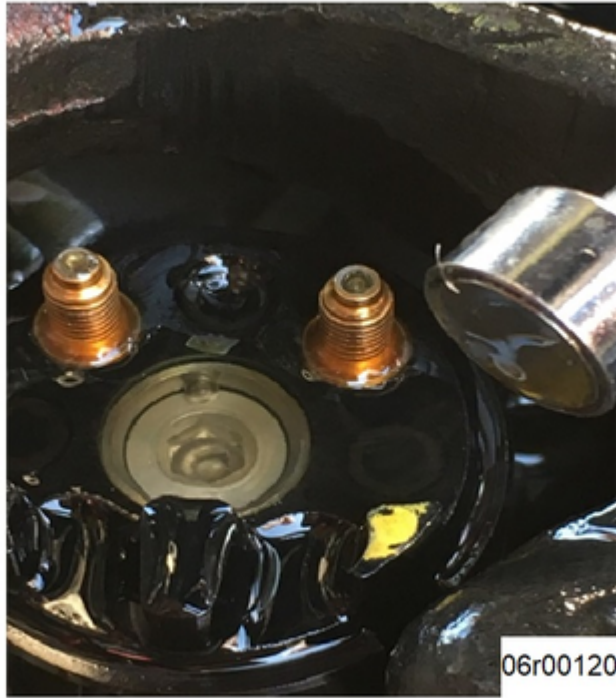
Figure 2, Medium Duty Injector Stator Contaminated with Metal Debris.
