Service Bulletin

Bulletin No.: 17-NA-384

Subject: Squeak, Rattle or Creak Coming from Second Row/Rear Seat Area

Brand:	Model:	Model Year:		VIN:		Engine:	Transmission:
		from	to	from	to		
Cadillac	XT5	2017	2019			All	All
GMC	Acadia (VIN N)						
Holden	Acadia

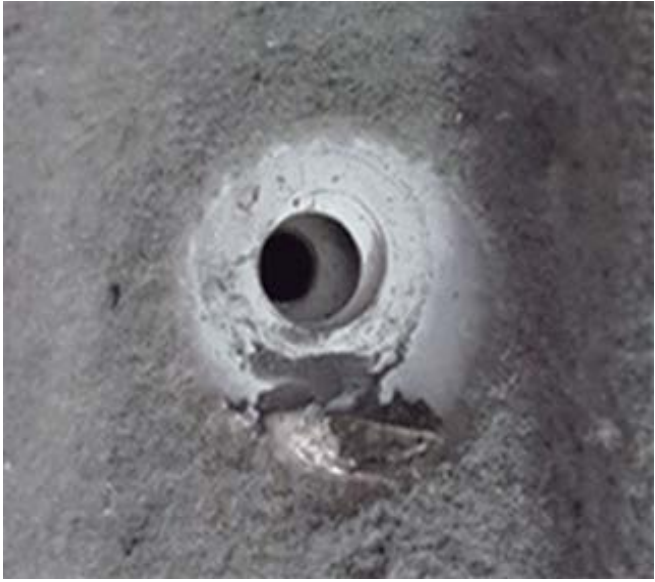
<p style="text-align: right;">4911773</p> <p>Note: The “winking” is caused by excessive overlap of body panels and, as shown in the graphic above, the sheet metal holes are offset. This is most commonly found at the right rear fastener location of the right rear seat, or the left rear fastener of the left rear seat.</p> <ul style="list-style-type: none"> • Possible “winking” condition of right rear 40% seat floor pan outboard track rear bolt hole, or the left rear 60% seat floor pan outboard track rear bolt hole. • A seat track synchronization/torque condition may require a torque sequencing of the seat attachment bolts, on either seat.

Correction	<p>Note: Perform the “winking” inspection, and repair procedure as necessary first, prior to performing the torque procedure.</p> <p>For vehicles exhibiting the condition, follow the Service Procedure below to inspect for and correct the winking condition, and also complete the torque sequencing procedure.</p>

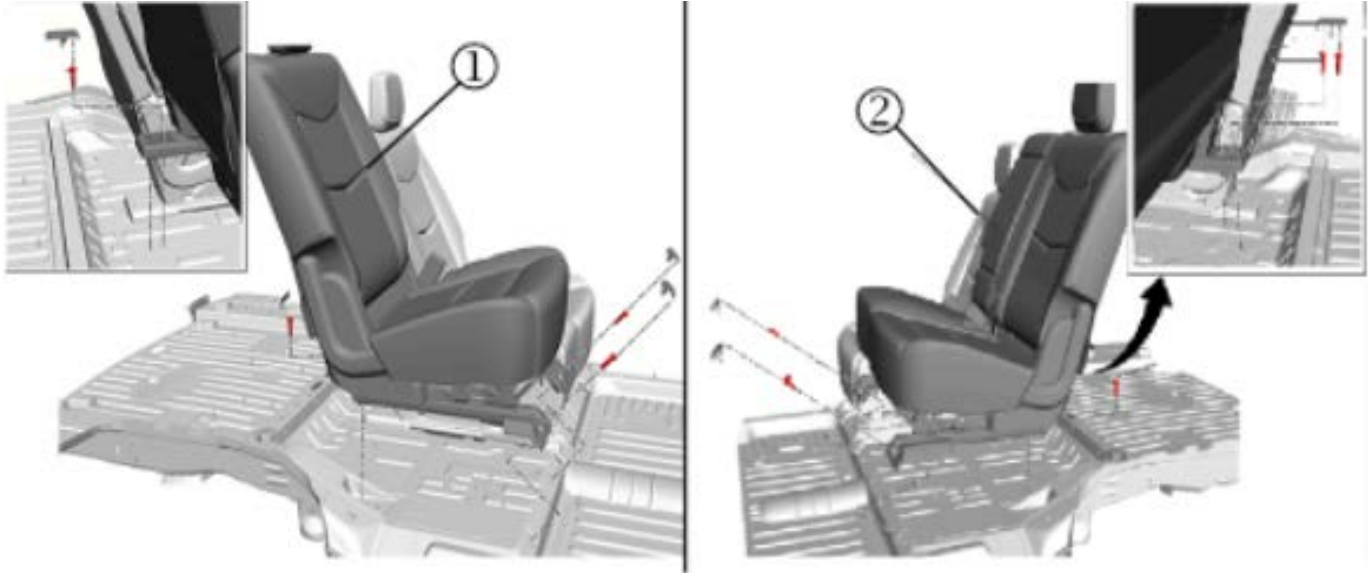
5403437

1. Verify which rear seat exhibits the condition: the right rear 40% seat, (1) and/or the left rear 60% seat. (2)

2. Remove the affected right (1) and/or left (2) rear seat. Refer to *Rear Seat Removal and Installation (40%)* and/or *Rear Seat Removal and Installation (60%)* in SI,
 - 2.1. Adjust the seat to full rearward position.
 - 2.2. Loosen the outboard front attachment bolt, then the inboard bolt.
 - 2.3. Adjust the seat to full forward position.

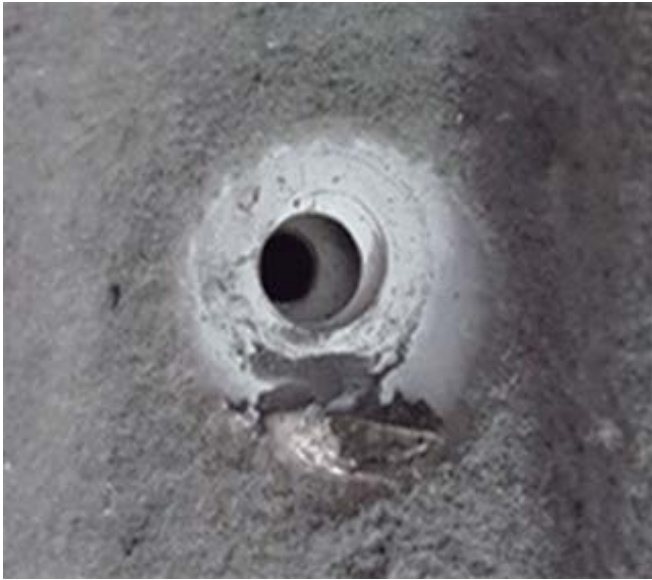
4911773

3. Inspect the right outboard rear seat fastener location of the right rear seat and/or the left outboard rear seat fastener location of the left rear seat for possible “winking” condition:

- If “winking” condition DOES exist, continue ahead to step #4 and remove sheet metal material.

4. Using a dremel, or suitable tool, grind a small amount of material from the floor sheet metal opening. Grind only enough of the overlapping metal to allow clearance for the seat bolt.
5. Use an air gun to blow out any metal debris in the nut and hole area.

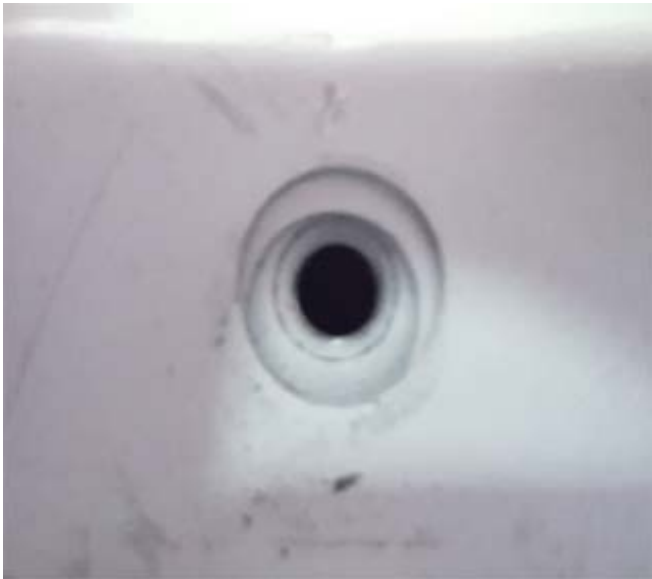
4911781

Note: In the graphic example above, the sheet metal is still offset, but the nut is centered enough to avoid contact of the seat bolt to the sheet metal.

- If “winking” condition DOES NOT exist, jump ahead to step #6 and follow the torque sequence procedure.
