Service Bulletin

Bulletin No.: 18-NA-069

Subject: Poor Engine Performance in Extremely Cold Weather Conditions for LFV Engines, Charge Air Cooler Icing - Malfunction Indicator Lamp (MIL) Illuminated, DTC P0299, P0236, P2227, P00C7 Set

Brand:	Model:	Model Year:		VIN:		Engine:	Transmission:
		from	to	from	to		
Chevrolet	Malibu	2016	2019			1.5L (LFV)

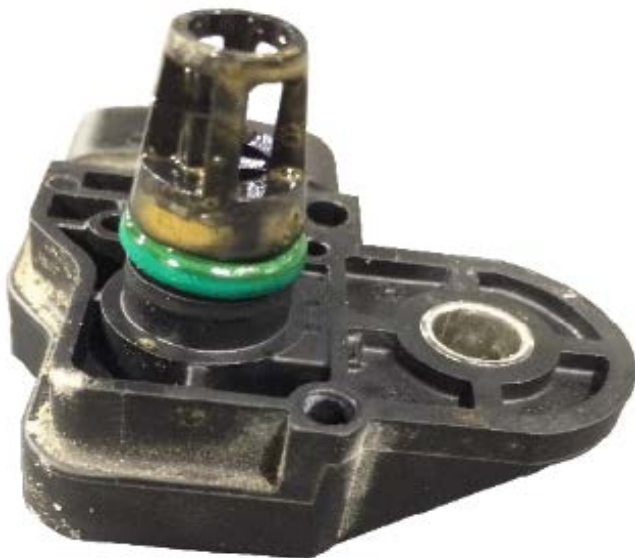
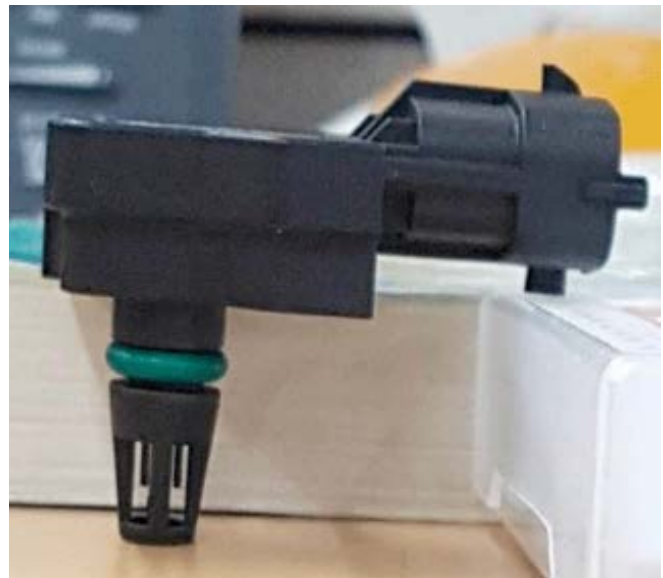
4. Inspect the sensor of any contaminants.

Important: Due to the sensitivity of the sensor, **Do Not** use any chemical cleaners including water and **Do Not** use compressed air to remove contaminants.

5. Allow time for any ice build-up to melt by placing the sensor port down.
6. Clean the sensor with a clean towel.
7. Install the sensor.
