Service Bulletin

Bulletin No.: 18-NA-161

Subject: Steering Jerks Or Kicks Back / Reduced Power Steering Assist / Engine Stall / No Start / Service Stabilitrak / IPC / Radio / HVAC Goes Blank Various DTCs

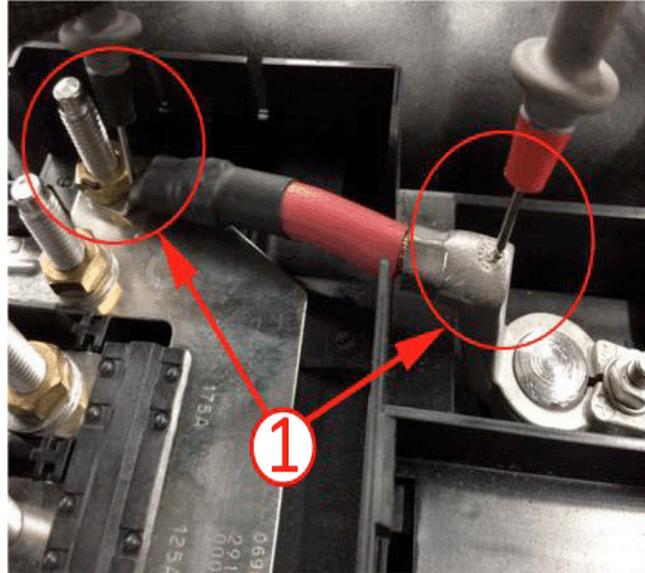
5073675

Inspect for any high resistance and/or loose connections at both the battery fuse block and the positive or negative battery cables.

1. Perform a loaded voltage drop test on the short positive battery cable (1).
- ⇒ Refer to “Measuring Voltage Drop” in SI. If the voltage drop is above 100 mV, replace the affected cable(s).
- For positive cable parts information, refer to the Parts Information section.

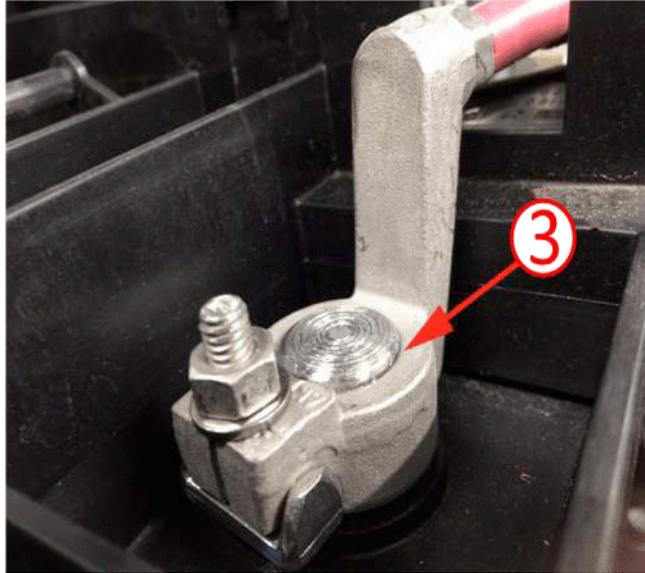
5073701

- ⇒ It is imperative that both the positive and negative battery top posts protrude above the battery cable clamps 1-2 mm (0.040 - 0.080 in) to be properly installed, as shown (3).

3. Check both the positive and negative battery cable clamp nuts and make sure they are properly tightened to 7 Nm (62 lb in).
 4. After the positive and negative battery cables are fully installed and tightened to 7 Nm (62 lb in), grasp each battery cable near the battery post and make sure they are secure and that they do not spin on the post. If they spin, replace the battery cable.

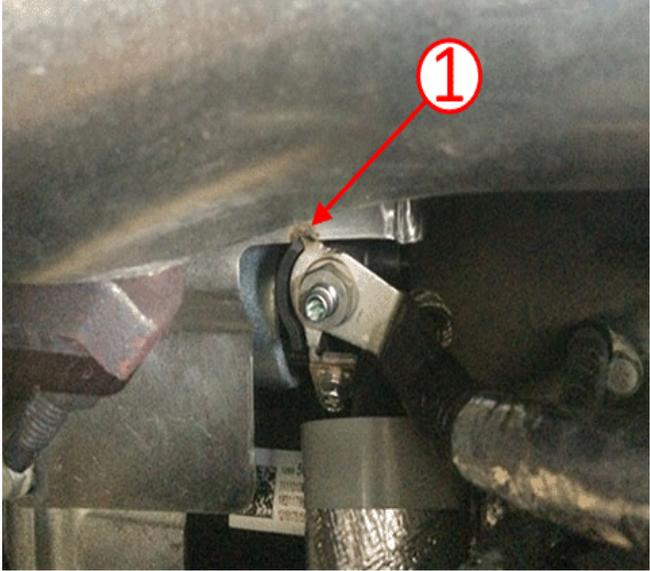
<p style="text-align: right;">5073866</p> <p>Inspect the starter solenoid B+ battery cable for possible contact at the starter heat shield (1) or a loose shield resting on terminal.</p> <ul style="list-style-type: none"> ⇒ If the battery cable is shorting out on the starter heat shield, replace the B+ battery cable and starter heat shield. ⇒ After installing the new starter heat shield and B+ battery cable, ensure there is adequate clearance and each fastener is torqued properly so it will no longer short out.
<p>Correction 4</p>	<p>Perform the "Battery Inspection/Test" procedure in SI, using the GR8, and replace the battery if it fails the test.</p> <ul style="list-style-type: none"> ⇒ Technicians must attach the GR8 test print out with a Battery Replace decision, that includes the Warranty Code, to the repair order.
