Service Bulletin

Bulletin No.: 18-NA-356

Subject: Vibration and/or Noise Heard During Hard Acceleration at Speeds of 77 km/h (48 mph) to 83 km/h (52 mph)

Brand:	Model:	Model Year:		VIN:		Engine:	Transmission:
		from	to	from	to		
Chevrolet	Colorado	2015	2020			3.6L Engine (RPO LGZ)	8L45 Automatic Transmission (RPO M5T)
GMC	Canyon

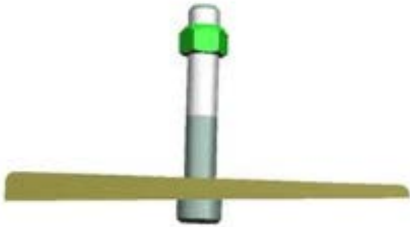
Involved Region or Country	North America and NA Export vehicles
Condition	Some customers may comment on a vibration and/or noise heard during hard acceleration at speeds of 77 km/h (48 mph) to 83 km/h (52 mph).
Cause	This condition may be caused when the driveline angles get extreme during axle wind up resulting in 2nd order vibration.
Correction	<div style="text-align: center;">

</div> <p style="text-align: right; font-size: small;">5181550</p> <p>Install a tapered shim between the axle and leaf spring to adjust the angle following the procedure below.</p>
