Service Bulletin

Bulletin No.: 19-NA-238

Subject: Propulsion System Disabled — MIL Illuminated, DTC P1B0D Set

Brand:	Model:	Model Year:		VIN:		Engine:	Transmission:
		from	to	from	to		
Chevrolet	Bolt EV	2017		—		—	
Opel	Ampera-e

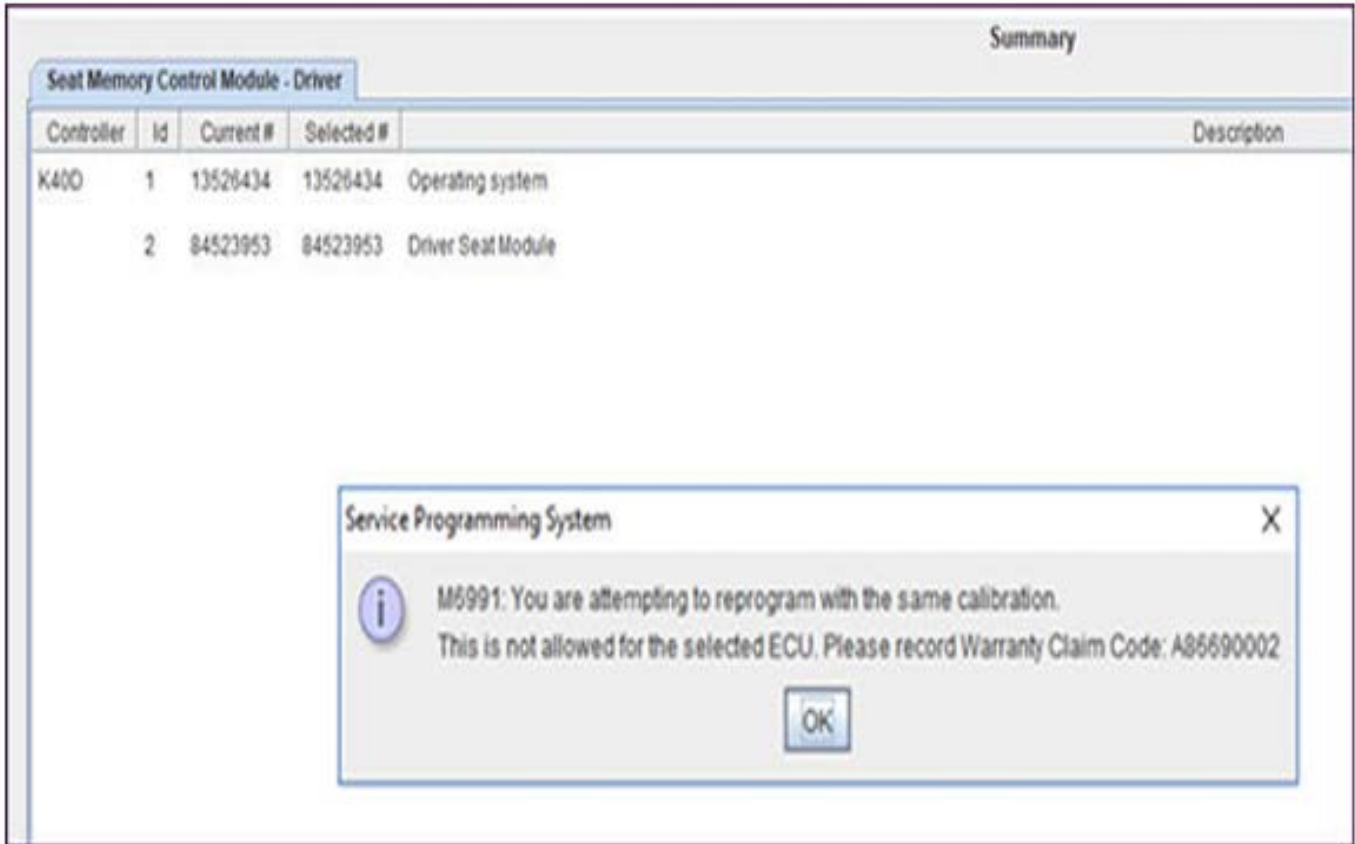
5164840

Note: If the Same Calibration/Software Warning appears on the SPS Summary screen, record the warranty claim code (WCC), select OK and follow the on-screen instructions.

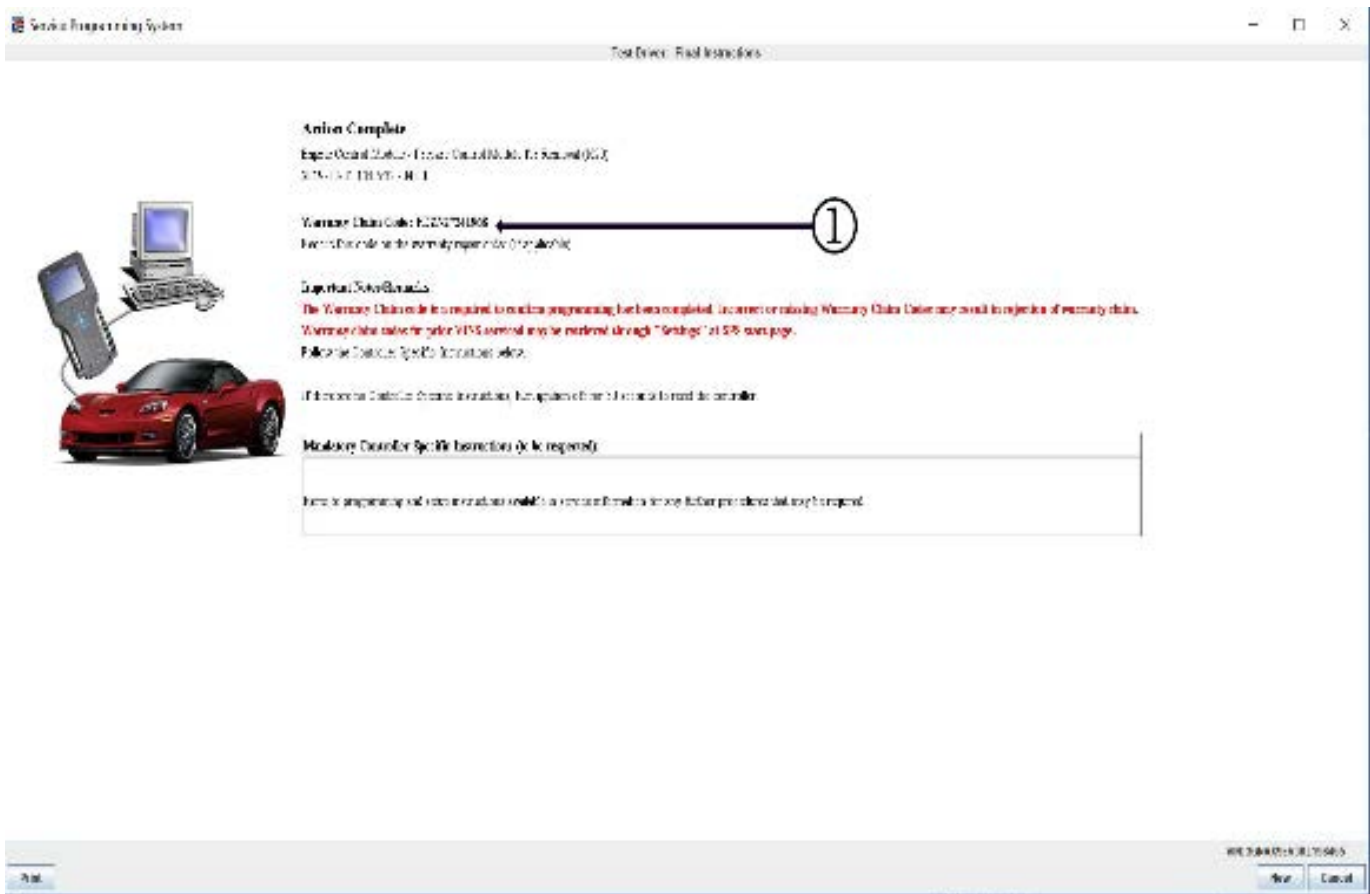
5418111

Note: To avoid warranty transaction rejections, you **MUST** record the warranty claim code provided on the SPS Warranty Claim Code (WCC) screen on the job card. Refer to callout 1 for the location of the WCC on the SPS screen.

3. Record the SPS Warranty Claim Code on the job card for warranty transaction submission.
4. Clear DTCs after the programming is complete. Clearing Powertrain DTCs will set the Inspection/Maintenance (I/M) system status indicators to No.
5. Perform the Diagnostic Repair Verification after completing the repair. Refer to **Diagnostic Repair Verification** in SI.
