Service Bulletin

Bulletin No.: 19-NA-239

Subject: XM Radio Displays Willies Roadhouse on All Channels

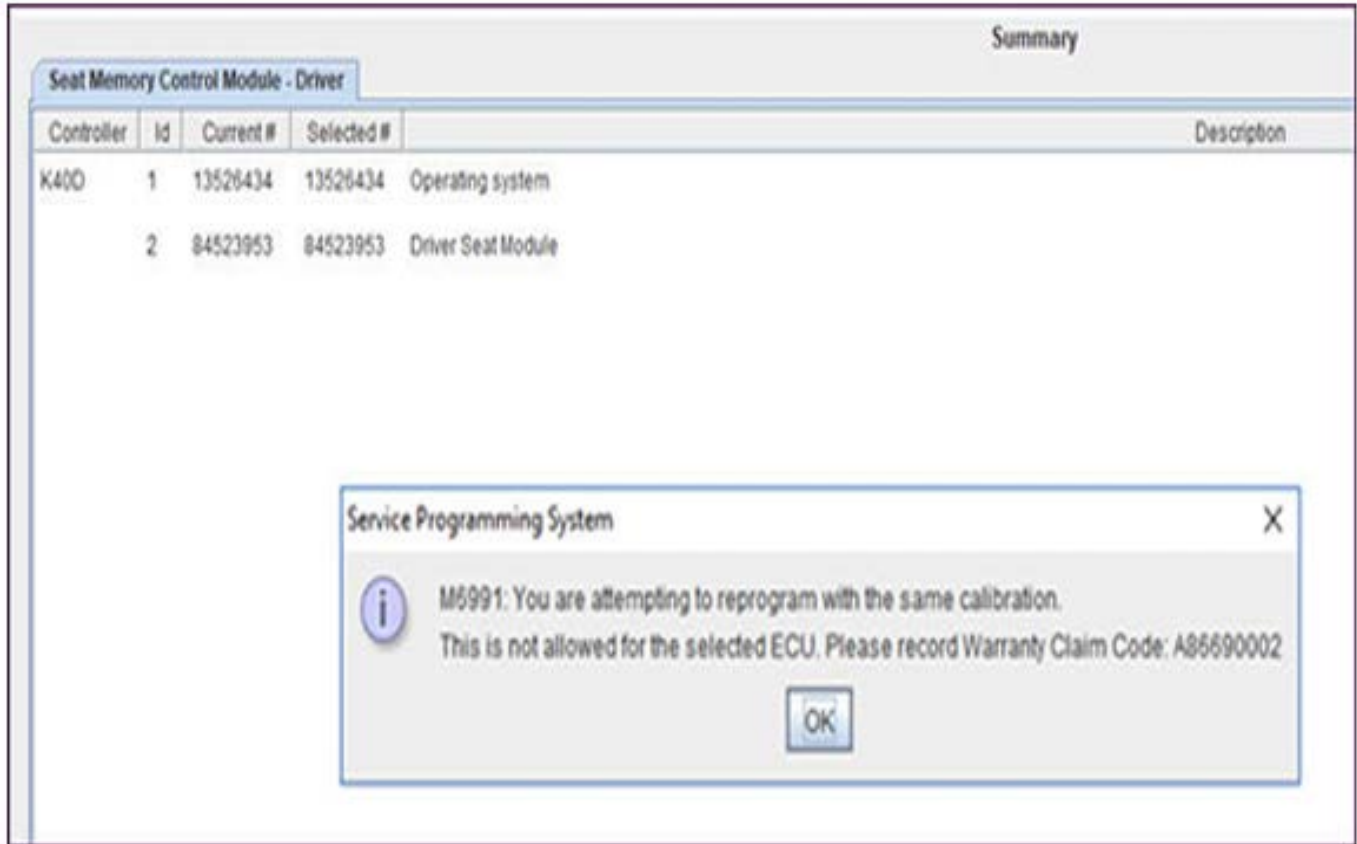
5164840

Note: If the Same Calibration/Software Warning is noted on the SPS Summary screen, record the warranty claim code (WCC) and select OK and follow screen instructions. After a successful programming event, the WCC is located in the Service Programming System dialogue box of the SPS Summary screen. No further action is required. Refer to the Warranty section of the bulletin.

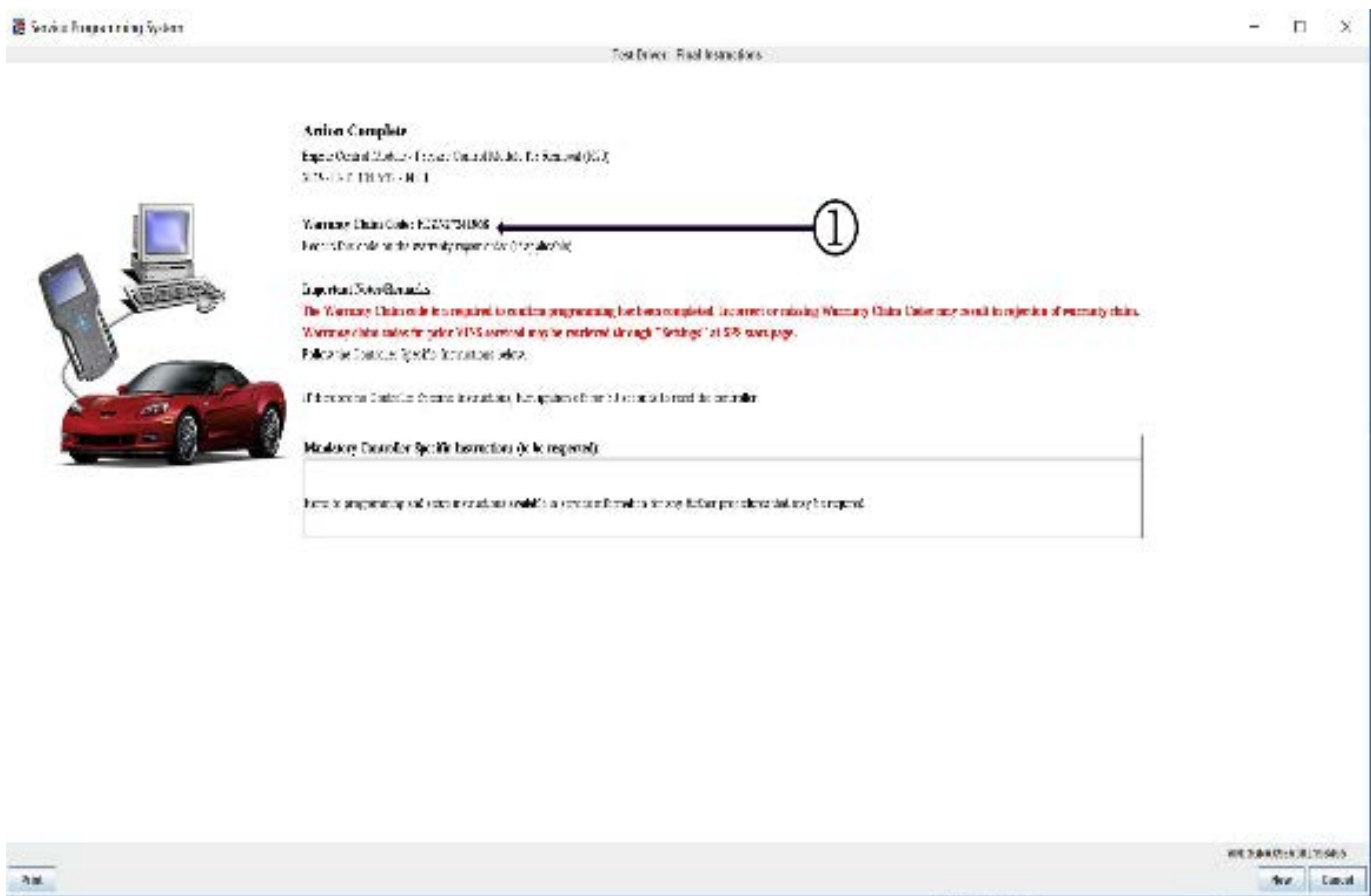
5418111

Note: To avoid warranty transaction rejections, you **MUST** record the warranty claim code provided on the SPS Warranty Claim Code (WCC) screen on the job card. Refer to callout 1 for the location of the WCC on the SPS screen.

- Record SPS Warranty Claim Code on job card for warranty transaction submission.
