Service Bulletin

Bulletin No.: 19-NA-240

Subject: Steering Wheel Oscillation, Vibration, Shake at 80-129 km/h (50-80 mph)

Brand:	Model:	Model Year:		VIN:		Engine:	Transmission:
		from	to	from	to		
Chevrolet	Silverado 2500HD/ 3500HD	2020	2020			All	All
GMC	Sierra 2500HD/ 3500HD	2020	2020

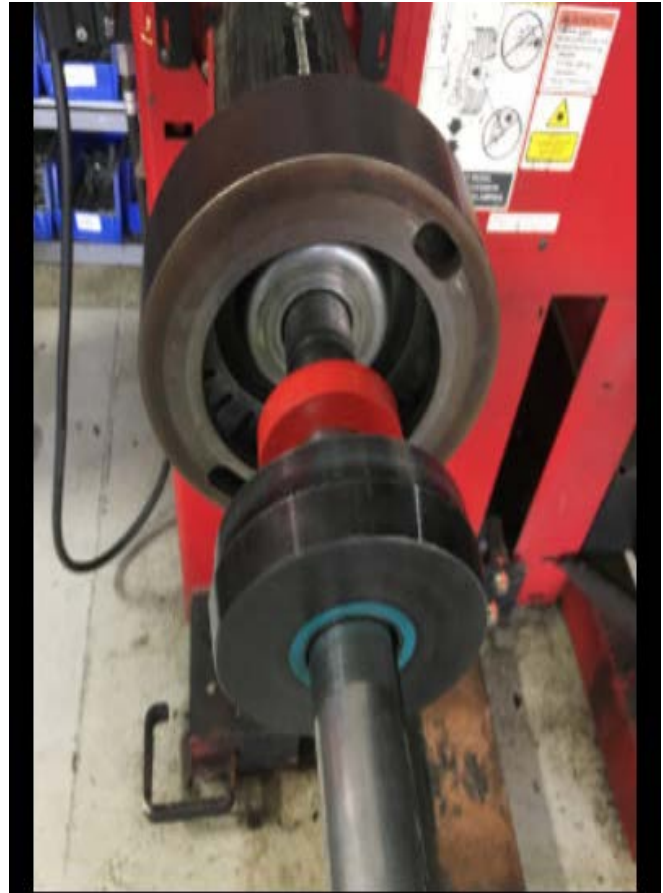
5422805

T1 Y-axis less than 25 mg

- T1 Y-axis consistently under 25 mg and steering wheel dither persists, move to **step 2**.

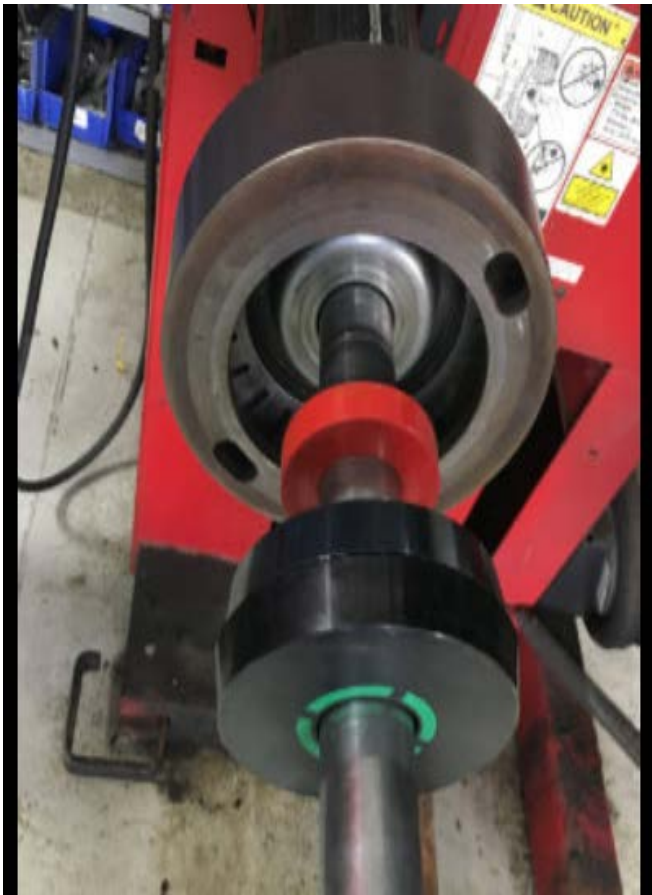
5422806

T1 Y-axis higher than 25 mg

- T1 Y-axis consistently over 25 mg, service all wheel and tire assemblies per the latest version of Corporate Bulletin Number 10-03-10-001.
- When mounting the wheels to the balancer, it is critical to make sure the assembly is held tightly centered during the measurement. Below are adapters that have been verified to maintain this relationship (Single rear wheel only).
- Balance and road force correct the assemblies. It is recommended to get the road force values to the specs below:

Less than 30 lbs on the front tires

Less than 45 lbs on the rear tires
