**Subject:** Engineering Information – Vibration and/or Banging Noise Heard From Under the Vehicle

Brand:	Model:	Model Year:		VIN:		Engine:	Transmission:
		from	to	from	to		
Chevrolet	Silverado 1500 (New Model)	2019	2020	-	-	-	Equipped without Transfer Case - Active Single, Two Speed (RPOs NP0, NQH)
	Silverado 1500						
GMC	Sierra 1500 (New Model)						
	Sierra 1500

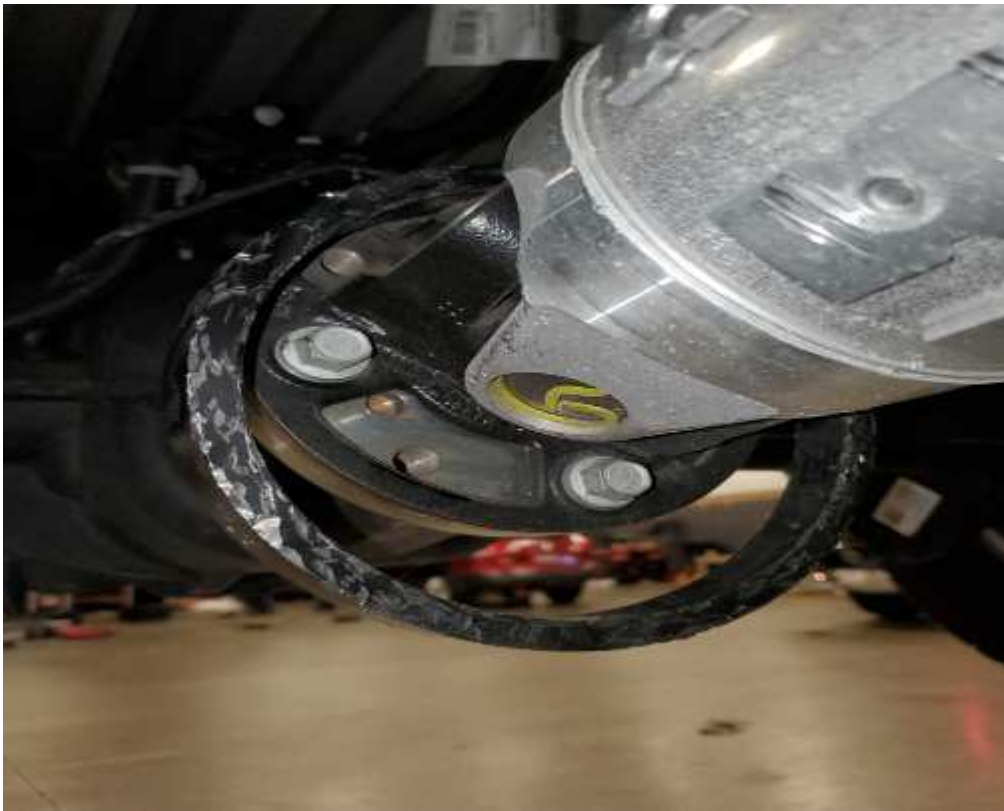
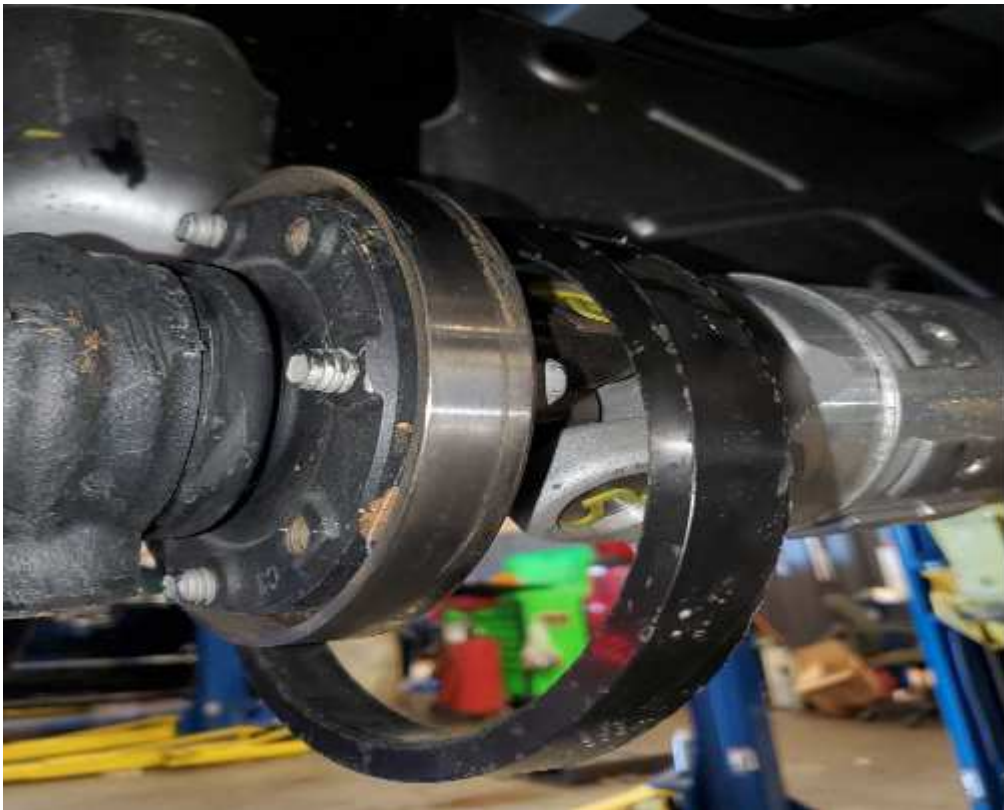
If you encounter a vehicle with the above concern, review the following questions listed below with the customer to determine if there was anything occurred that might have caused the TVA damper from the prop shaft rear flange to come off, as shown in the pictures above. Then contact the engineer listed with your findings.
