Service Bulletin

Bulletin No.: 19-NA-055

Subject: Accessory Front Floor Liner Warped, Bent Inward

Brand:	Model:	Model Year:		VIN:		Engine:	Transmission:
		from	to	from	to		
Chevrolet	Cruze Gen II (VIN B)	2018	2019			All	All
	Cruze Gen II (VIN B)	2020	2020				
	Equinox	2018	2020				
GMC	Terrain	2018	2020

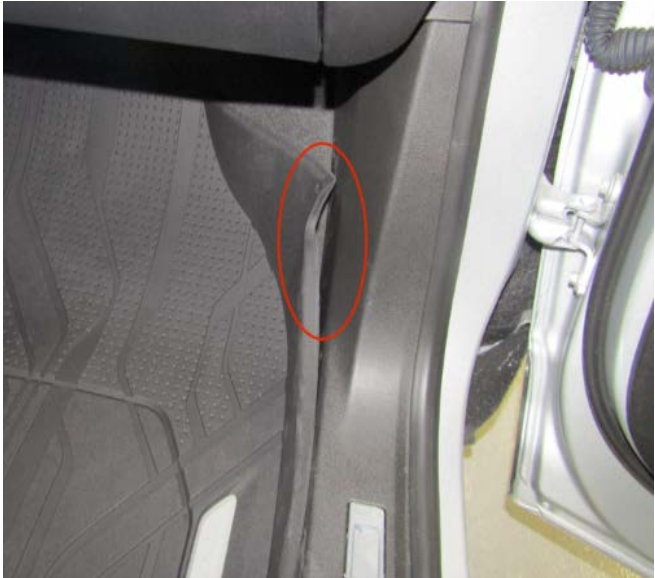
<p style="text-align: right;">5280096</p> <p>Customer may comment on one, or both, front floor liners that being warped or bent inward.</p>
Cause	The cause of the condition may be a wire harness behind the garnish trim which pushes the trim inboard, creating a gap to the floor liner.

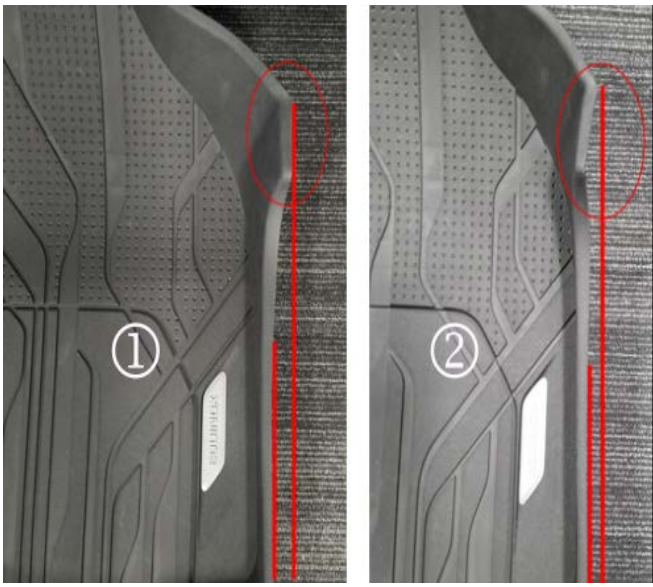
Note: Examples of a good (1) and bad (2) floor liner are shown in the graphic above.

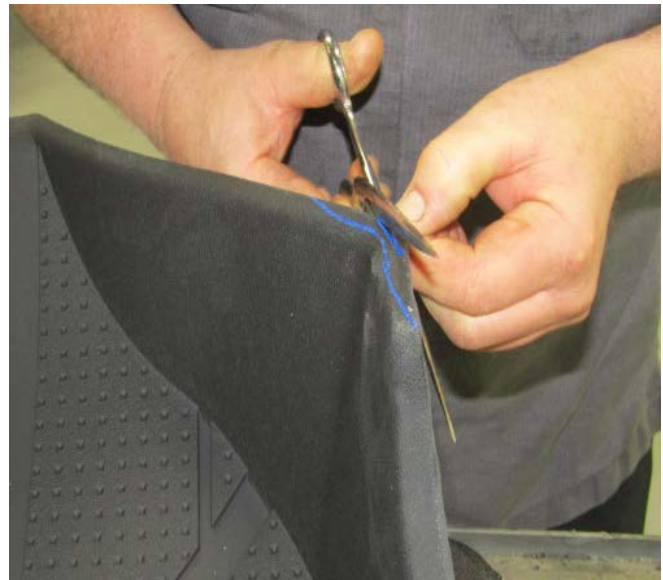
5280130

- If the outboard corner, remains warped or has taken a set, the trimming repair will not improve the condition and it would be necessary to replace the floor liner.
