# Service Bulletin

Bulletin No.: 19-NA-087

**Subject:** Radio Software Version V805 Over-the-Air Update

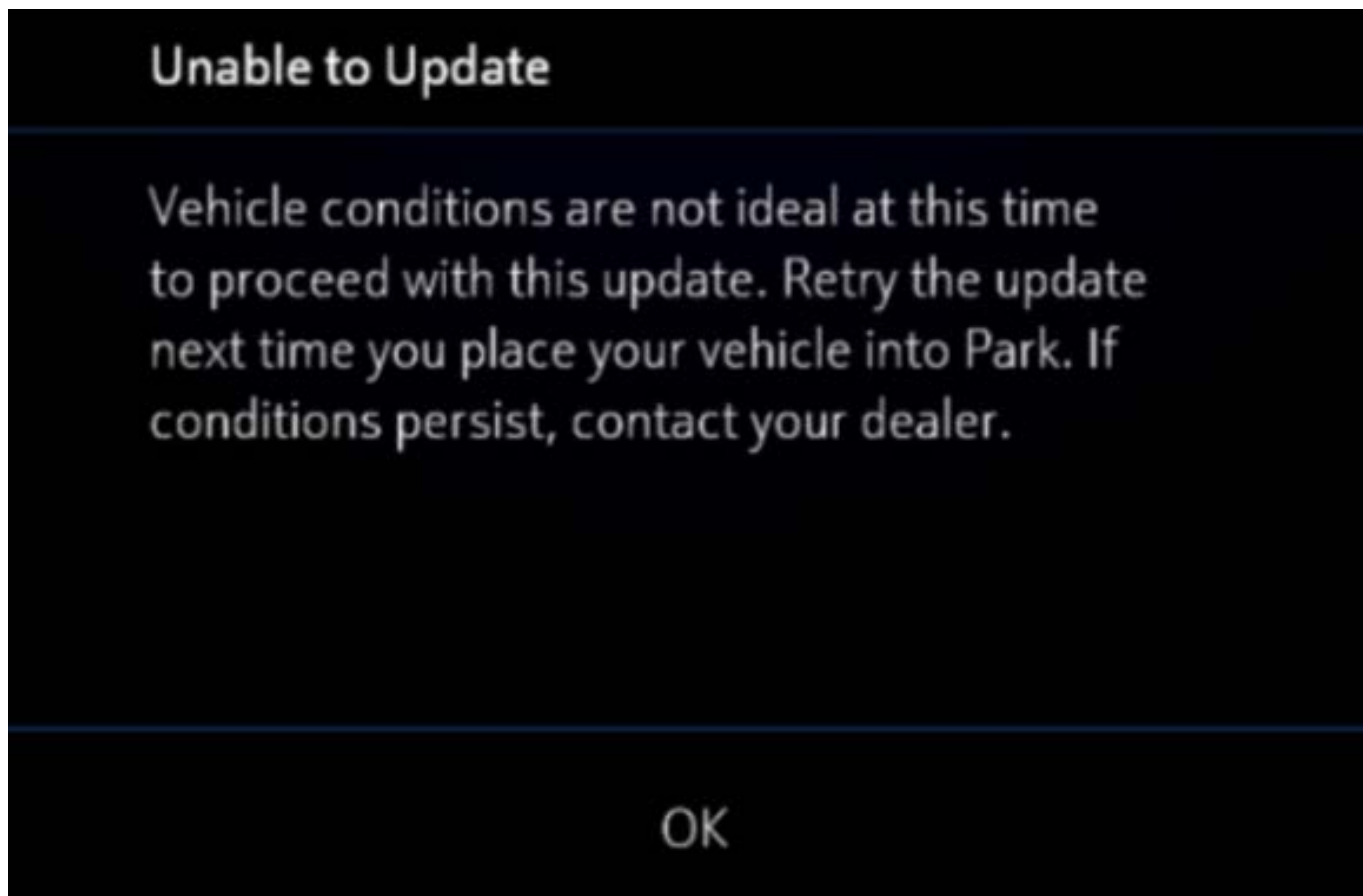
5313329

**Scenario 1:** Vehicle conditions are not ideal.

If the above screen is shown, download the update through TIS2Web and perform USB update. Upon USB insertion while vehicle is running, the "Install Now" pop up will be presented. Ensure the vehicle battery is being maintained (using EL-49642 or battery maintainer) while performing this update.

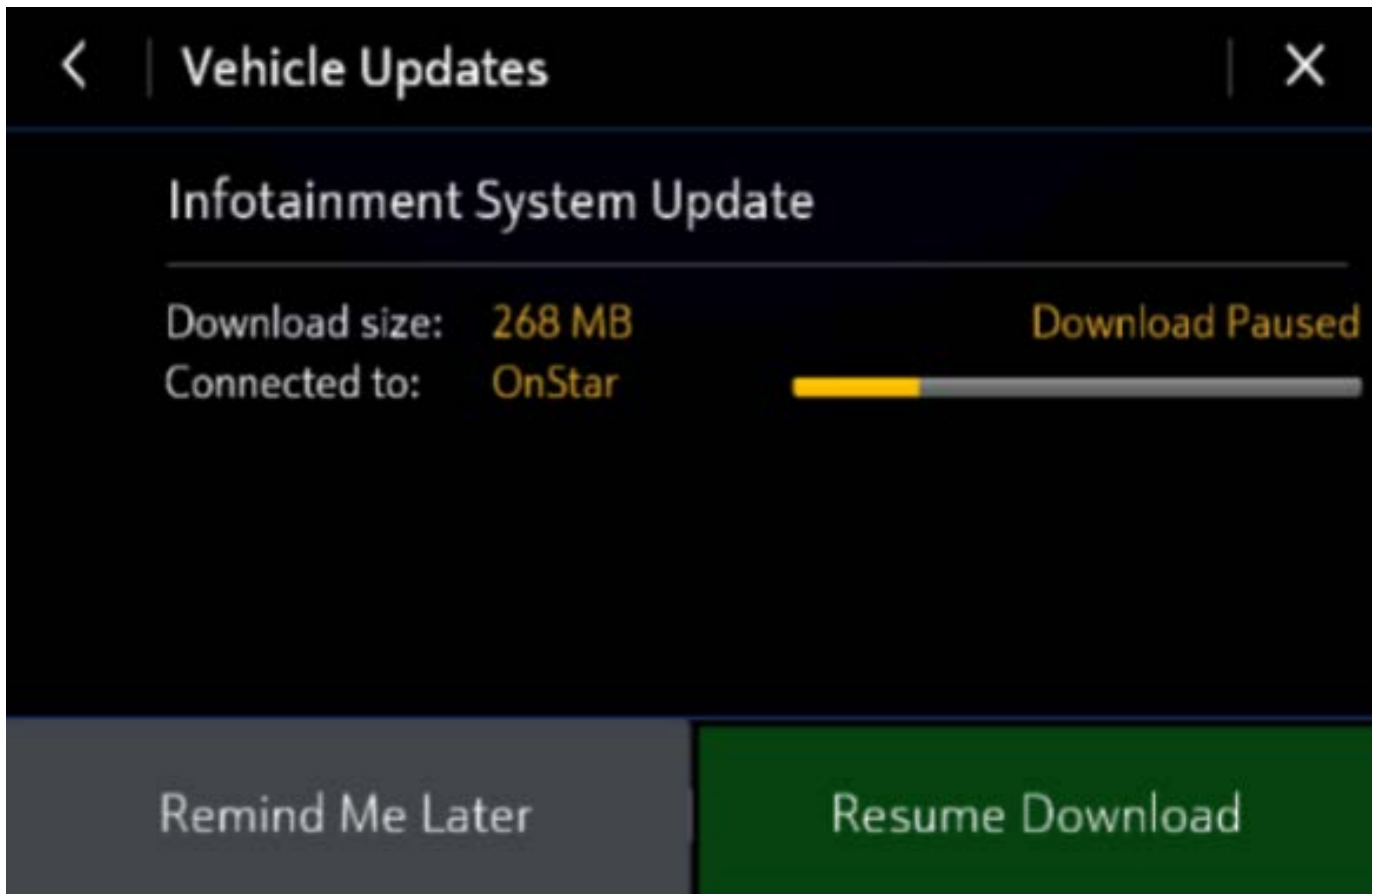
5313326

**Scenario 2:** Consistently Paused Download

If the above screen is shown and resuming the download repeatedly fails, a USB update will need to be performed. Turn the vehicle on, return to the home screen, and insert USB stick (see previous section). A pop up should be shown to "Install Now." Click "Install Now", verify the part number is correct and follow on screen prompts.

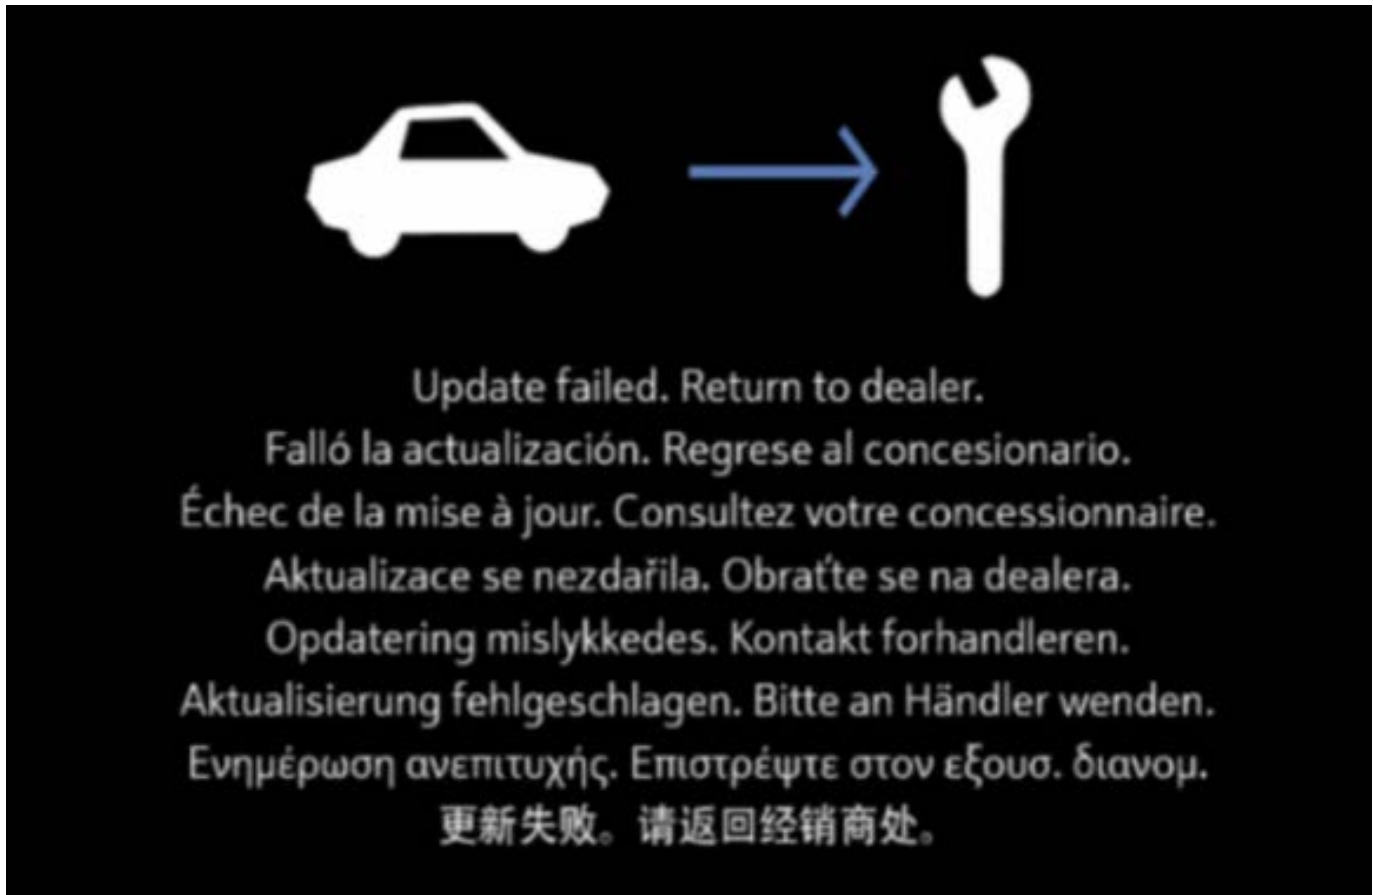
5313330

**Scenario 3:** Update Failed. Return to dealer screen.

1. If the above screen is shown, download the update through TIS2Web and insert USB stick into the radio **twice** (USB stick is not recognized on first insertion). A blue progress bar should come on the screen and update will proceed. If this screen above is shown when trying to update the radio through USB, reformat to FAT32 on your PC, and then try to download the update through TIS2WEB again.

2. After selecting USB File Transfer, if you are prompted by TIS2Web to select a software P/N then follow the on-screen instruction to attempt to gather the software P/N from the A11 Radio using GDS2 scan tool. If GDS2 indicates the radio is not communicating, go back to TIS2Web, select A11 Radio, and select when radio displays **"Update failed. Return to dealer."** to complete the USB File Transfer programming event.

3. If the screen above is shown again, contact Technical Assistance (TAC) for further assistance.
