Service Bulletin

Bulletin No.: 19-NA-103

Subject: Intermittent Click Noise at Front of Vehicle, ABS, Traction Control System (TCS)/ Stabilitrak Lamps May Illuminate Intermittently and/or Deactivate for Ignition Cycle, DTC P0721, P215B, C0500-C0504 and/or C0506-C050A Set

Brand:	Model:	Model Year:		VIN:		Engine:	Transmission:
		from	to	from	to		
Chevrolet	Volt	2016	2019

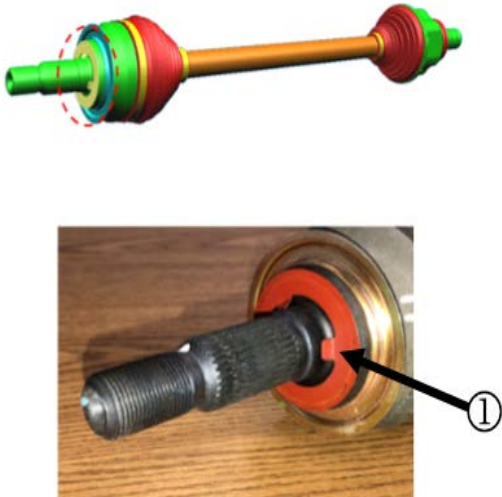
5317523

Involved Region or Country	North America, Europe, GM Korea Company		
Condition	<p>Some customers may comment on hearing an intermittent click noise in the front of vehicle. The ABS, TCS/Stabilitrak system lamps may also illuminate intermittently and those systems may be deactivated/shut off for that ignition cycle.</p> <p>Technicians may find one, or more, of the following DTCs set: P0721, P215B, C0500-C0504, C0506-C050A.</p>		
Cause

Correction	<p>Upon verifying the condition, remove and discard the anti-click washer on the affected half shaft(s), then inspect the wheel speed sensor on that side(s). Follow the recommended steps in the Service Procedure below.</p>

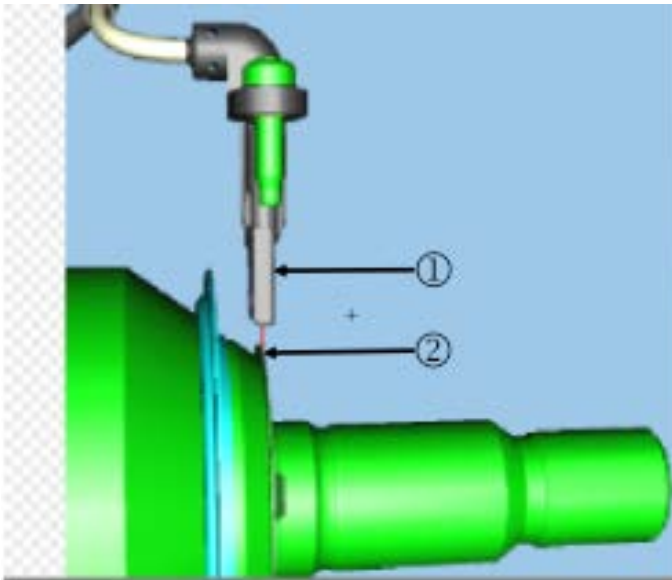
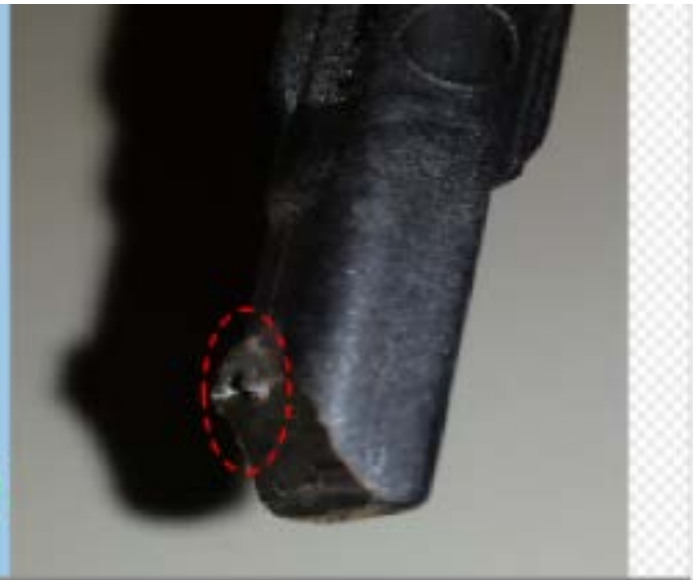
5317529

Note: As shown in the above illustration, the wheel speed sensor (WSS) (1) is directly in-line with the anti-click washer (2) on the outboard joint of the half shaft.

4. **Before reinstalling the bearing/hub**, inspect the WSS on either/both affected side(s) for possible damage. It may be damaged due to contact with the oversized damaged washer.

- If no damage is found, reinstall the front wheel bearing and hub assembly, and no further repairs are necessary. Refer to *Front Wheel Bearing and Hub Replacement* in SI.
- If the WSS is found to be damaged (as shown circled in the graphic above), continue ahead to step # 5 and replace the WSS.
